1 **Geomorphological impacts of an extreme flood in SE Spain**

3 J. M. Hooke

## 9 **Abstract**

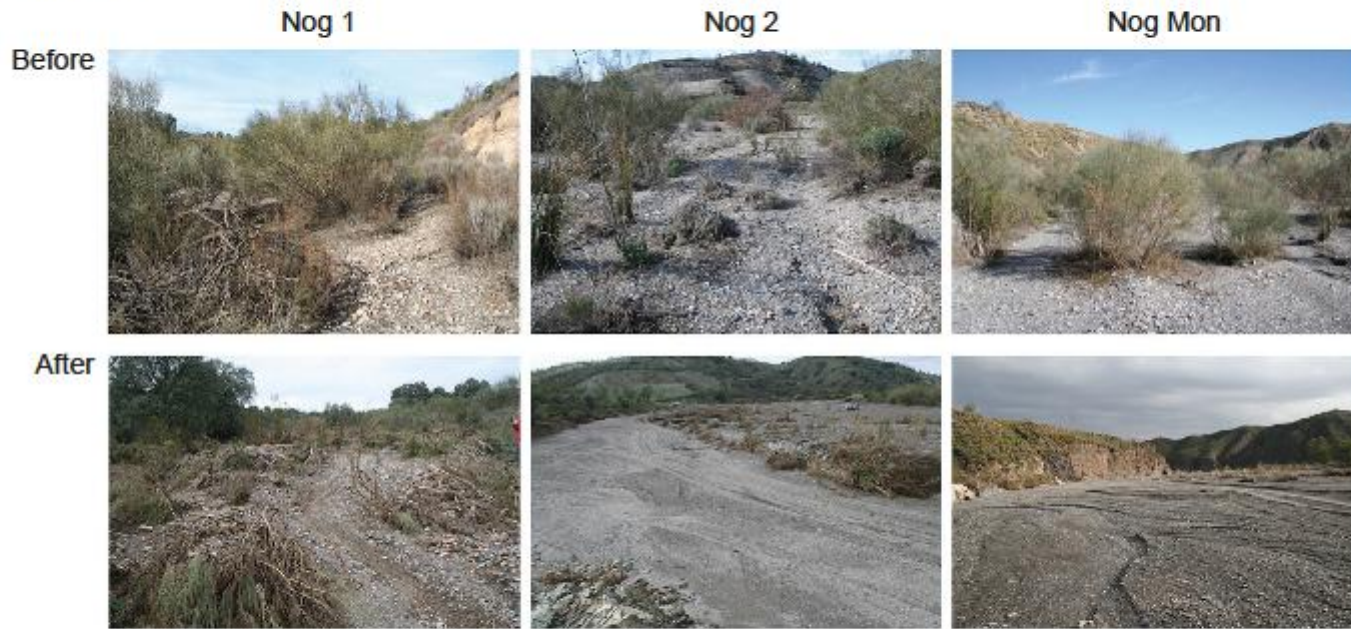
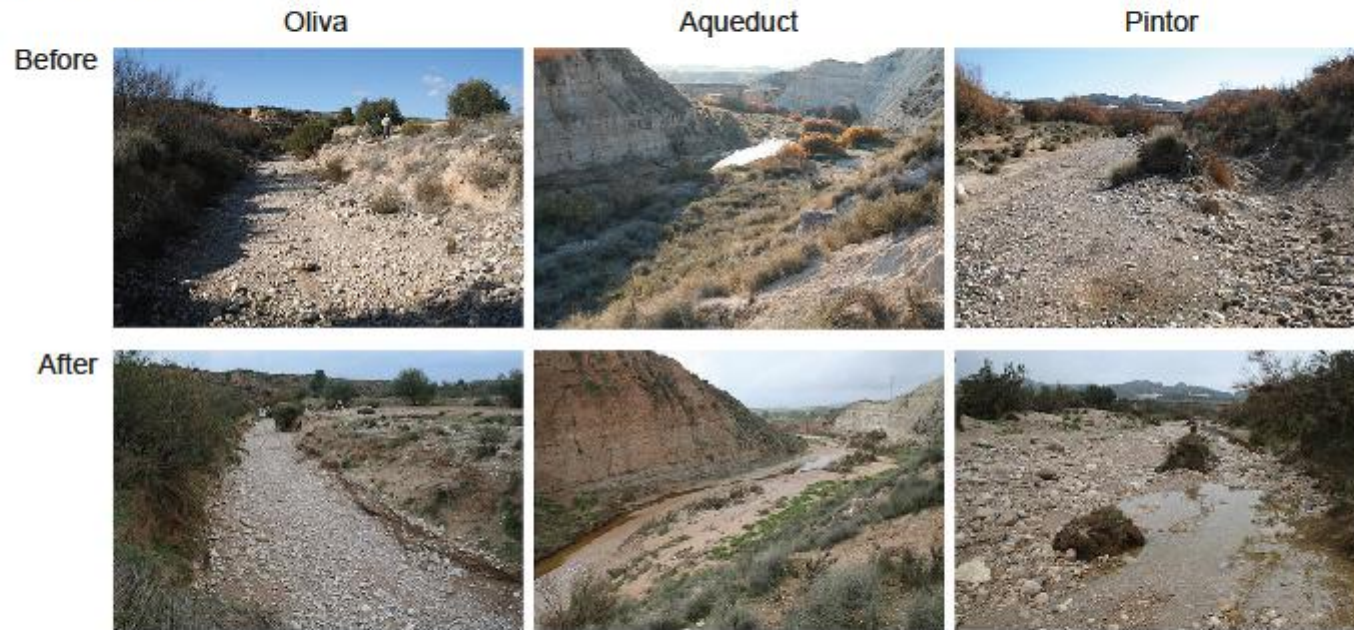
(A) Nogalte

(B) Torrealvilla

166 Nogalte and Torrealvilla can be seen in Figure 2, and in comparison with the post-flood state. The  
167 characteristics of each site are provided in Table 1. The Nogalte is a schist catchment and the  
168 channel is composed of very loose, friable gravel with limited, very coarse material. Some narrow,  
169 confined bend reaches occur; but much of the course, including the monitored reaches, is braided,  
170 comprising low relief channels, with the full, active channel width occupying much of the valley  
171 floor. A main, primary, or inner (low flow) channel (Hooke and Mant, 2002b) is present but multiple  
172 minor channels flow across the braid bars (Fig. 2A). The extensive gravel bars are mostly vegetated  
173 by *Retama spp.* bushes. The Torrealvilla is in marl bedrock with overlying extensive gravel terraces  
174 on the upper slopes. The marl is highly erodible, and sediment load ranges from cobbles to silt-clay.

175 The channels are mostly confined in narrow valleys and are predominantly single, wandering  
176 channels (Fig. 2B). Some check dams are present in the main stem and in tributary headwaters,  
177 including some that were destroyed in the 1997 event (Hooke and Mant, 2002a) and have since  
178 been rebuilt.
