Article

Detecting and Monitoring Cracks in Aerospace Materials Using Post-Processing of TSA and AE Data

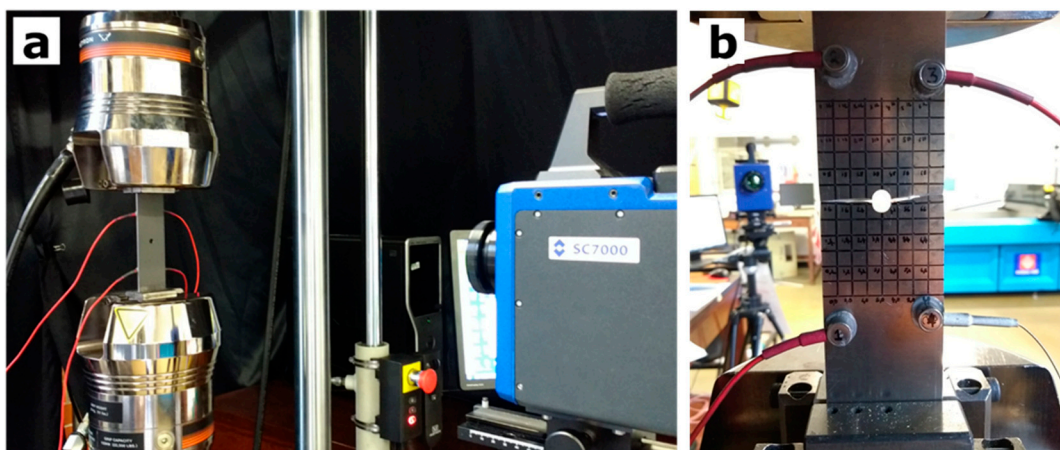
Four AE sensors (Nano 30; MISTRAS Group, Inc., Cambridge, UK) were bonded to the back of the specimens, as shown in Figure 1b, using silicone sealant (Loctite 595), which also served as the acoustic couplant between the sensors and the specimen. Once bonded, a Hsu-Neilson sensitivity test was conducted to ensure adequate coupling, with all sensors recording 99 dB responses [17].

Figure 1. Experimental set-up: (a) From front (thermoelastic stress analysis (TSA) data collection) and (b) back (acoustic emission (AE) data collection). Specimen width is 40 mm.

sensor number was constrained by the acquisition system to four. The asymmetric sensor positioning, shown in Figure 1, was selected intentionally to avoid symmetry in the maps of difference in time of arrival between sensor pairs, as symmetry has been found to increase the likelihood of finding multiple crossing points in the Delta-T Mapping process and thus calculate erroneous location results [18].

The front of the specimen was coated with a thin layer of graphite (Graphit33; Kontakt Chemie, Iffezheim, Germany) and then loading was carried out under tension–tension cyclic conditions with $F_{\max} = 11.62$ kN and $F_{\min} = 1.162$ kN, at a frequency of 13 Hz. Data were collected simultaneously from the TSA system and AE systems until the specimen failed (Figure 1).

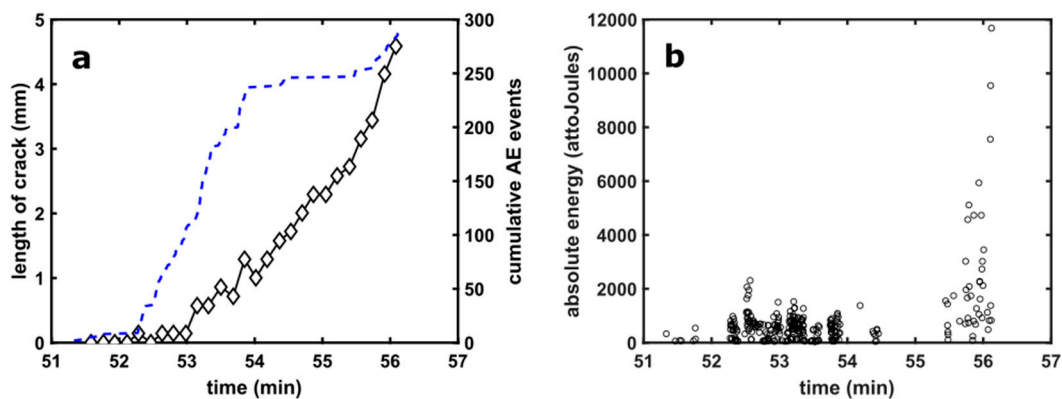
The first indications of cracking behaviour were detected in the AE data 51 min 20 s after fatigue cycling began. It can be seen in Figure 2a that AE events began to be recorded at this time, and that these were low energy events (Figure 2b). The optical flow technique indicates the initiation of a crack tens of seconds later. Both the number of AE events and the energy of each individual event show a general increase until 56 min, when full failure of the specimen occurred. The crack length, as calculated from the optical flow algorithm, also increases to a length of 4.6 mm in the same timeframe (Figure 2a). Just before final failure, there is a large increase in the energy released during each AE event, which would be expected as crack propagation speed increases during failure of the specimen.

Figure 2. Results of TSA and AE testing on one specimen: (a) Length of crack as calculated using the optical flow algorithm (black diamonds) and cumulative AE events (blue dashed line). (b) Absolute energy of individual AE events.

A plateau in the AE events can be seen between approximately 54 min and 55 min 30 s; however, the same trend is not seen in the crack length as measured by TSA. This apparent reduction in AE activity is unexpected, as the crack growth activity is expected to continue throughout, producing AE events. Examination of events before and after this plateau reveals that the amplitudes are only just above the 55 db threshold, therefore we assume that events were “just missed” due to the high threshold selected to eliminate background noise; this is exemplified in Figure 3 which shows a typical AE hit from this experiment. This hit was recorded on AE channel 1 as part of an event calculated to have originated from the region of cracking (corresponding to $x = -5.89$ cm and $y = -1.24$ cm in Figure 4). It can be seen that the constant background noise, clearly visible in the pre-trigger region (before time = 0), is relatively high, reaching 0.0458 V, or 52.22 dB, in this particular example, with the vast majority of its energy at 30 kHz. The transient energy arriving at the trigger point is characteristic of AE originating from crack growth activity due to its high rise time and frequency content [20], with the majority of the energy in this instance contained between 200 and 330 kHz likely owing to the resonance of the sensors in this region.

The position of identified AE events located with Delta-T Mapping can be seen in Figure 4a, where most events are clustered around the crack position. However, events were also registered far from the crack, at up to 30 mm from the crack path. As seen in Figure 2b, the later events are higher energy but there is no correlation between time and expected crack-tip position (i.e., later, larger energy events are not closer to the edge of the specimen). Though unmeasurable, as the true source locations are unknown, it would appear that the error in the location of AE signals collected during the experiment is larger than the 1.71 mm error calculated in the preliminary location study (for example, locating events in the central hole). This is likely due to the fact that the preliminary location study was conducted with Hsu-Neilson sources, which give a large amplitude signal that are inherently easier to locate than the low amplitude signals recorded during this experiment. Furthermore, as the specimen was not being loaded in the test machine during the collection of preliminary data for the location study, it was not subject to the noise which is present in the experimental data. The structured noise in the experimental data likely acts to reduce the accuracy of the identification of the start time of the hit using the Akaike Information Criterion which forms part of the Delta-T Mapping process (for a full description, see [15]), thus giving a lower accuracy of location than expected.

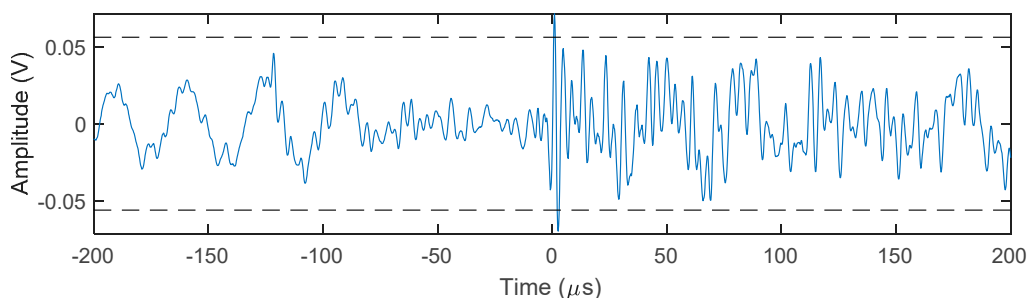
Figure 3. Typical AE hit for this experiment, recorded on channel 1 and associated with the AE event at $x = -5.89$ cm and $y = -1.24$ cm.

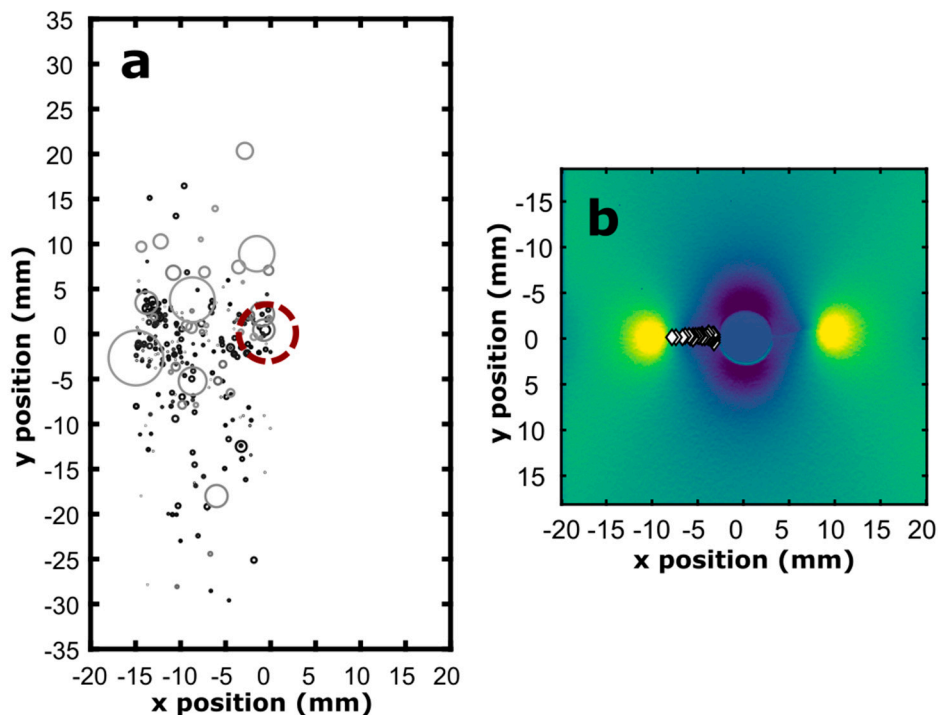
Figure 4. The location of (a) AE events as determined with Delta-T Mapping; darker circles are earlier in time, larger circles have higher absolute energy, and (b) crack positions as determined with the optical flow TSA method. For clarity, data are only shown on the side of the specimen where the first crack initiated. AE and TSA data are plotted on the same scale; AE region of interest (ROI) was larger in the vertical direction than the TSA data collection ROI.

In contrast, the crack-tip positions located with the optical flow analysis of TSA data are shown in Figure 4b. The optical flow data have been reflected about the longitudinal axis to allow direct comparison with the AE data, and only data from the left-hand side of the hole are shown for both TSA and AE results, as this was the first crack to initiate. The optical flow results are much closer to the crack path than the AE events, and have previously been shown to match well with the final crack morphology [9].

It should be noted that the specimen geometry was chosen based on previous TSA experiments [9]. Therefore, it was designed to produce optimum conditions for the TSA method to locate the crack position, but not the AE. In fact, the small size of the specimen means that the AE sensors are positioned very close to one another, meaning that the difference in time of arrival of signals between one sensor and another is also small, and thus the inherent recording errors have a very large impact on the accuracy of the technique in this instance. Furthermore, the size of the specimen creates a situation where there will be multiple large amplitude reflected signals which will also produce erroneous locations. This said, for practical SHM purposes the ability to detect a cluster of high energy events to within 30mm of a source of damage may be adequate information for maintenance purposes.
