POST FAILURE ENERGY ABSORBING MECHANISMS OF FILAMENT
WOUND COMPOSITE TUBES

Thesis submitted in accordance with the requirements
of the University of Liverpool for the degree of Doctor
in Philosophy by Robert Keal.

September 1983

Department of Metallurgy
and Materials Science,
University of Liverpool.

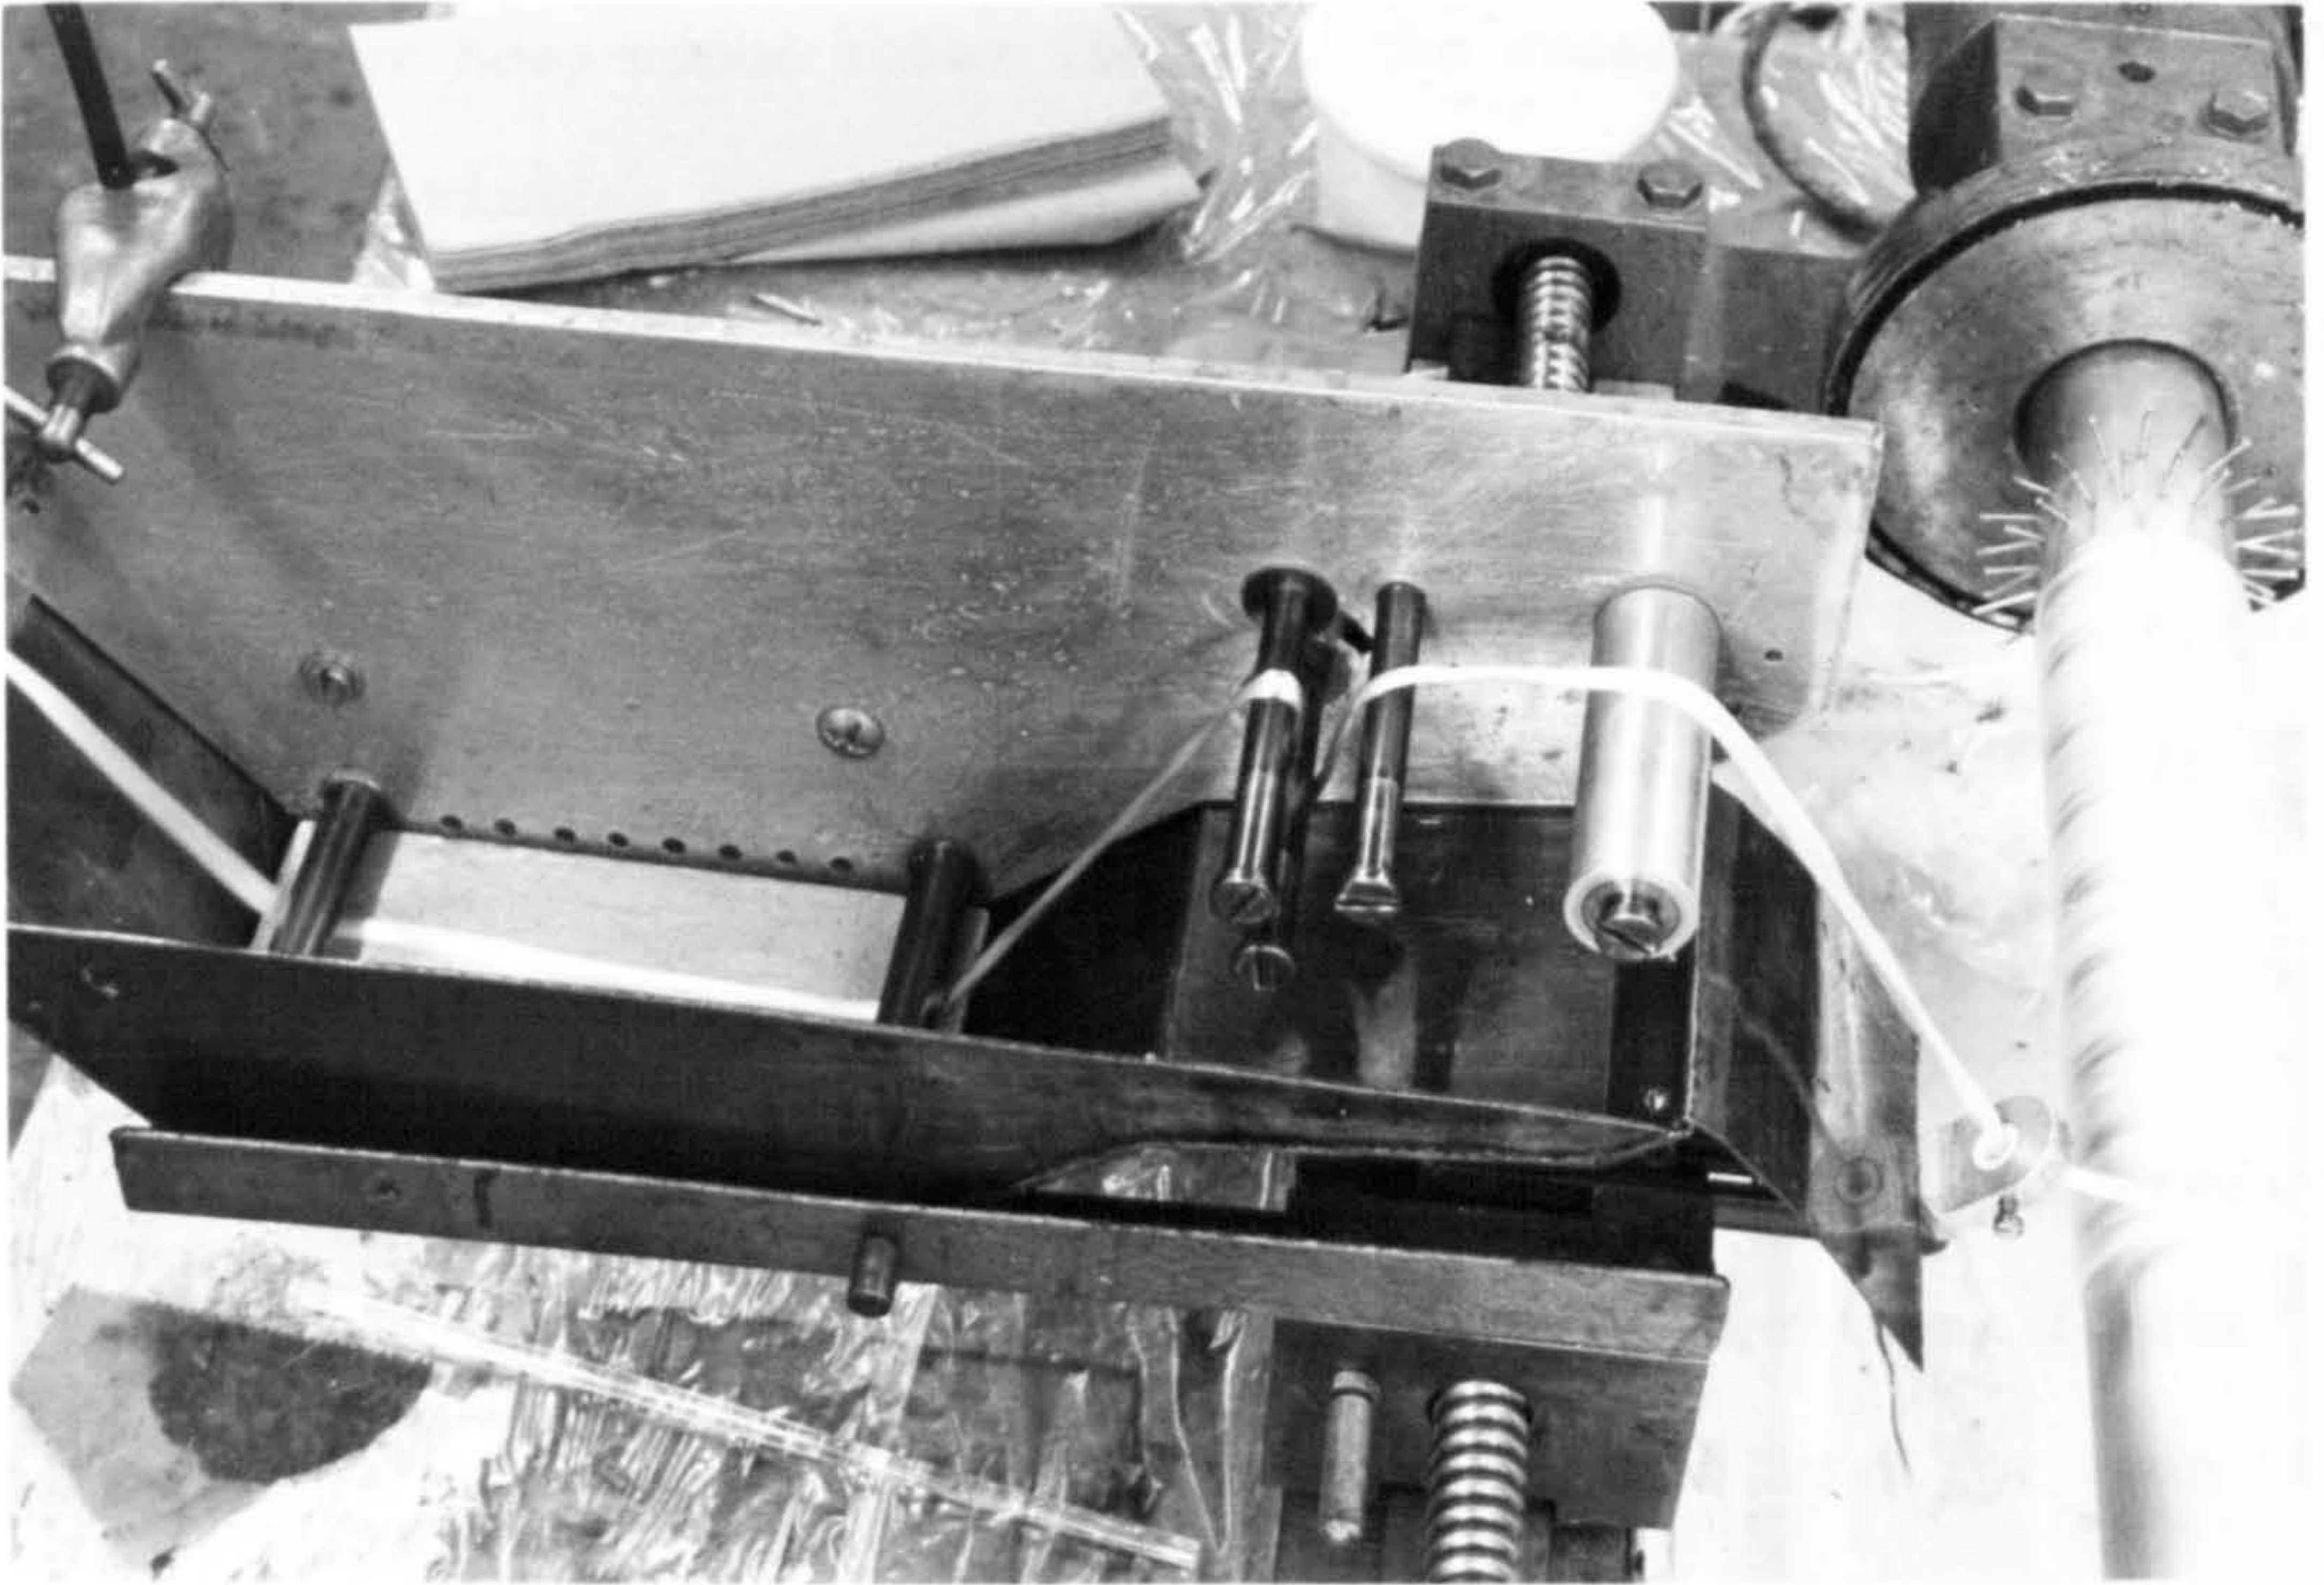
Fig.3.2. Resin bath on the filament winding machine. Note the glass fibres passing through the bath and around the guide pins. Resin omitted to improve clarity.

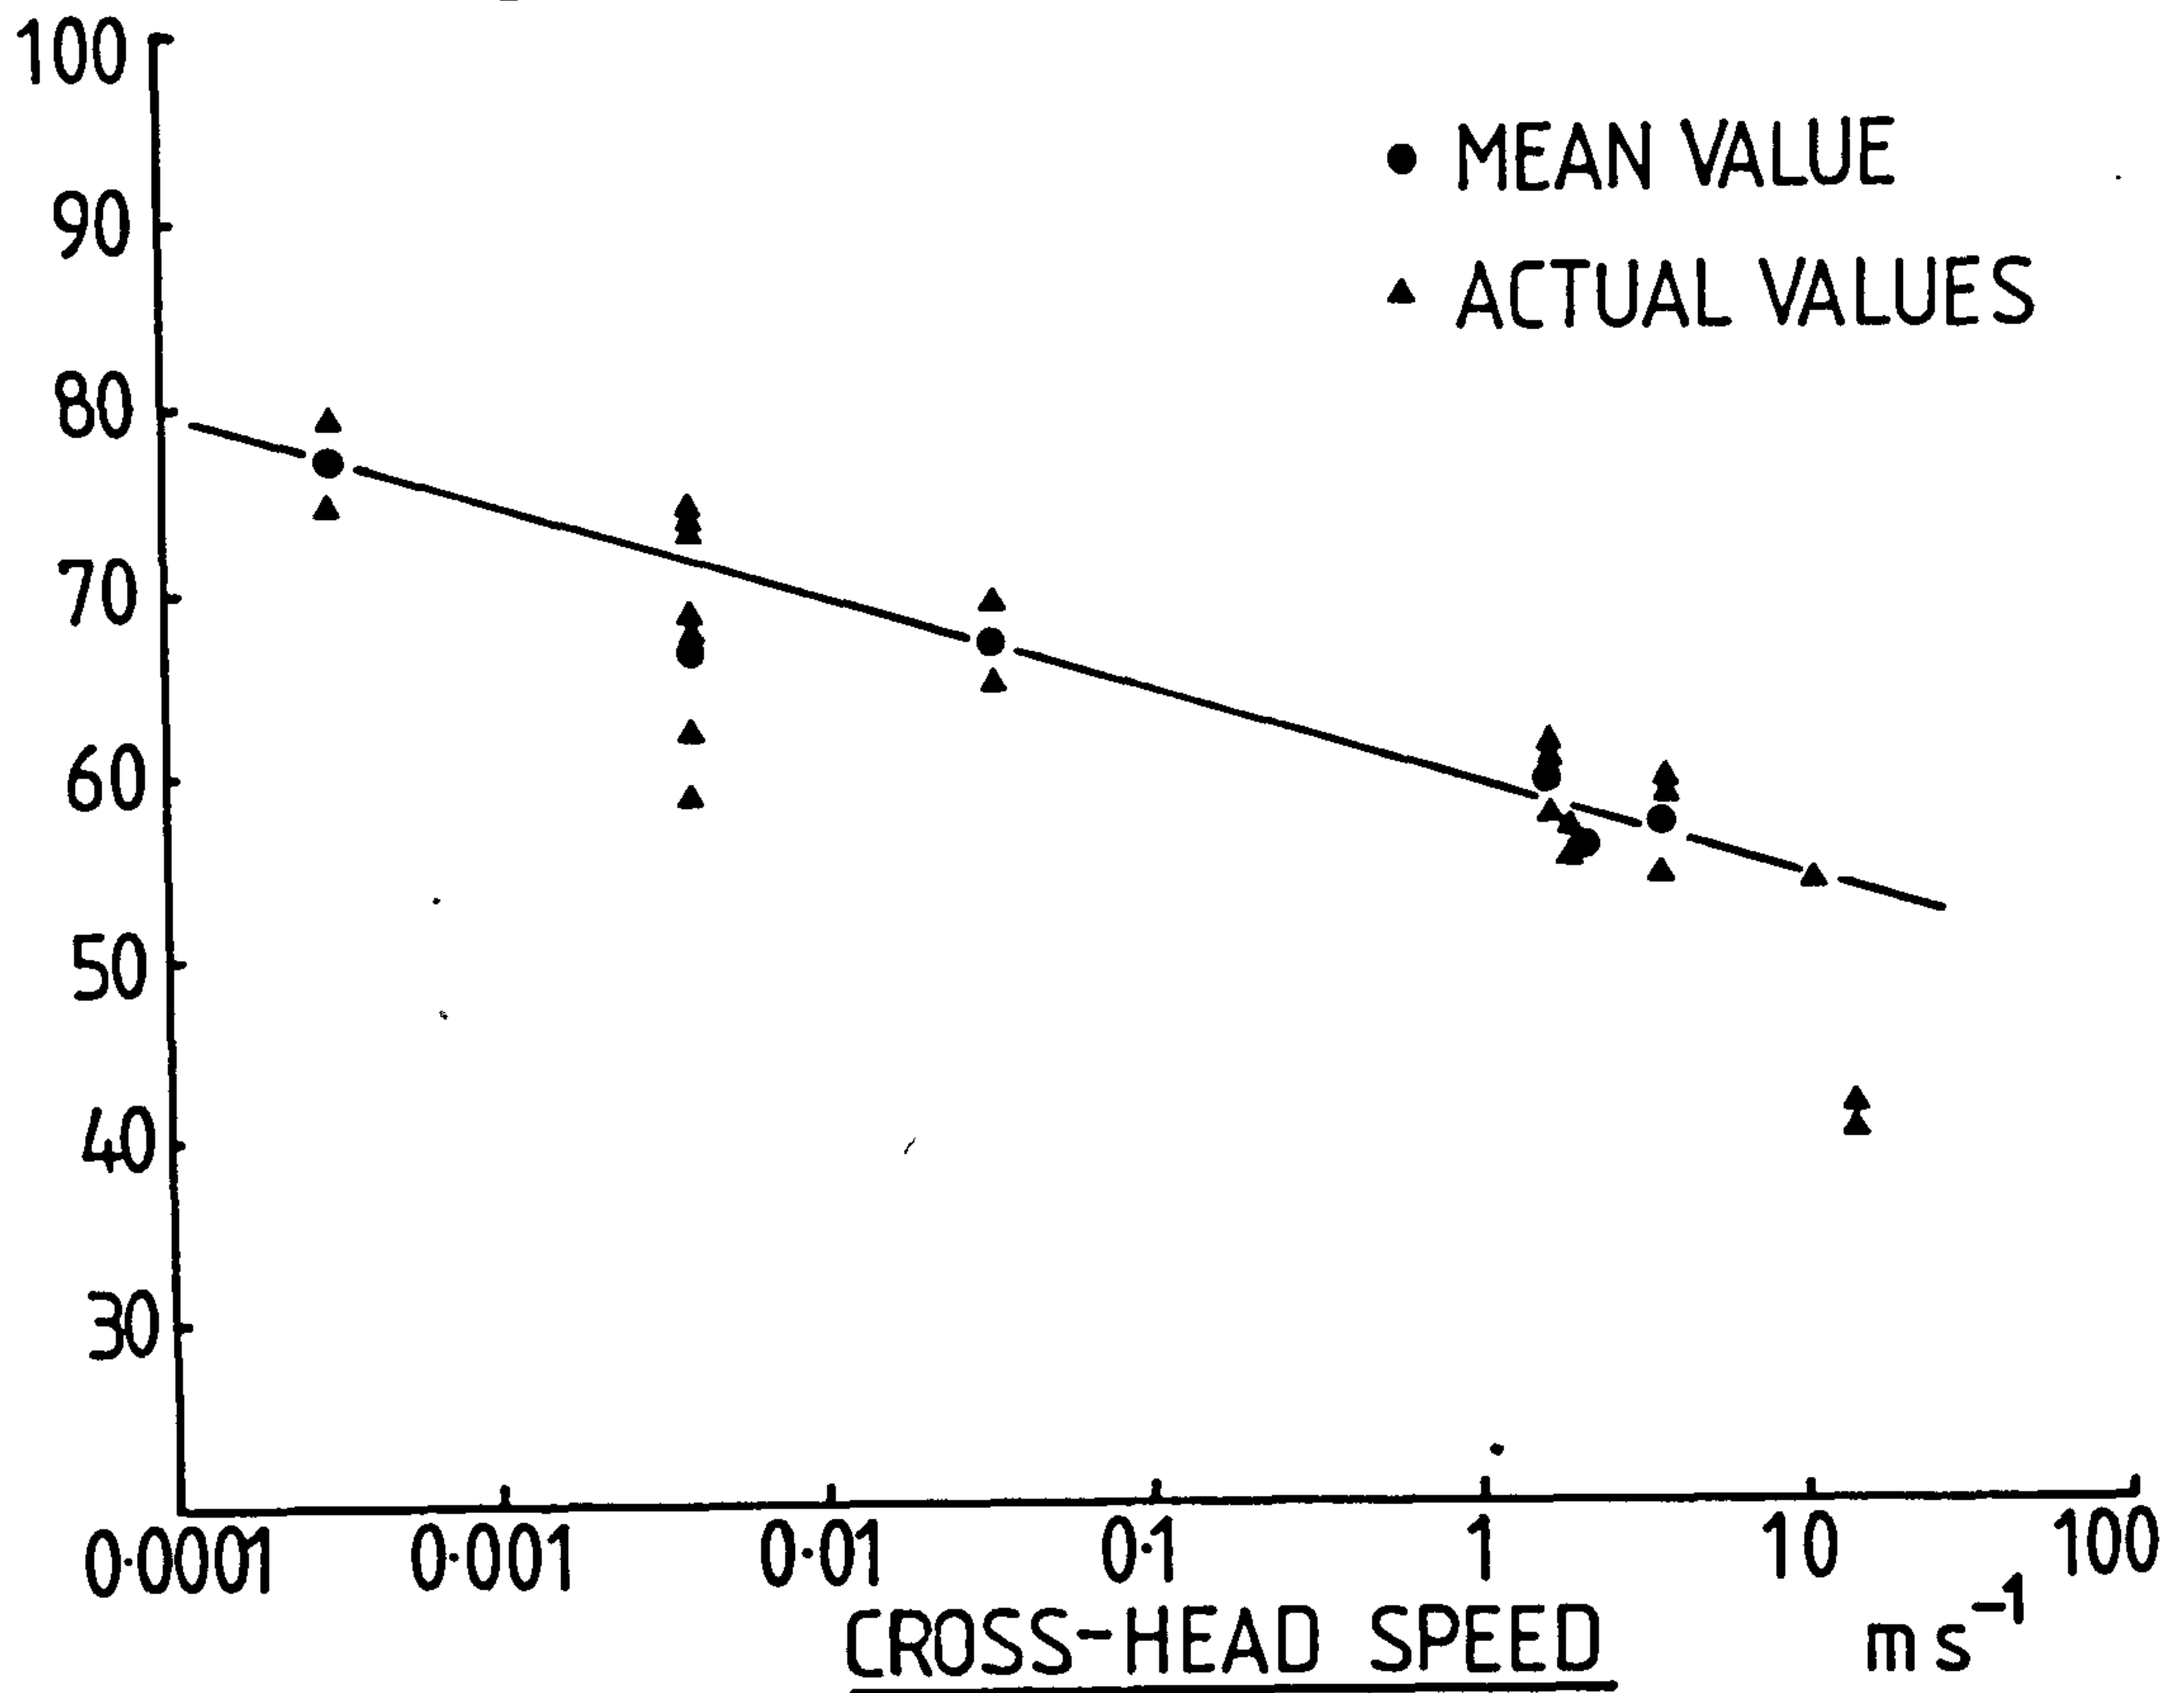
Fig. 4.2. Variation of specific energy absorption during crushing of polyester 0/90 degree tubes with cross-head speed.

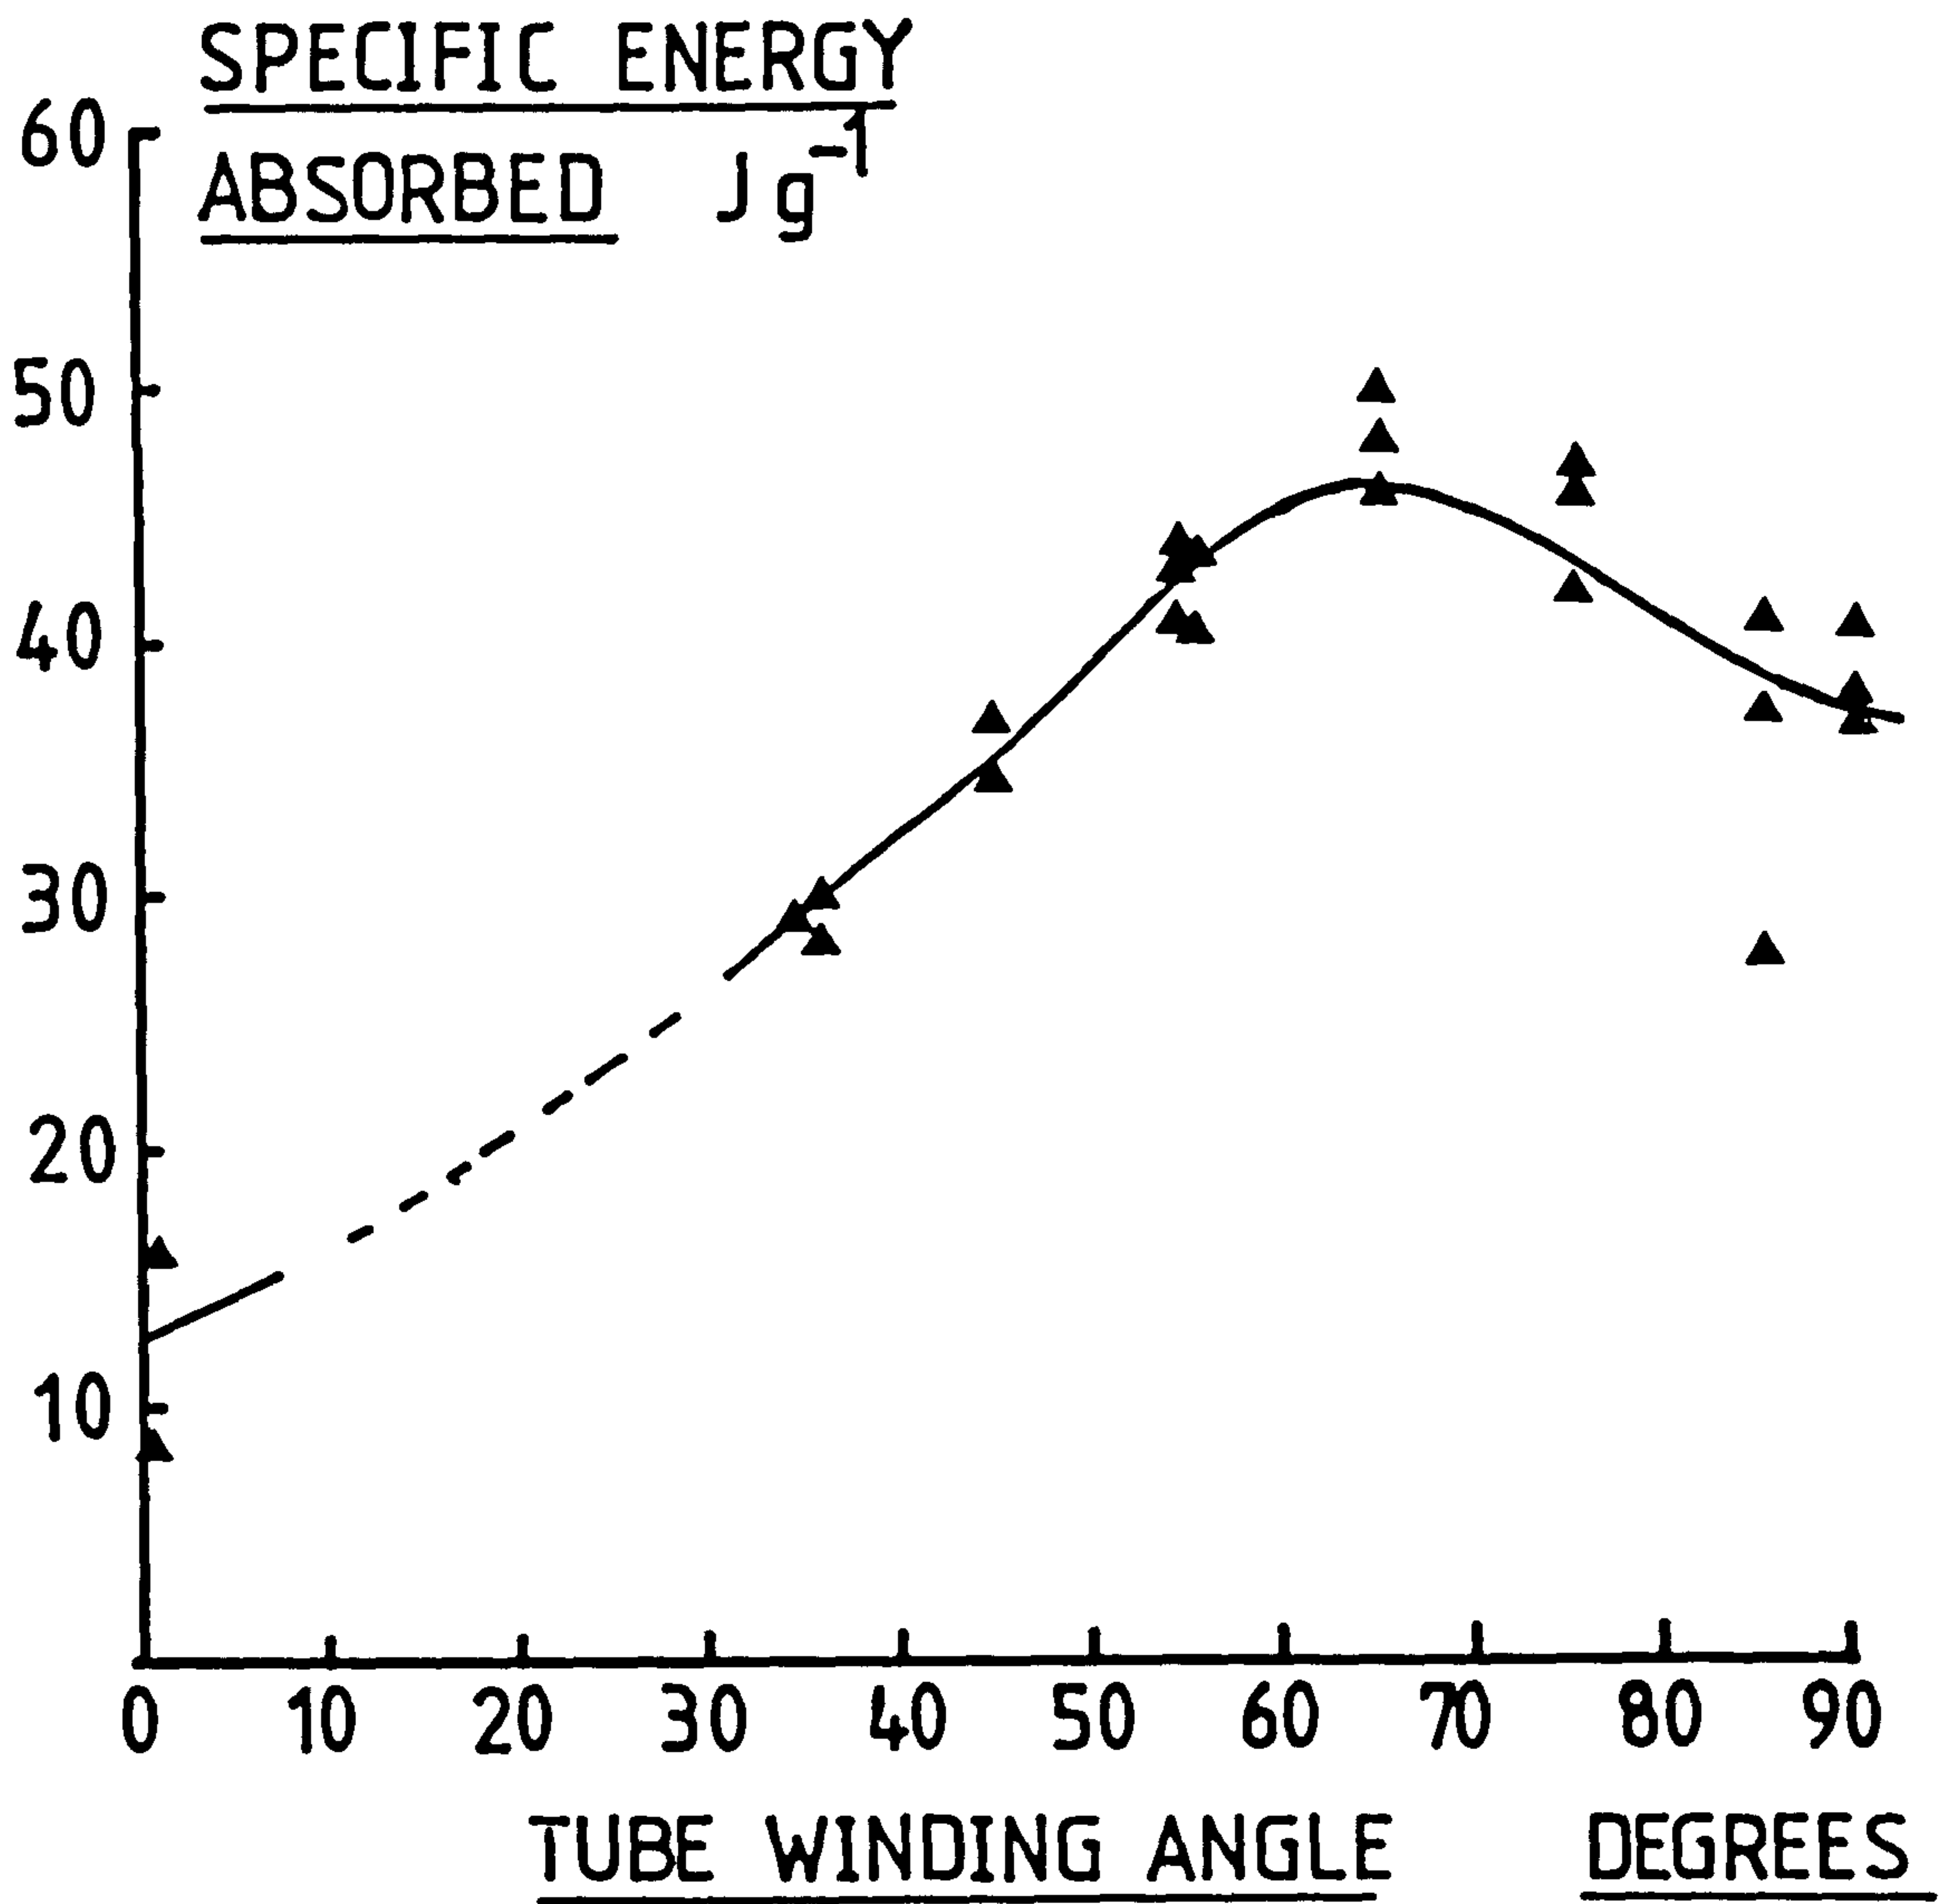
Fig. 4.14. Effect of fibre orientation on the specific energy absorption of polyester tubes crushed at $0.16 \times 10^{-3} \text{ ms}^{-1}$.

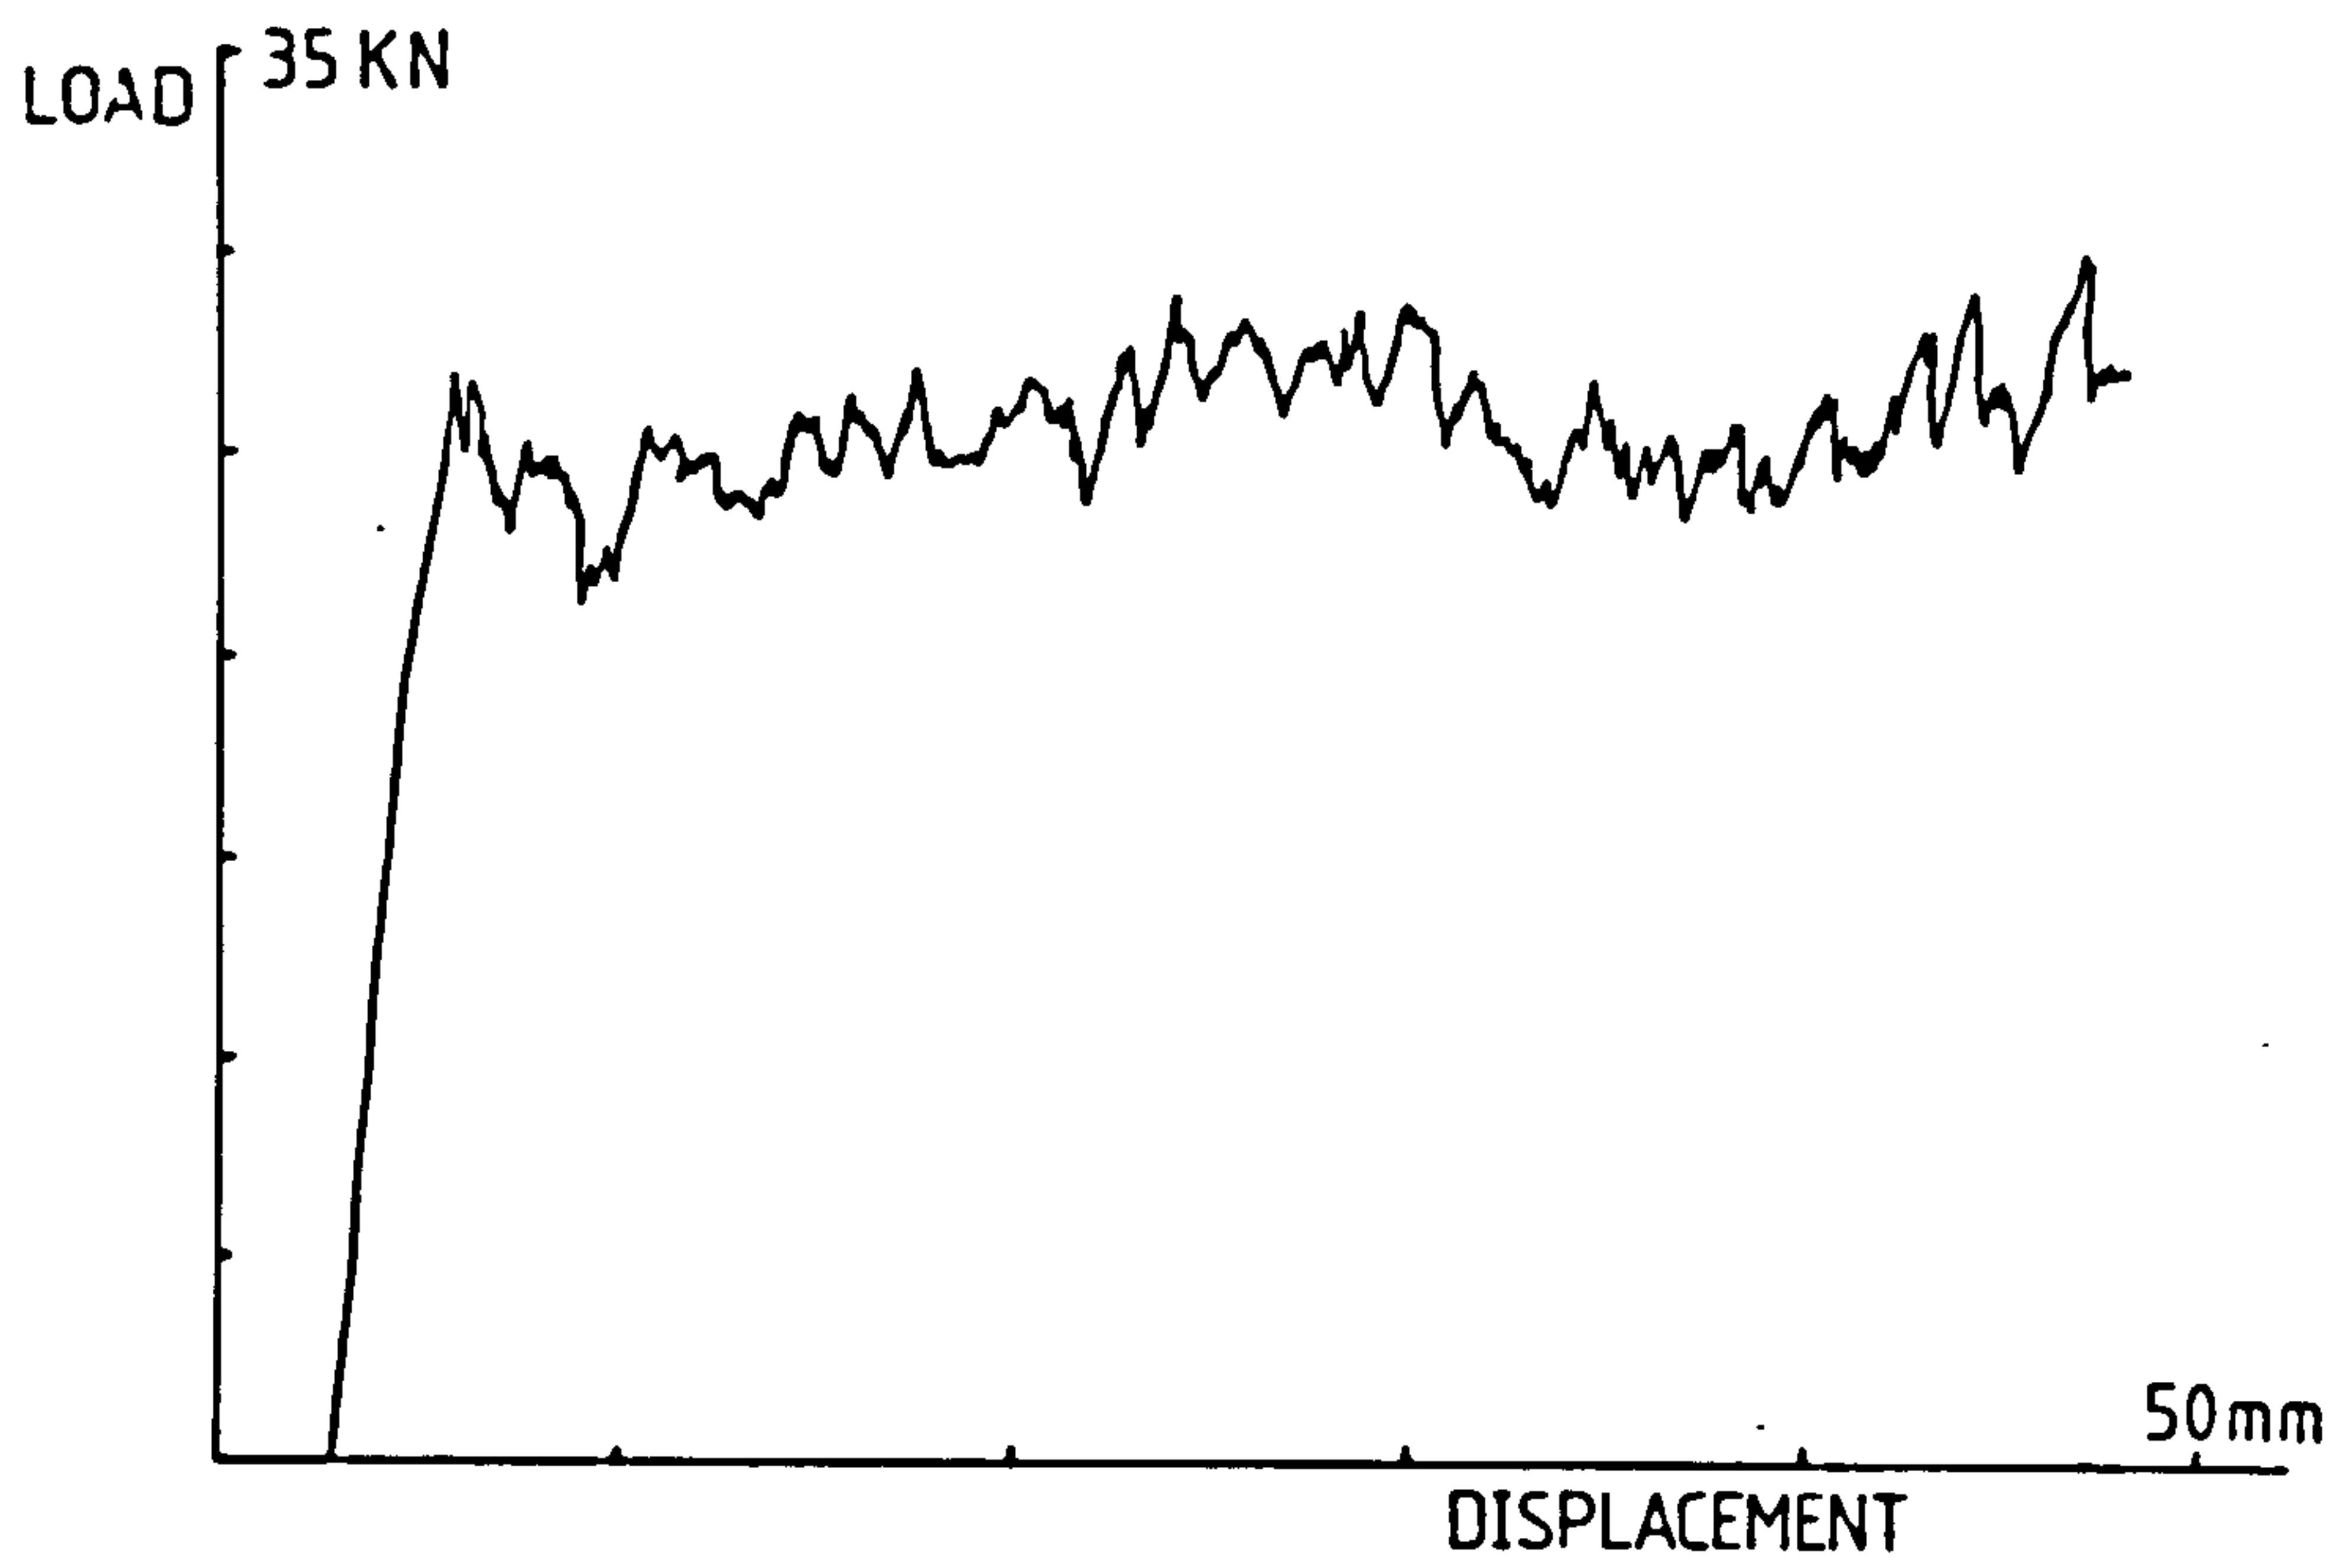
Fig. 4.19. Typical load-displacement trace for a 75 degree angle tube.

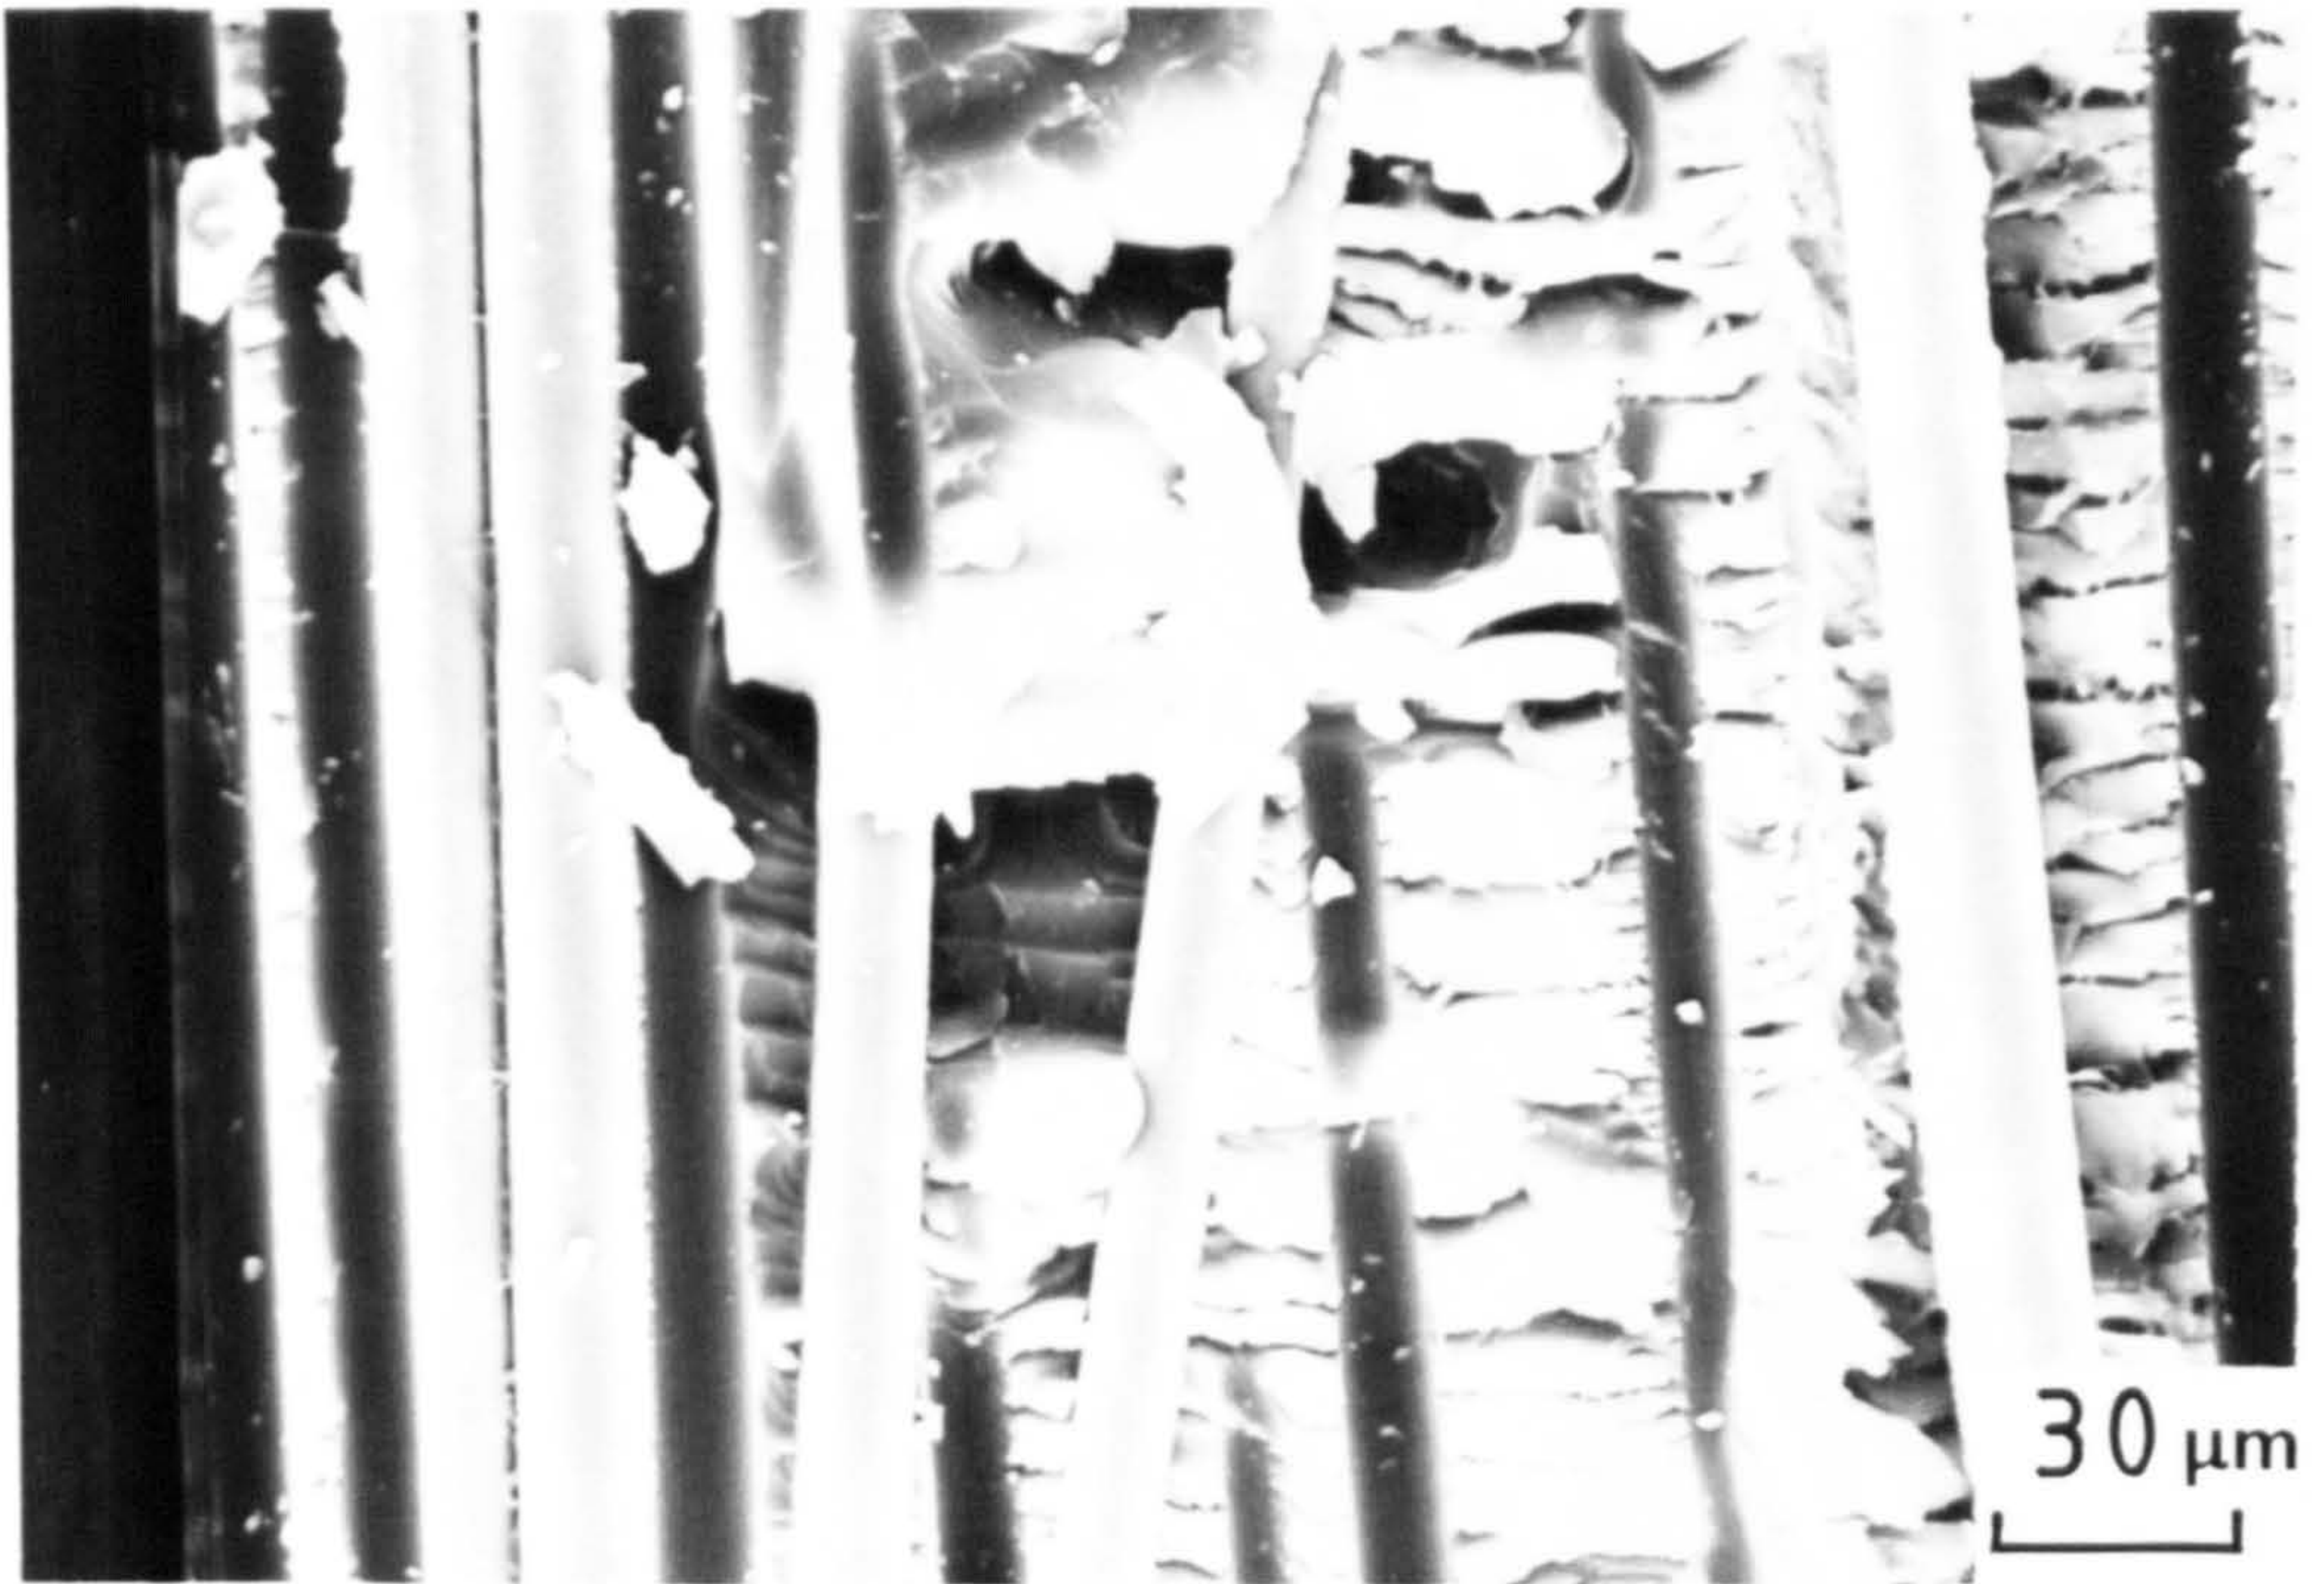
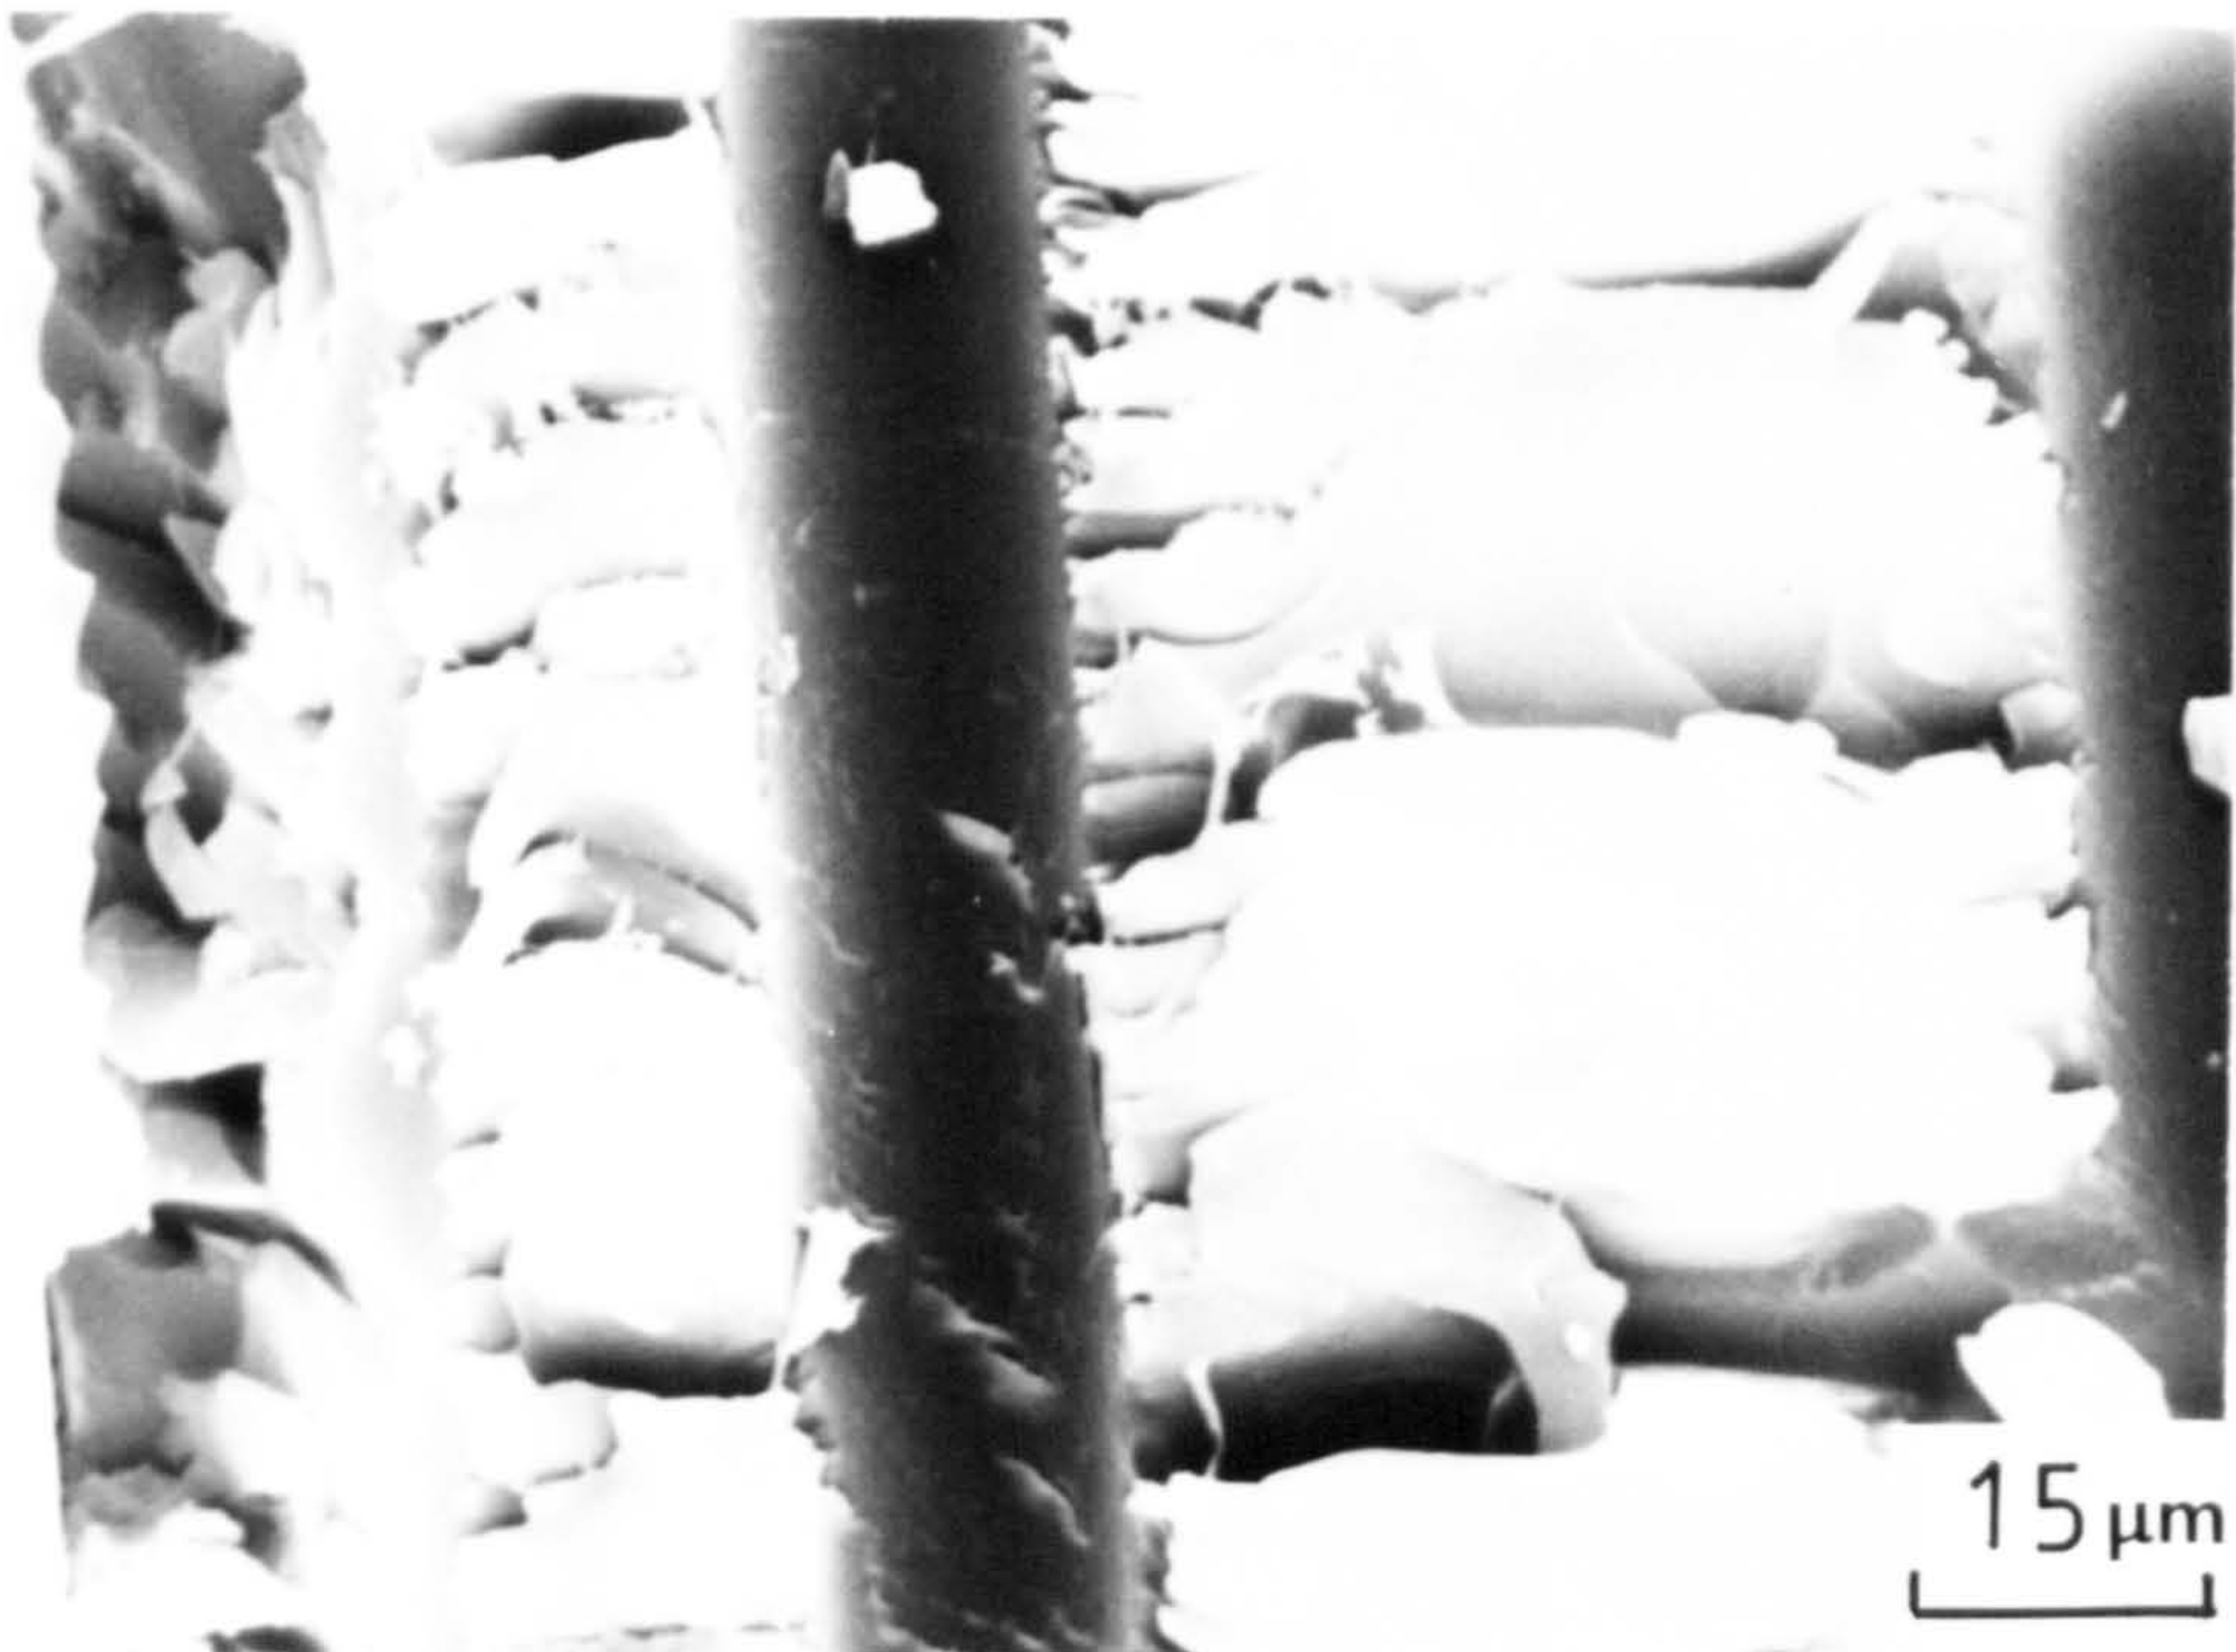
(a) Fracture surface showing clean fibres with jagged torn resin.

(b) Higher magnification showing resin fracture surface.

Fig.5.1. SEM photomicrograph of the fracture surface from a 10° off-axis tensile test of a unidirectional glass-polyester specimen.
