POST FAILURE ENERGY ABSORBING MECHANISMS OF FILAMENT
WOUND COMPOSITE TUBES

Thesis submitted in accordance with the requirements
of the University of Liverpool for the degree of Doctor
in Philosophy by Robert Keal.

September 1983

Department of Metallurgy
and Materials Science,
University of Liverpool.

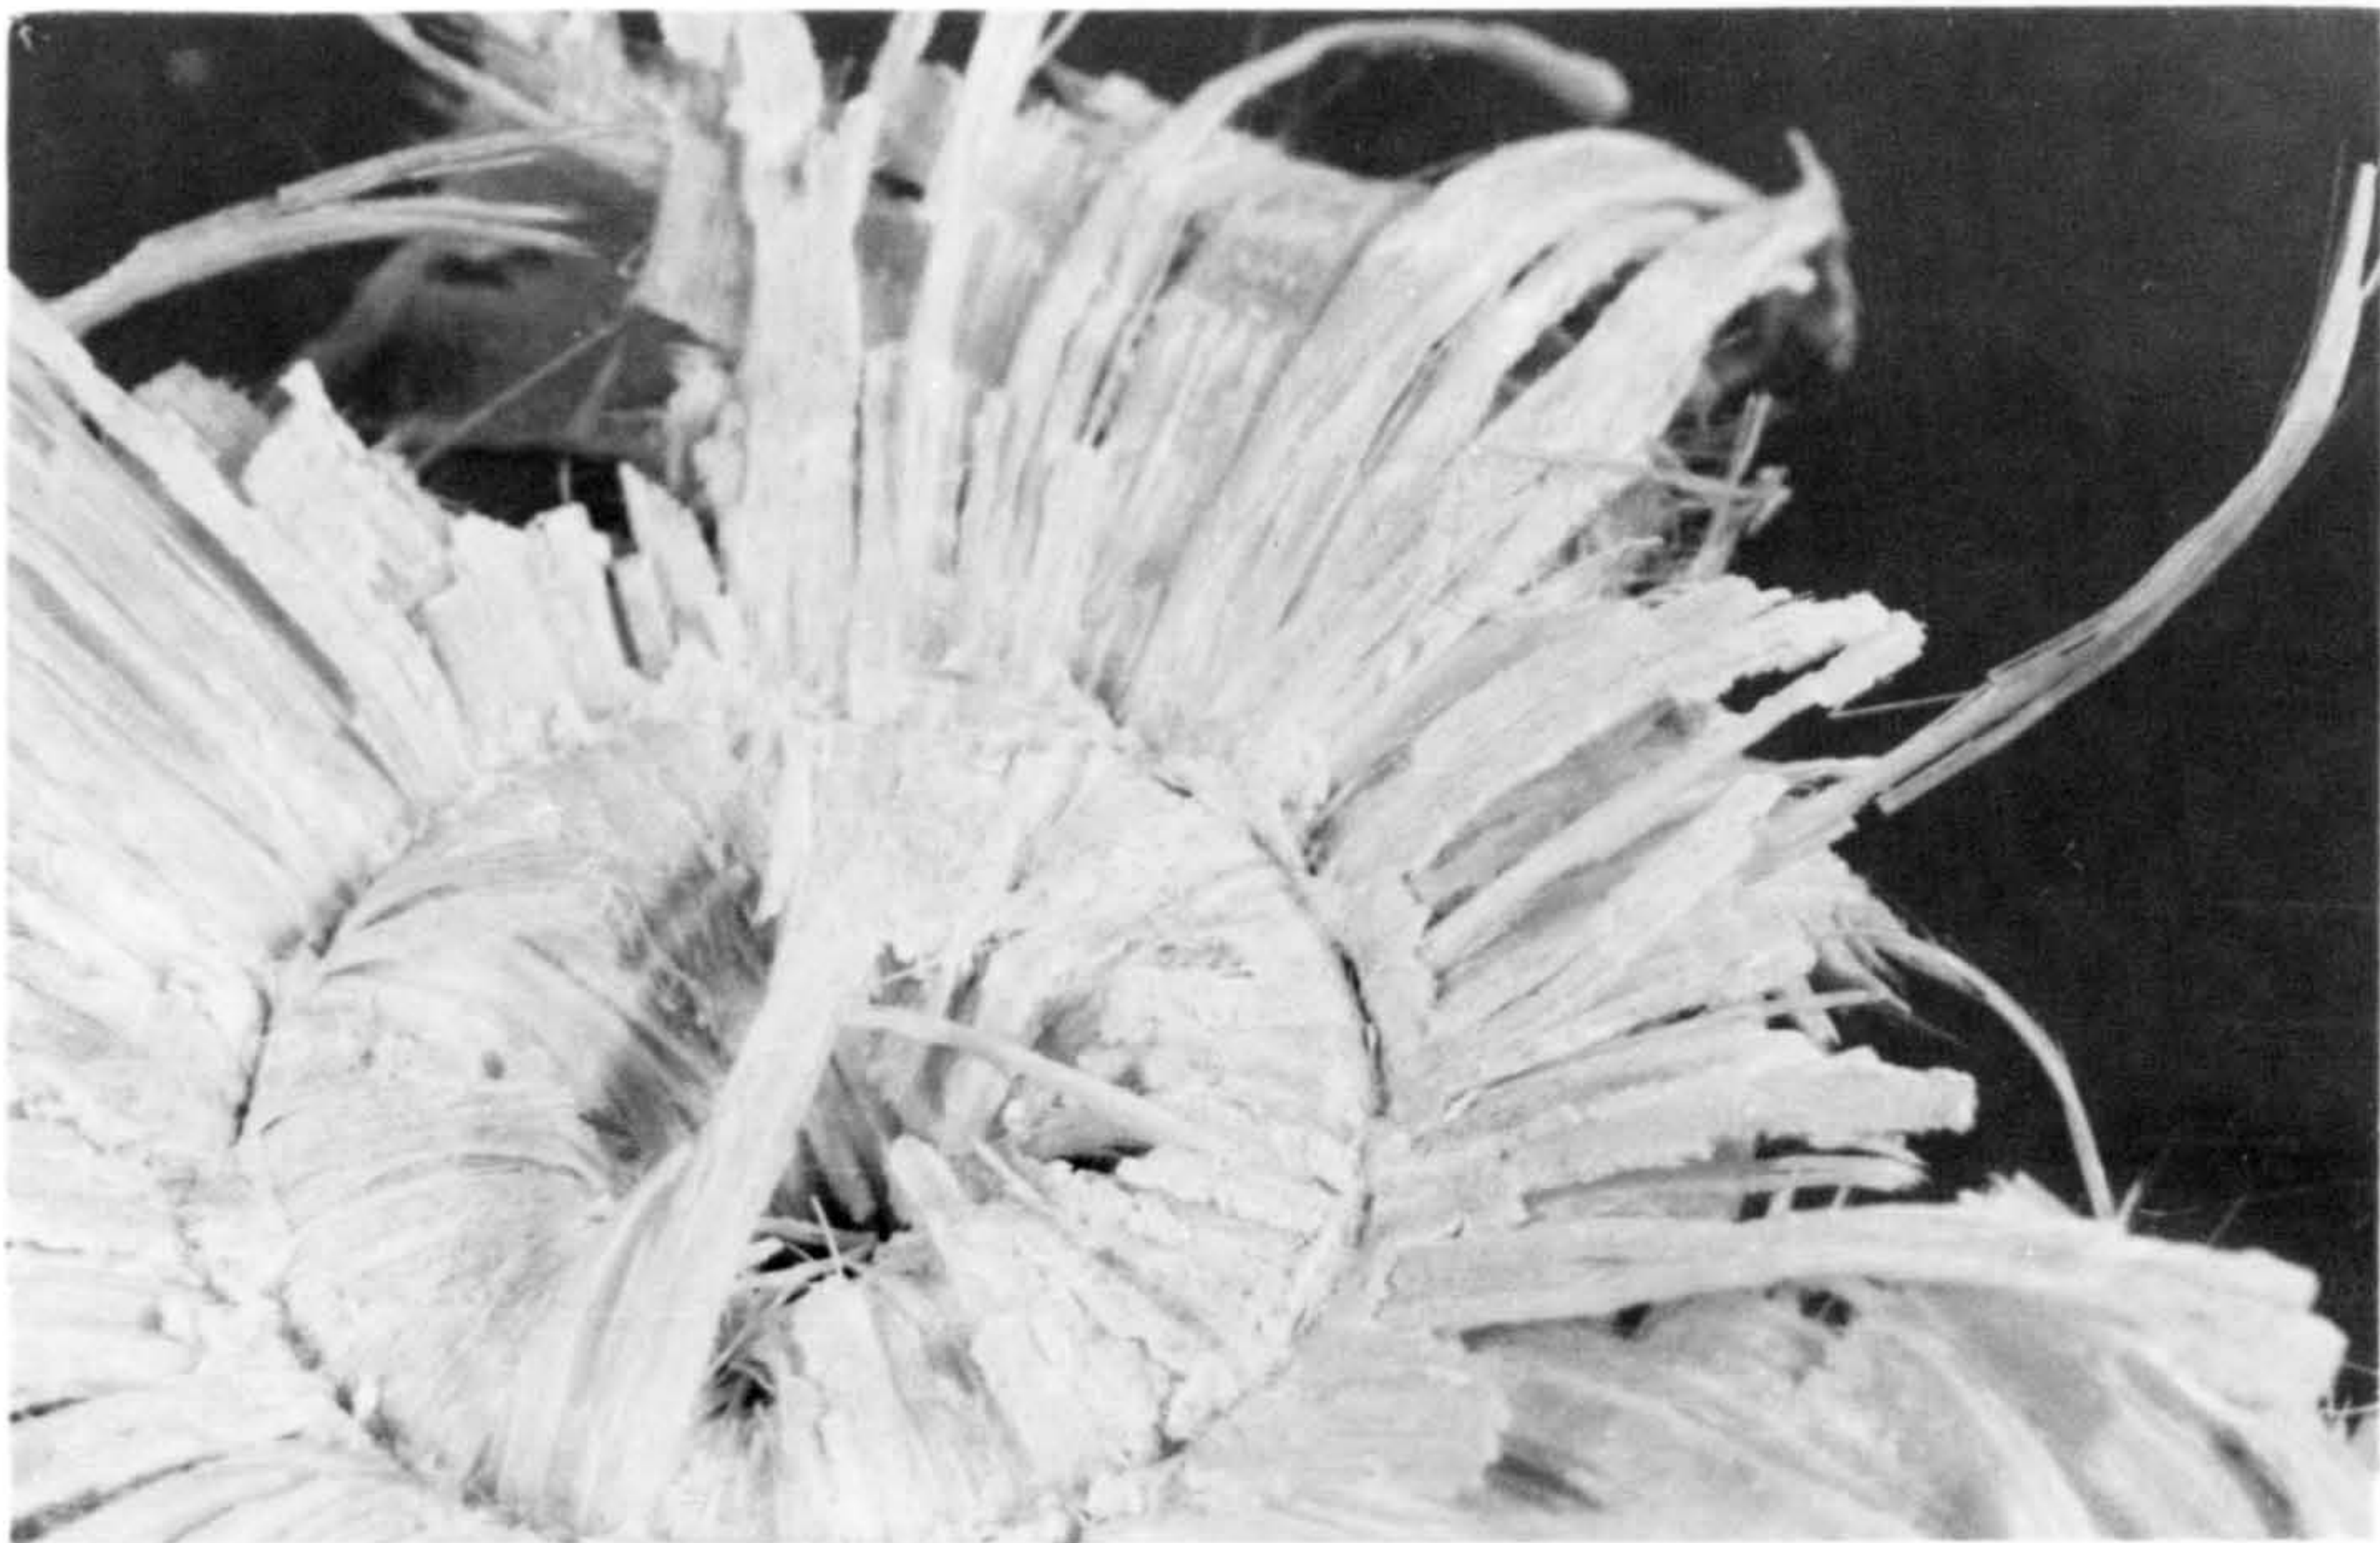
(a) General view of crush zone. The axial fibres are bent and fractured.

(b) Close-up of crush zone showing fractured fibres.

A general view of a $0^{\circ}/90^{\circ}$ tube subjected to axial crushing at $4 \times 10^{-3} \text{ m s}^{-1}$ is shown in Fig. 5.4. A close-up view of the crush zone is shown in Fig. 5.4(b). The progressive nature is apparent with crushing commencing at the bevelled end. The outer axial fibres were bent outwards with limited fibre breakage.

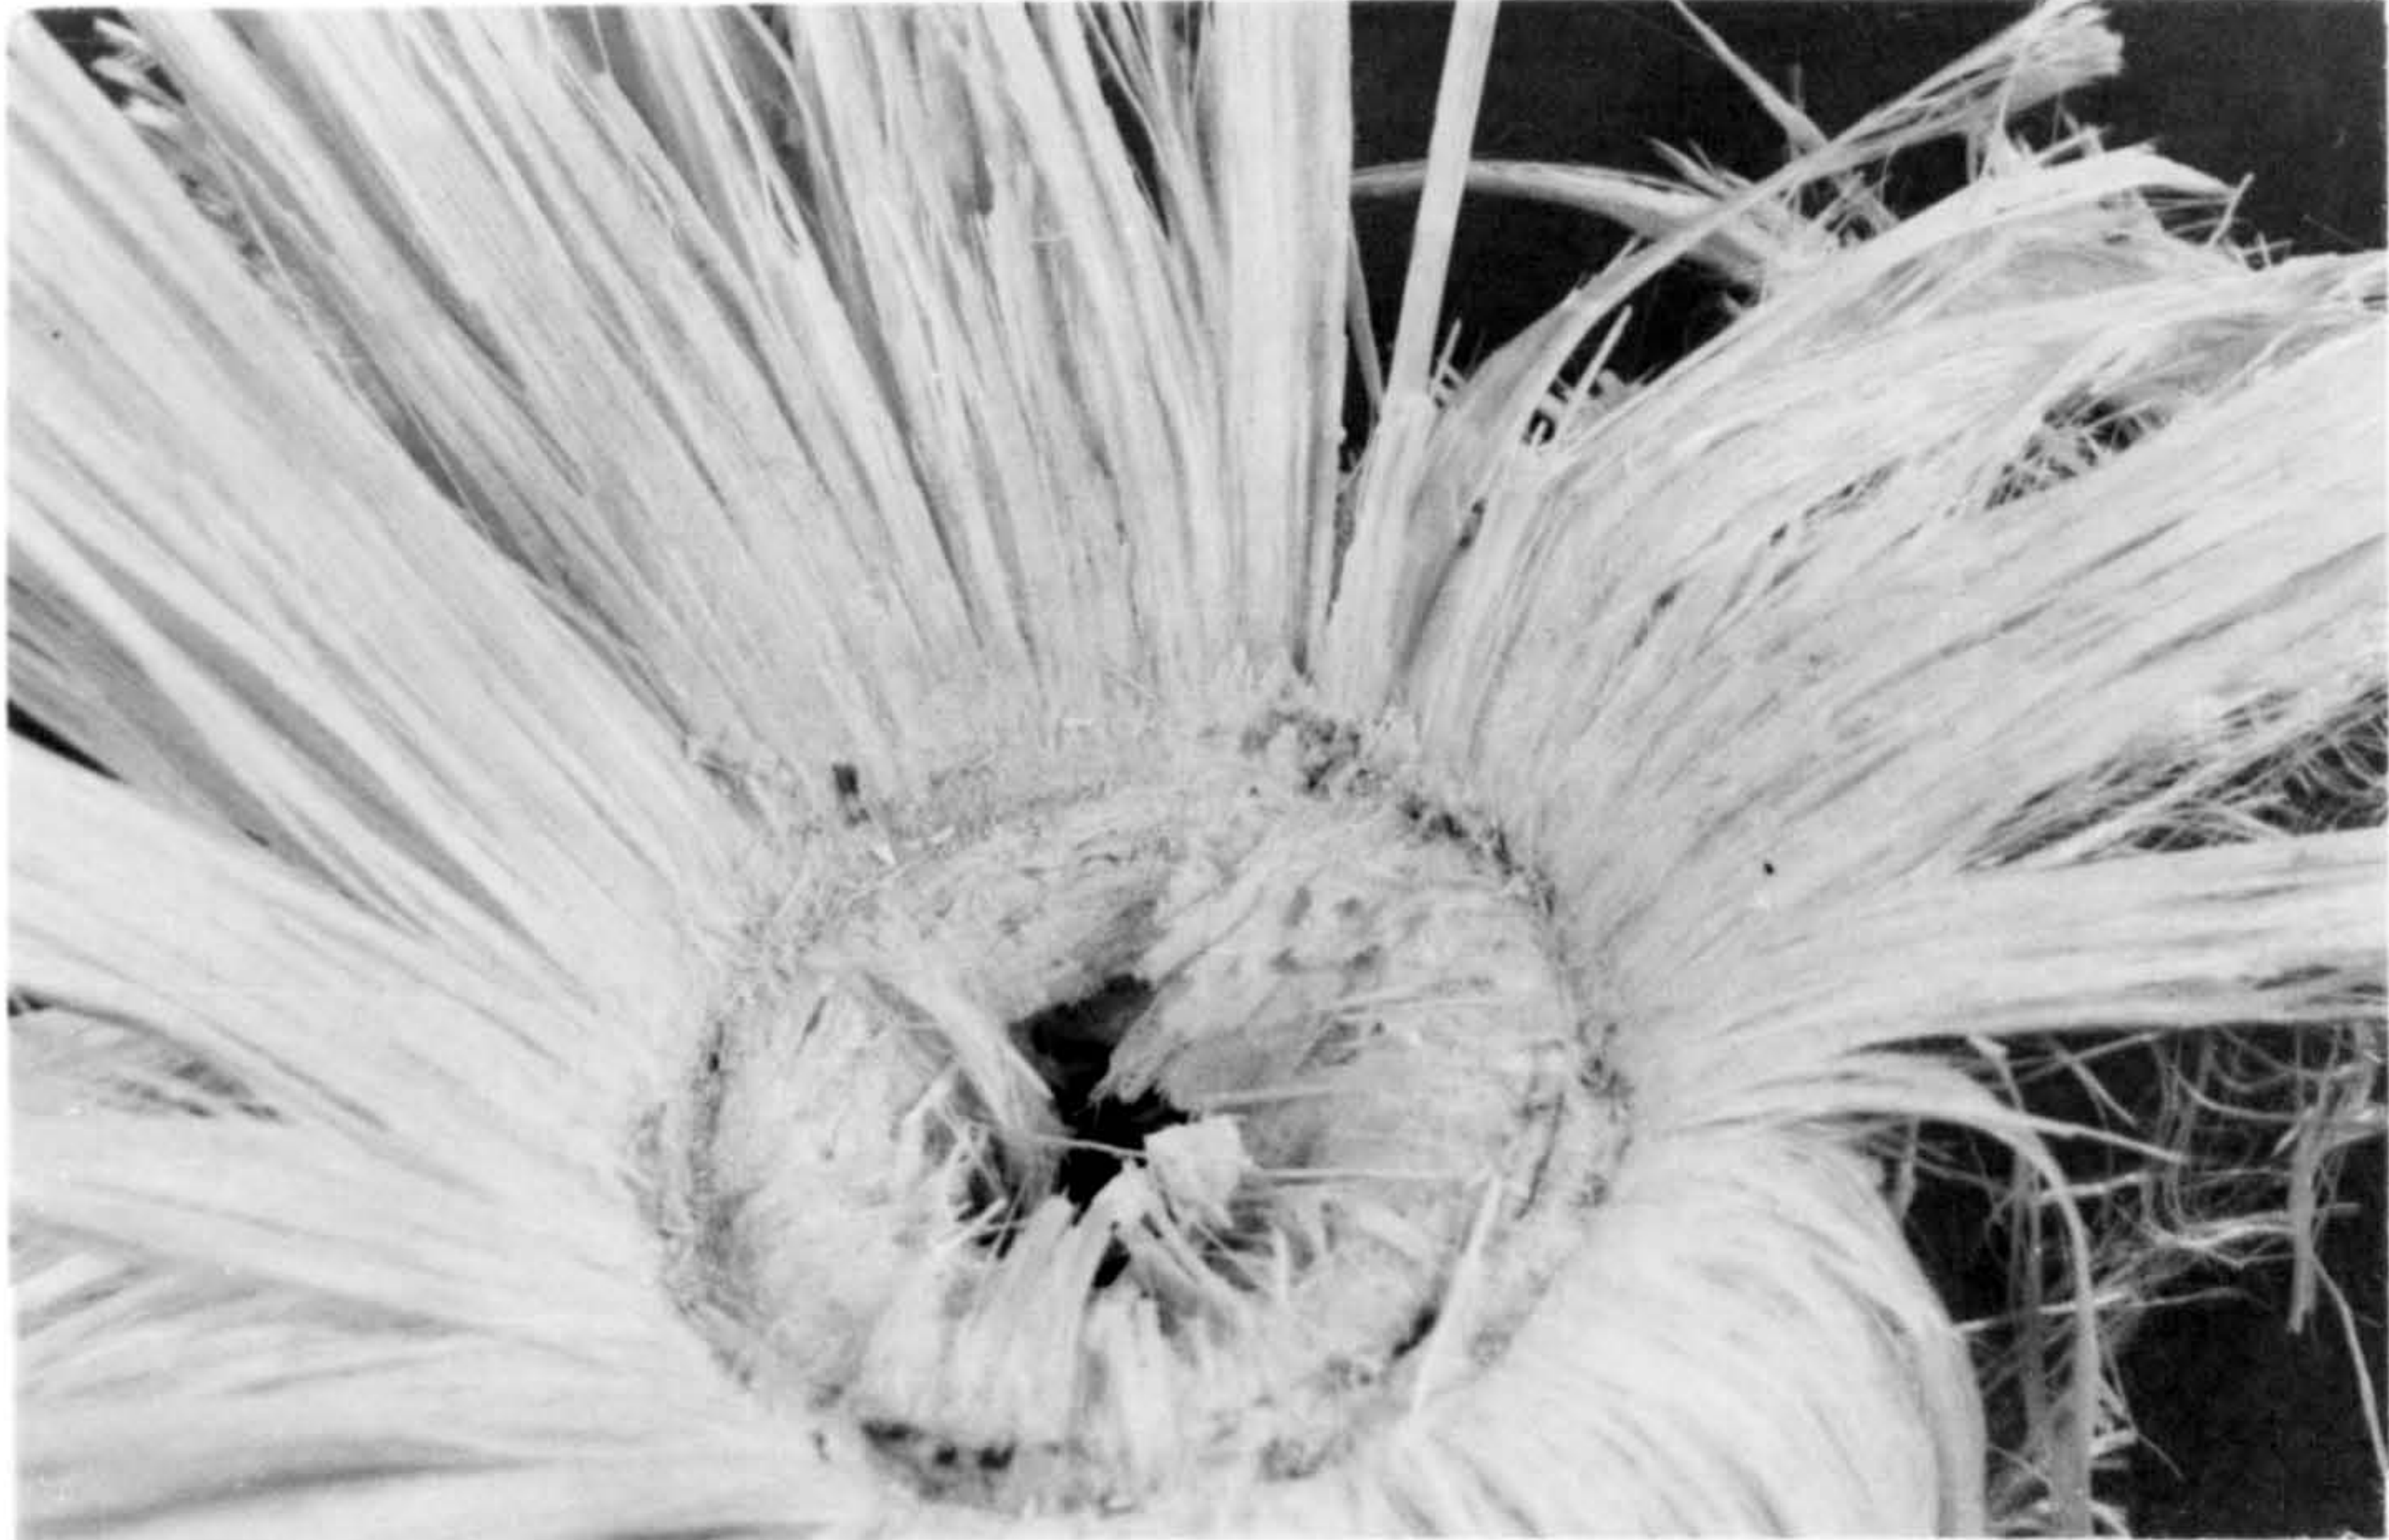
Fig.5.5 Crushed polyester $0^{\circ}/90^{\circ}$ tube tested at 4.0 m s^{-1} .

(a) General view of crush zone. The axial fibres are generally unbroken.

(b) Close-up of crush zone showing unbroken axial fibres.

Fig. 5.5 shows a typical $0^{\circ}/90^{\circ}$ tube tested at 4 m s^{-1} . The general appearance is similar to that of the tube tested at $4 \times 10^{-3} \text{ m s}^{-1}$ (Fig. 5.4), except that the axial fibres are not fractured to such an extent and the fibre bundle width is less. The region of compressed material in the centre of the tube wall is clearly visible.

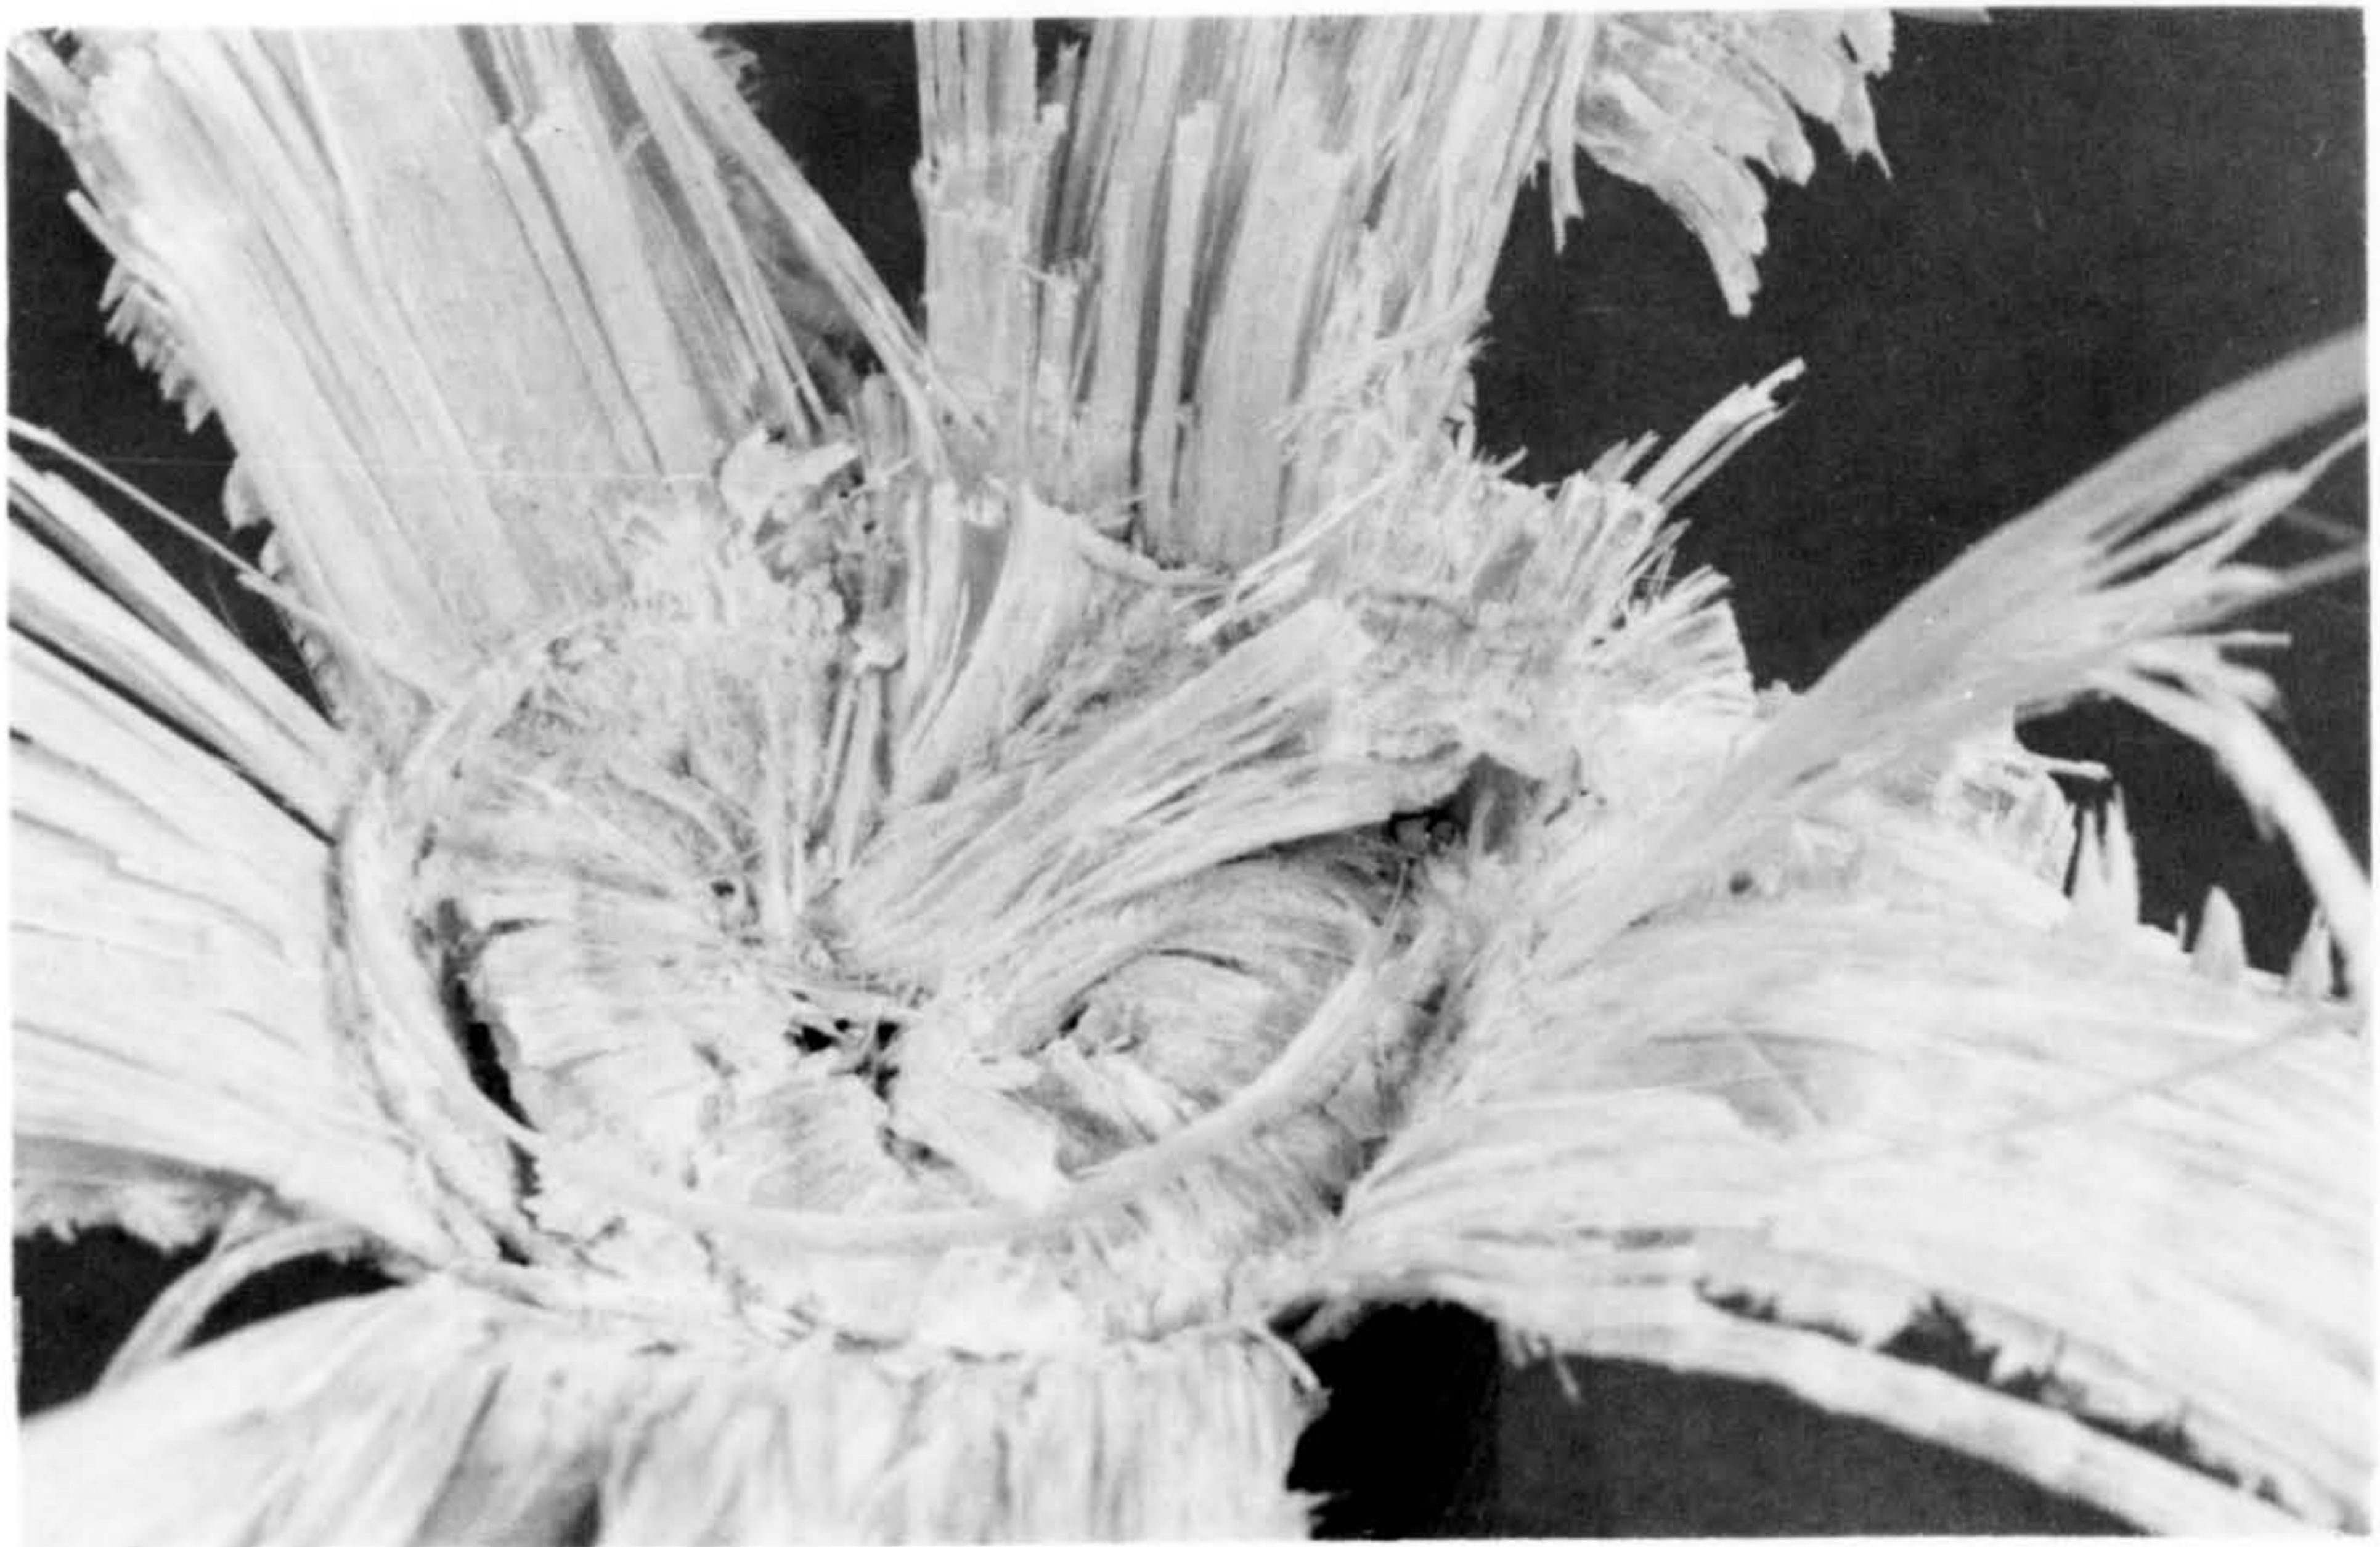
Fig.5.7. Crushed $0^{\circ}/90^{\circ}$ epoxy tube (MY750) tested at $4 \times 10^{-3} \text{ m s}^{-1}$.

(a) General view of crush zone.

(b) Close-up of crush zone. Axial fibres break and bend inwards and outwards.

Typical appearances of a $0^{\circ}/90^{\circ}$ epoxy (MY 750) tube crushed at 4×10^{-3} and 4 m s^{-1} are shown in Figs 5.7 and 5.8. The crush process was similar to that for tubes with polyester (Crystic 272) matrices. As with polyester $0^{\circ}/90^{\circ}$ tubes, the amount of axial fibre fracture was less at 4 m s^{-1} than at $4 \times 10^{-3} \text{ m s}^{-1}$. A well-defined bundle wedge formed in the centre of the tube wall.

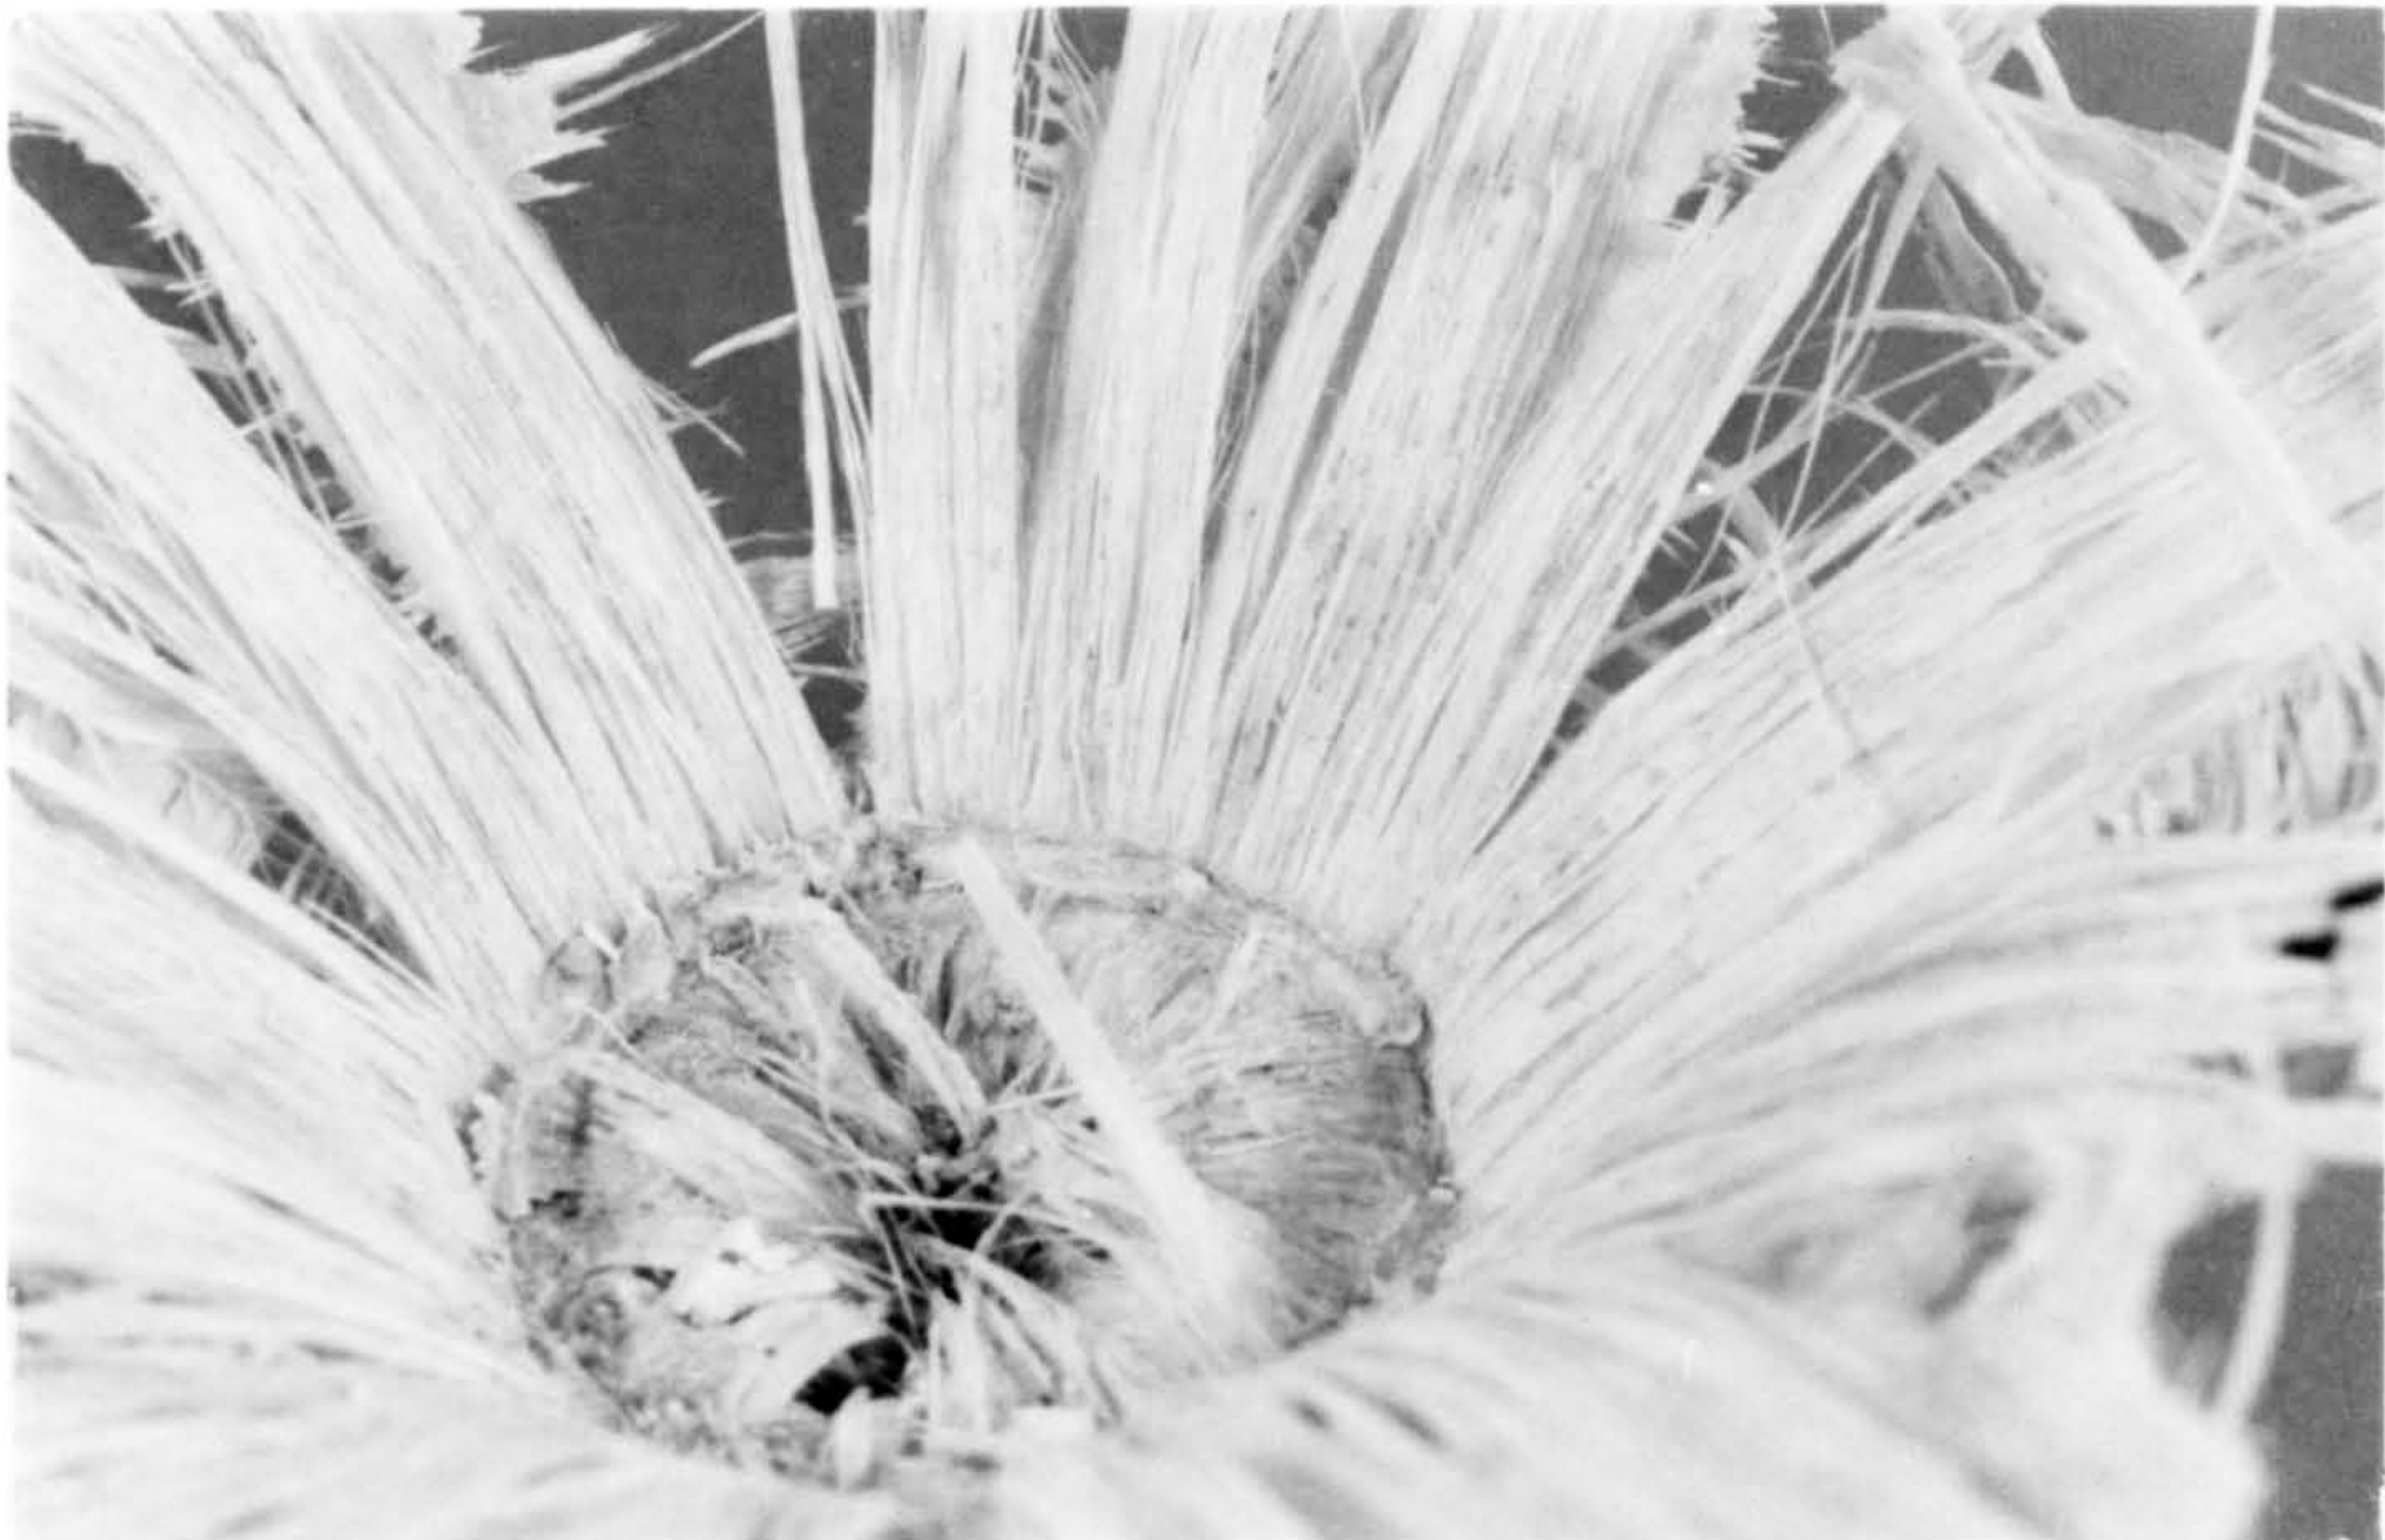
Fig.5.8. Crushed $0^{\circ}/90^{\circ}$ epoxy tube (MY750) tested at 4 m s^{-1} .

(a) General view of crush zone.

(b) Close-up of crush zone. Axial fibres bend inwards and outwards. Outer axial fibres are generally unbroken.

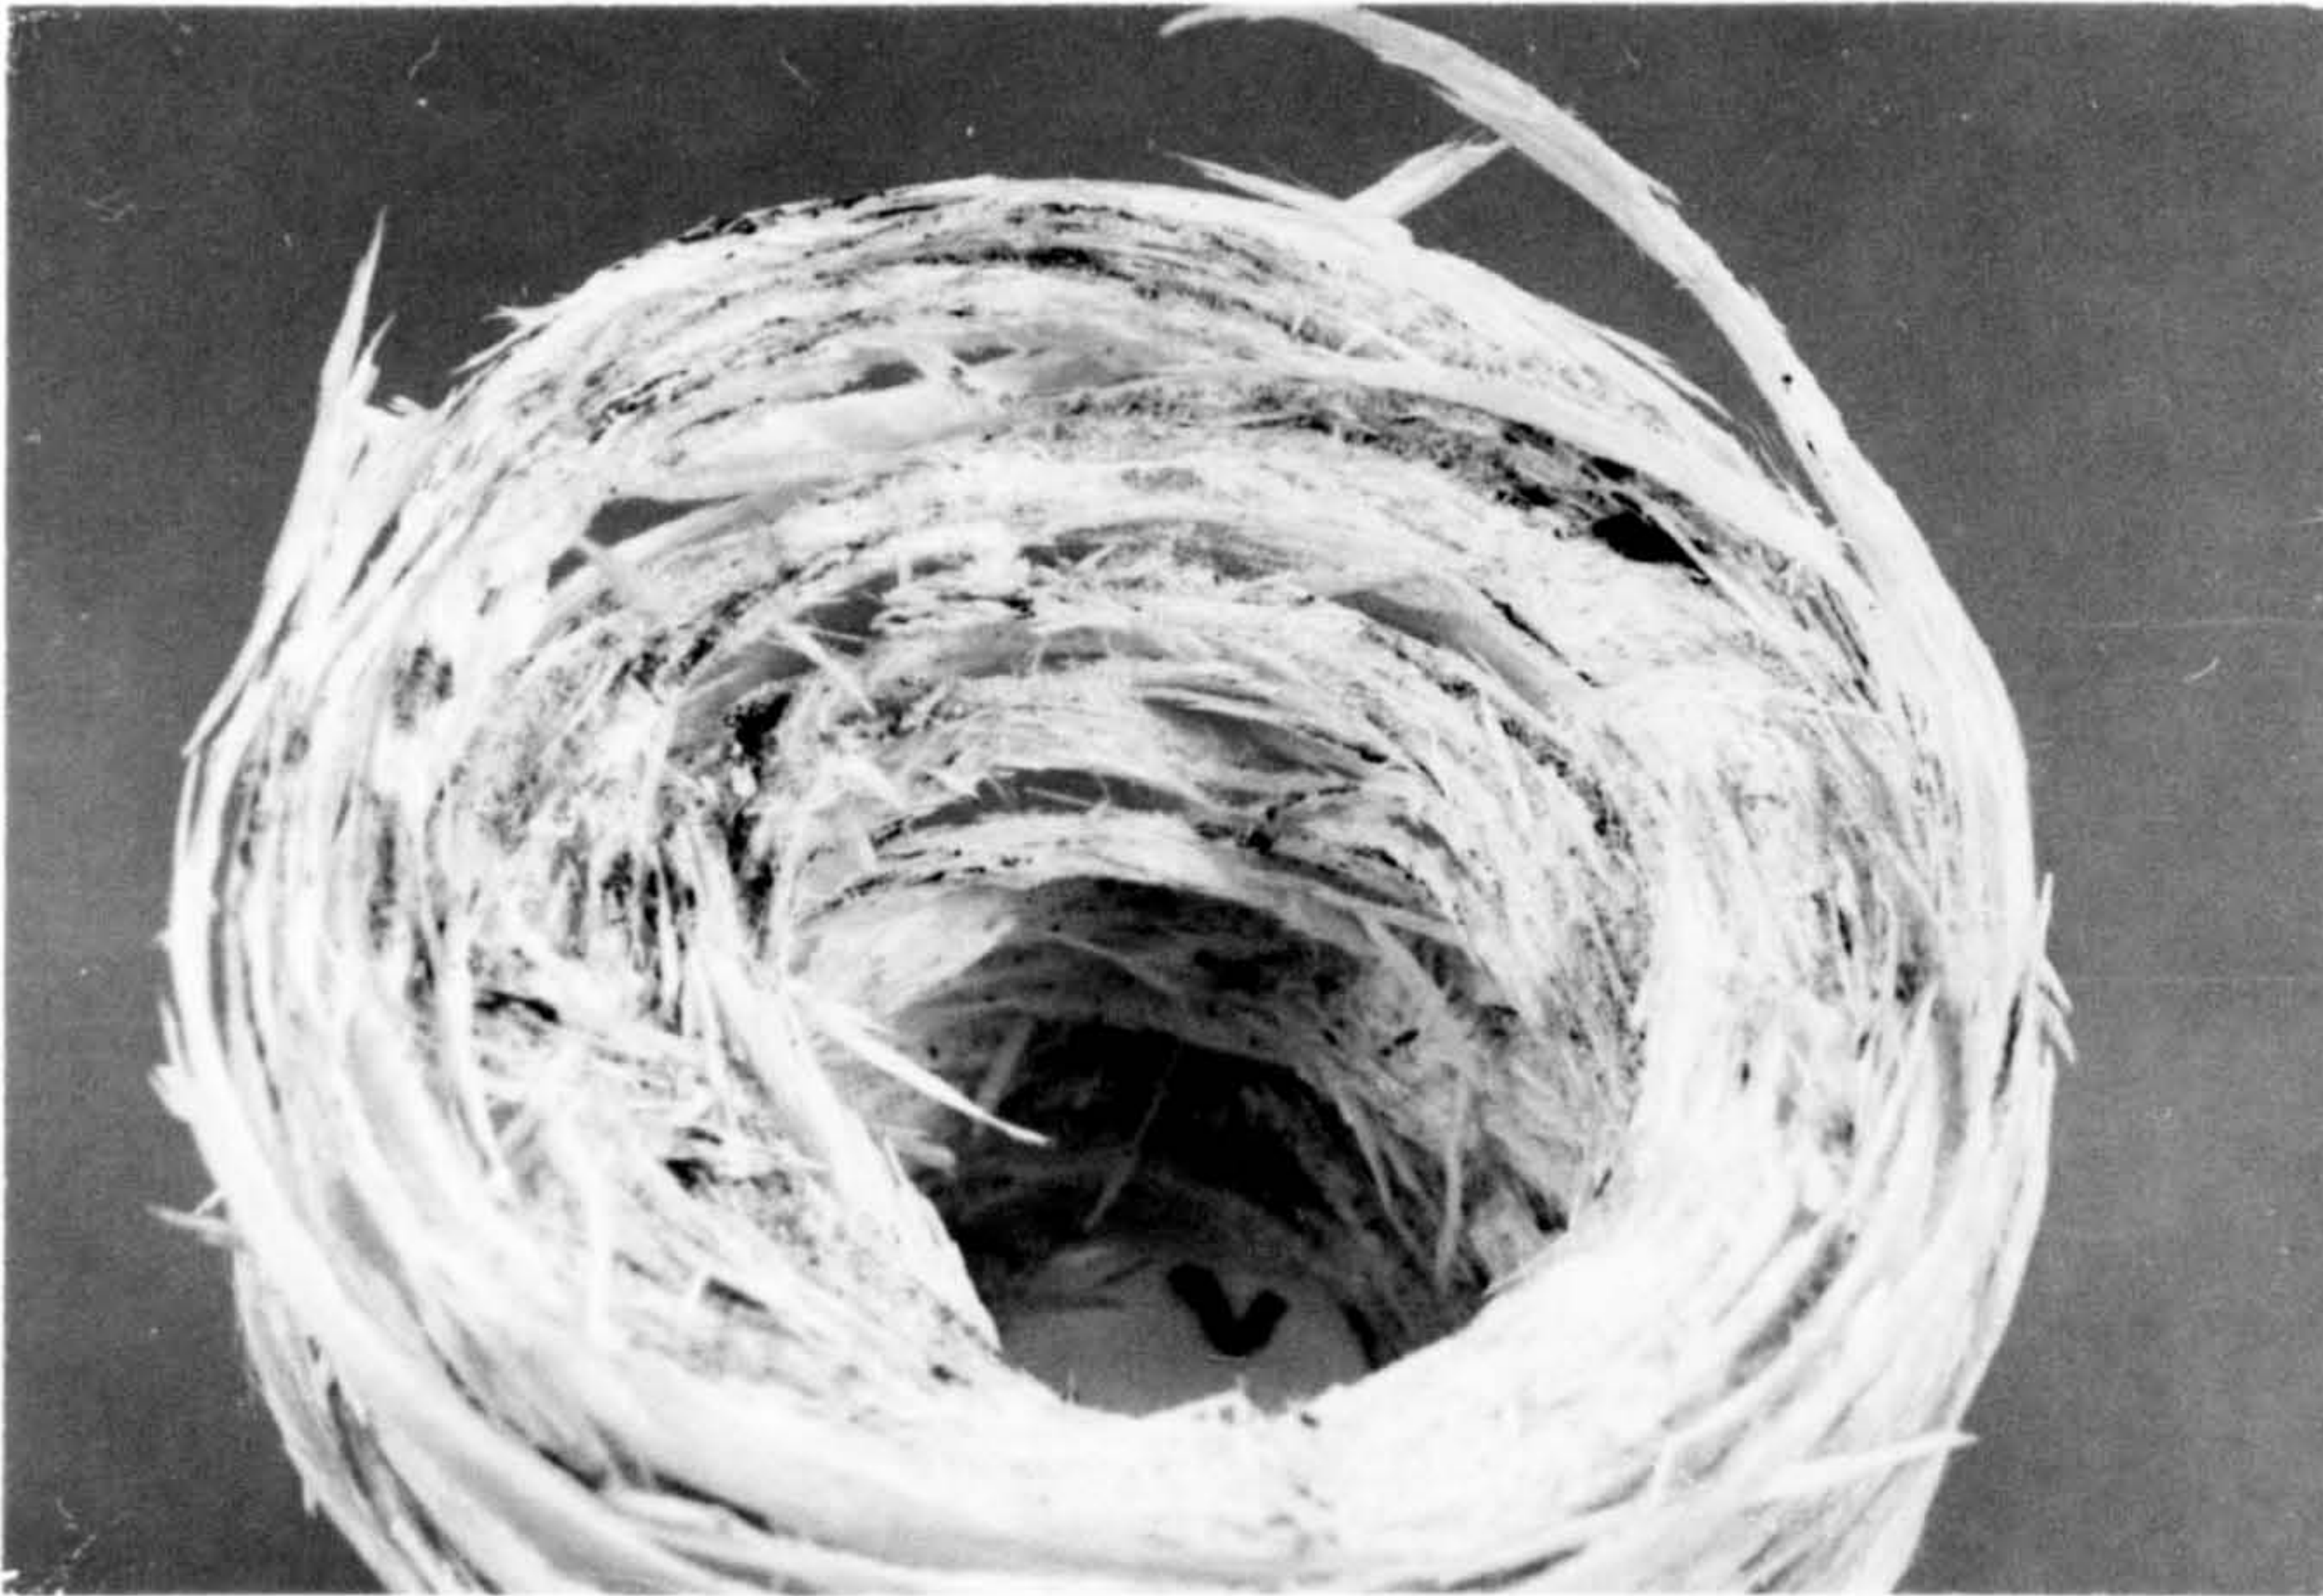
Fig.5.10. Crushed hoop-wound tube.

(a) General view of crush zone.

(b) Close-up of crush zone showing long fibre tows detached from the tube wall.

became detached from the tube wall as progressive crushing occurred. The outer hoop windings fractured in a tensile manner and then separated from the tube wall by shear, passing down the outside of the uncrushed tube. These fibres tows fractured into various lengths which varied from two to three times the tube circumference to short lengths of less than 1 cm. The long detached hoop windings are shown in Fig. 5.10(b).

As the outer hoops were fractured and compressed down the outside of the tube, the inner hoops were crushed inwards and downwards into the cavity of the tube. Because of the necessary reduction in circumference, a complex crushing process occurred involving bending, fracture and interpenetration. The short lengths of fractured fibre bundles can be observed in the inner region of the tube wall in Fig. 5.10(b).
