POST FAILURE ENERGY ABSORBING MECHANISMS OF FILAMENT
WOUND COMPOSITE TUBES

Thesis submitted in accordance with the requirements
of the University of Liverpool for the degree of Doctor
in Philosophy by Robert Keal.

September 1983

Department of Metallurgy
and Materials Science,
University of Liverpool.

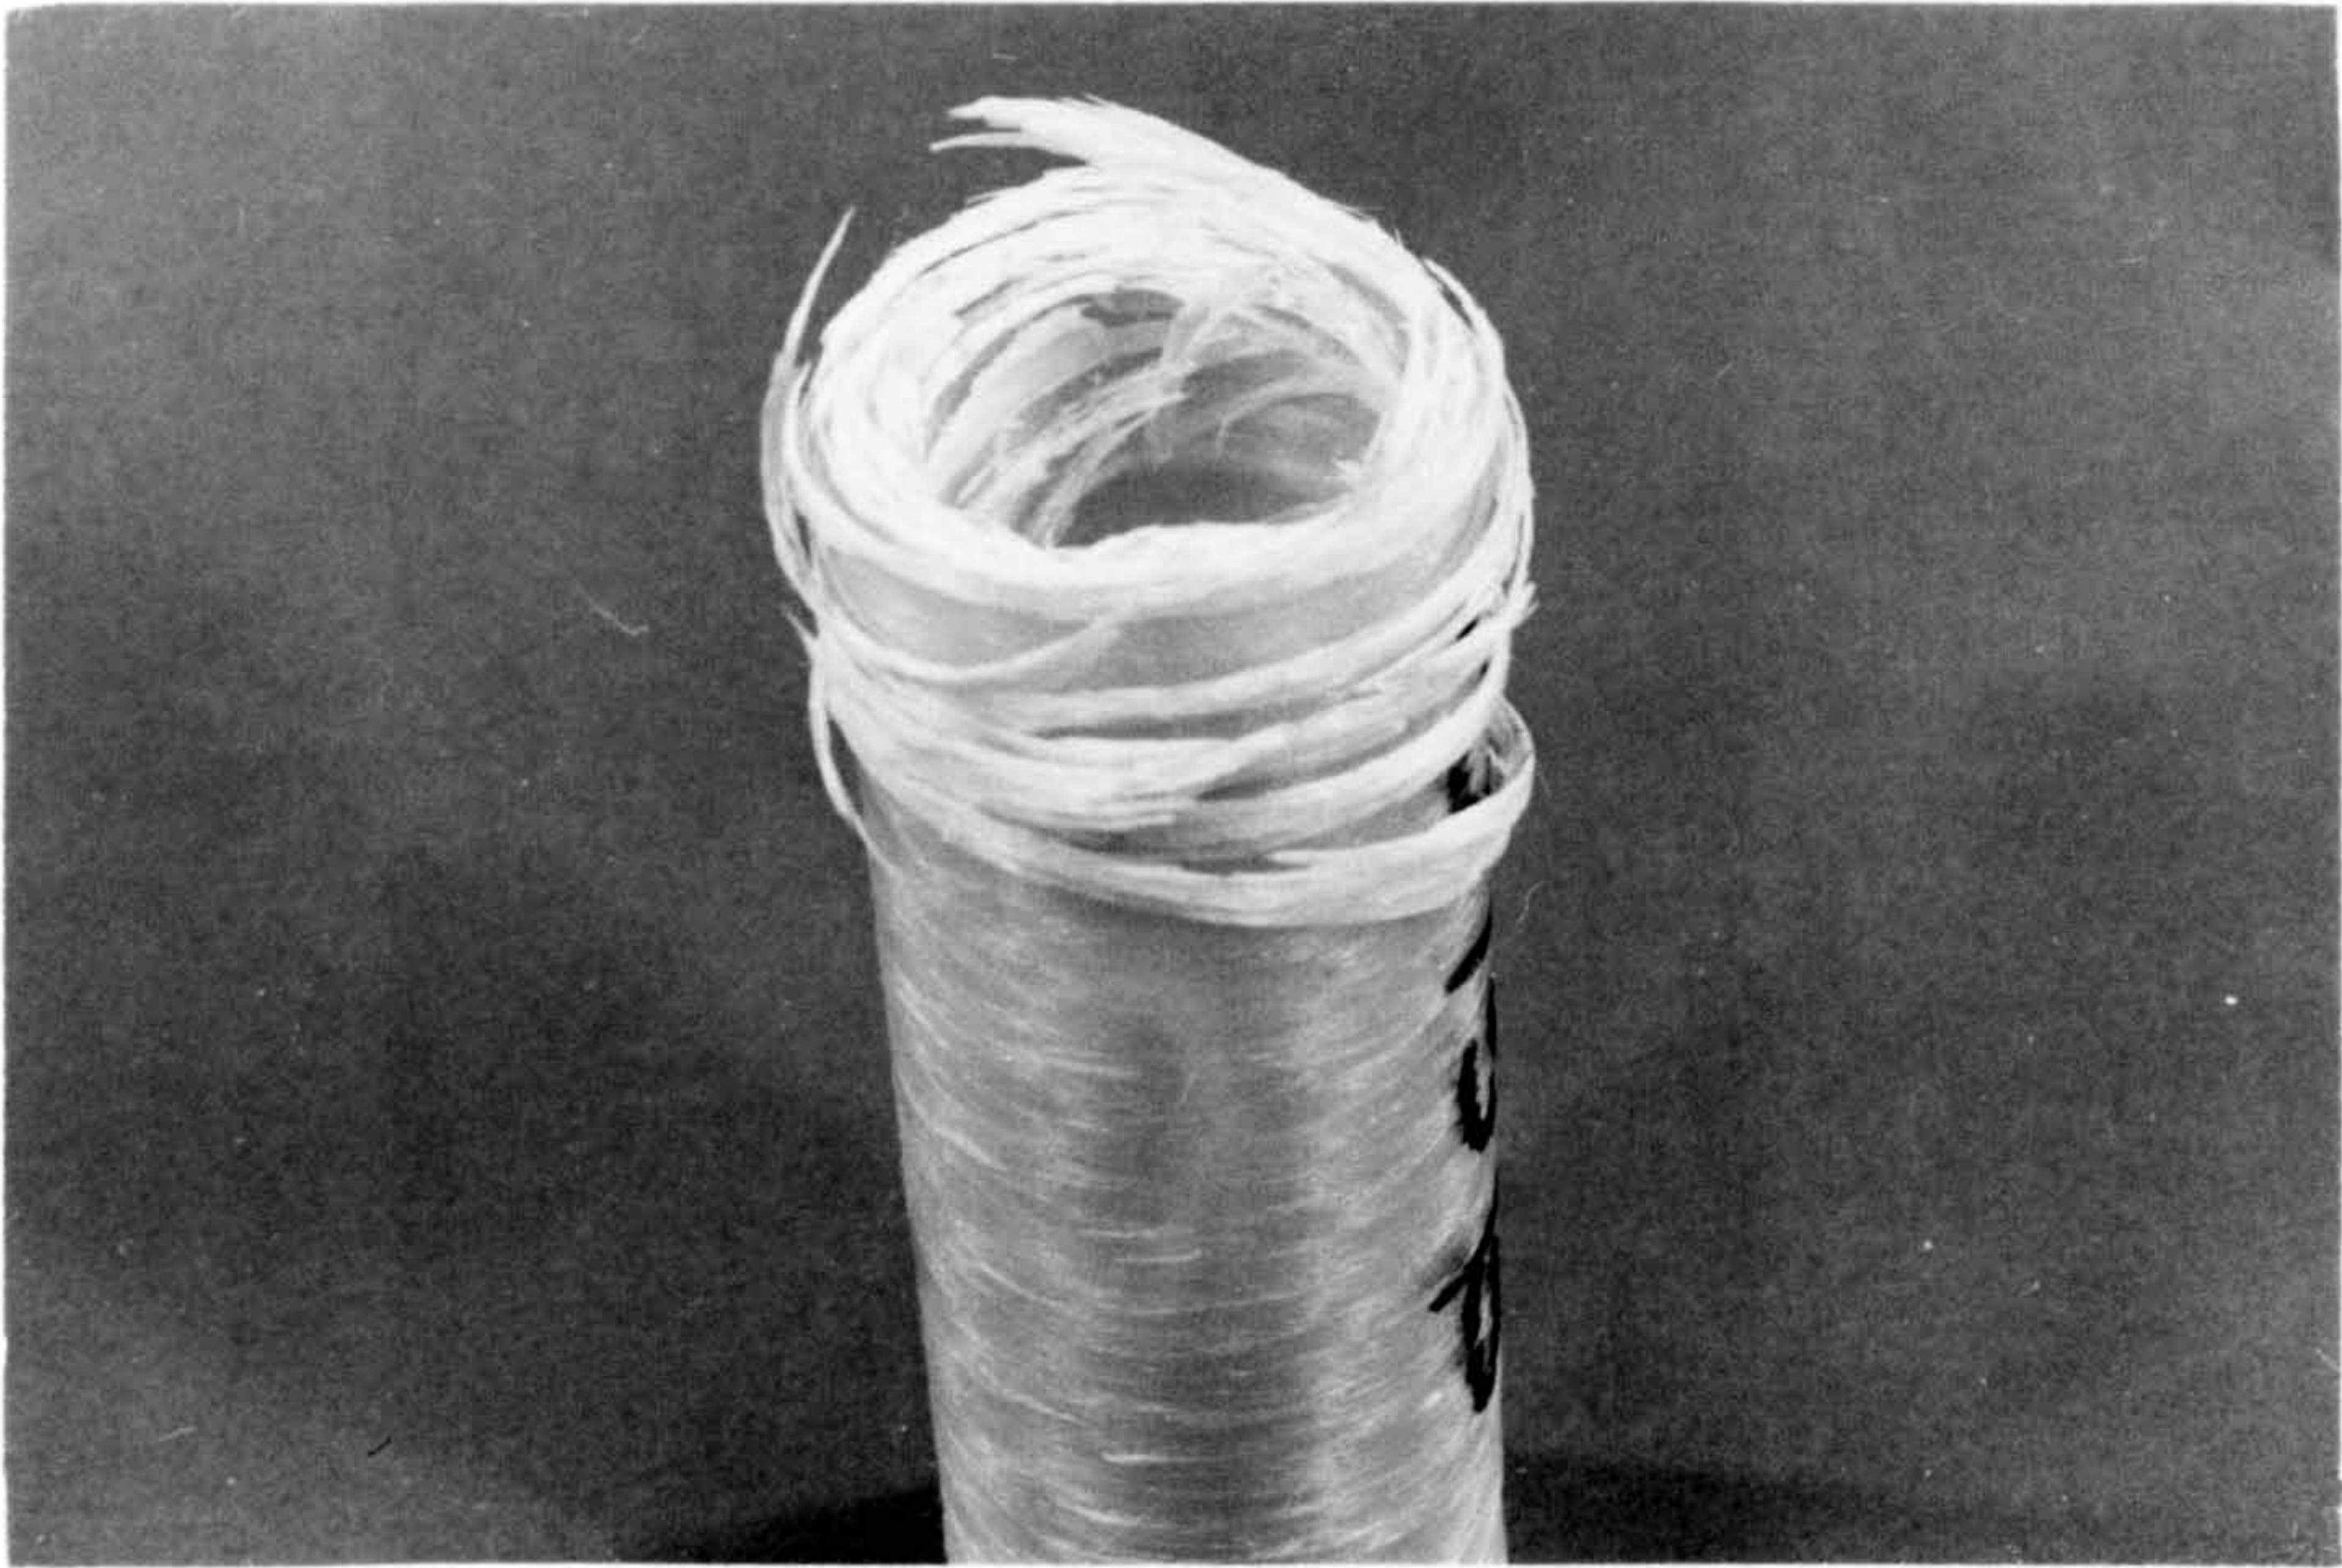
Fig.5.11. Crushed 85° angle-wound tube.

(a) General view of crush zone.

(b) Close-up of crush zone showing fibre tows detached from inside and outside of the tube wall.

The mechanism of failure of 85° and 75° angle-wound tubes was similar to that for hoop-wound tubes. During crushing, long fibre bundle tows became detached from the tube wall. These passed downwards either inside or outside the uncrushed tube wall. The width of the fibre bundles in 75° angle tubes (Fig. 5.12) was greater than in the hoop-wound tubes. This was partly a result of the lay-up sequence which led to the formation of cross-overs of the fibre tows during tube manufacture. These cross-over regions tended to hold the fibre bundles together so that plates of material, rather than long thin bundles, became detached from the tube wall.

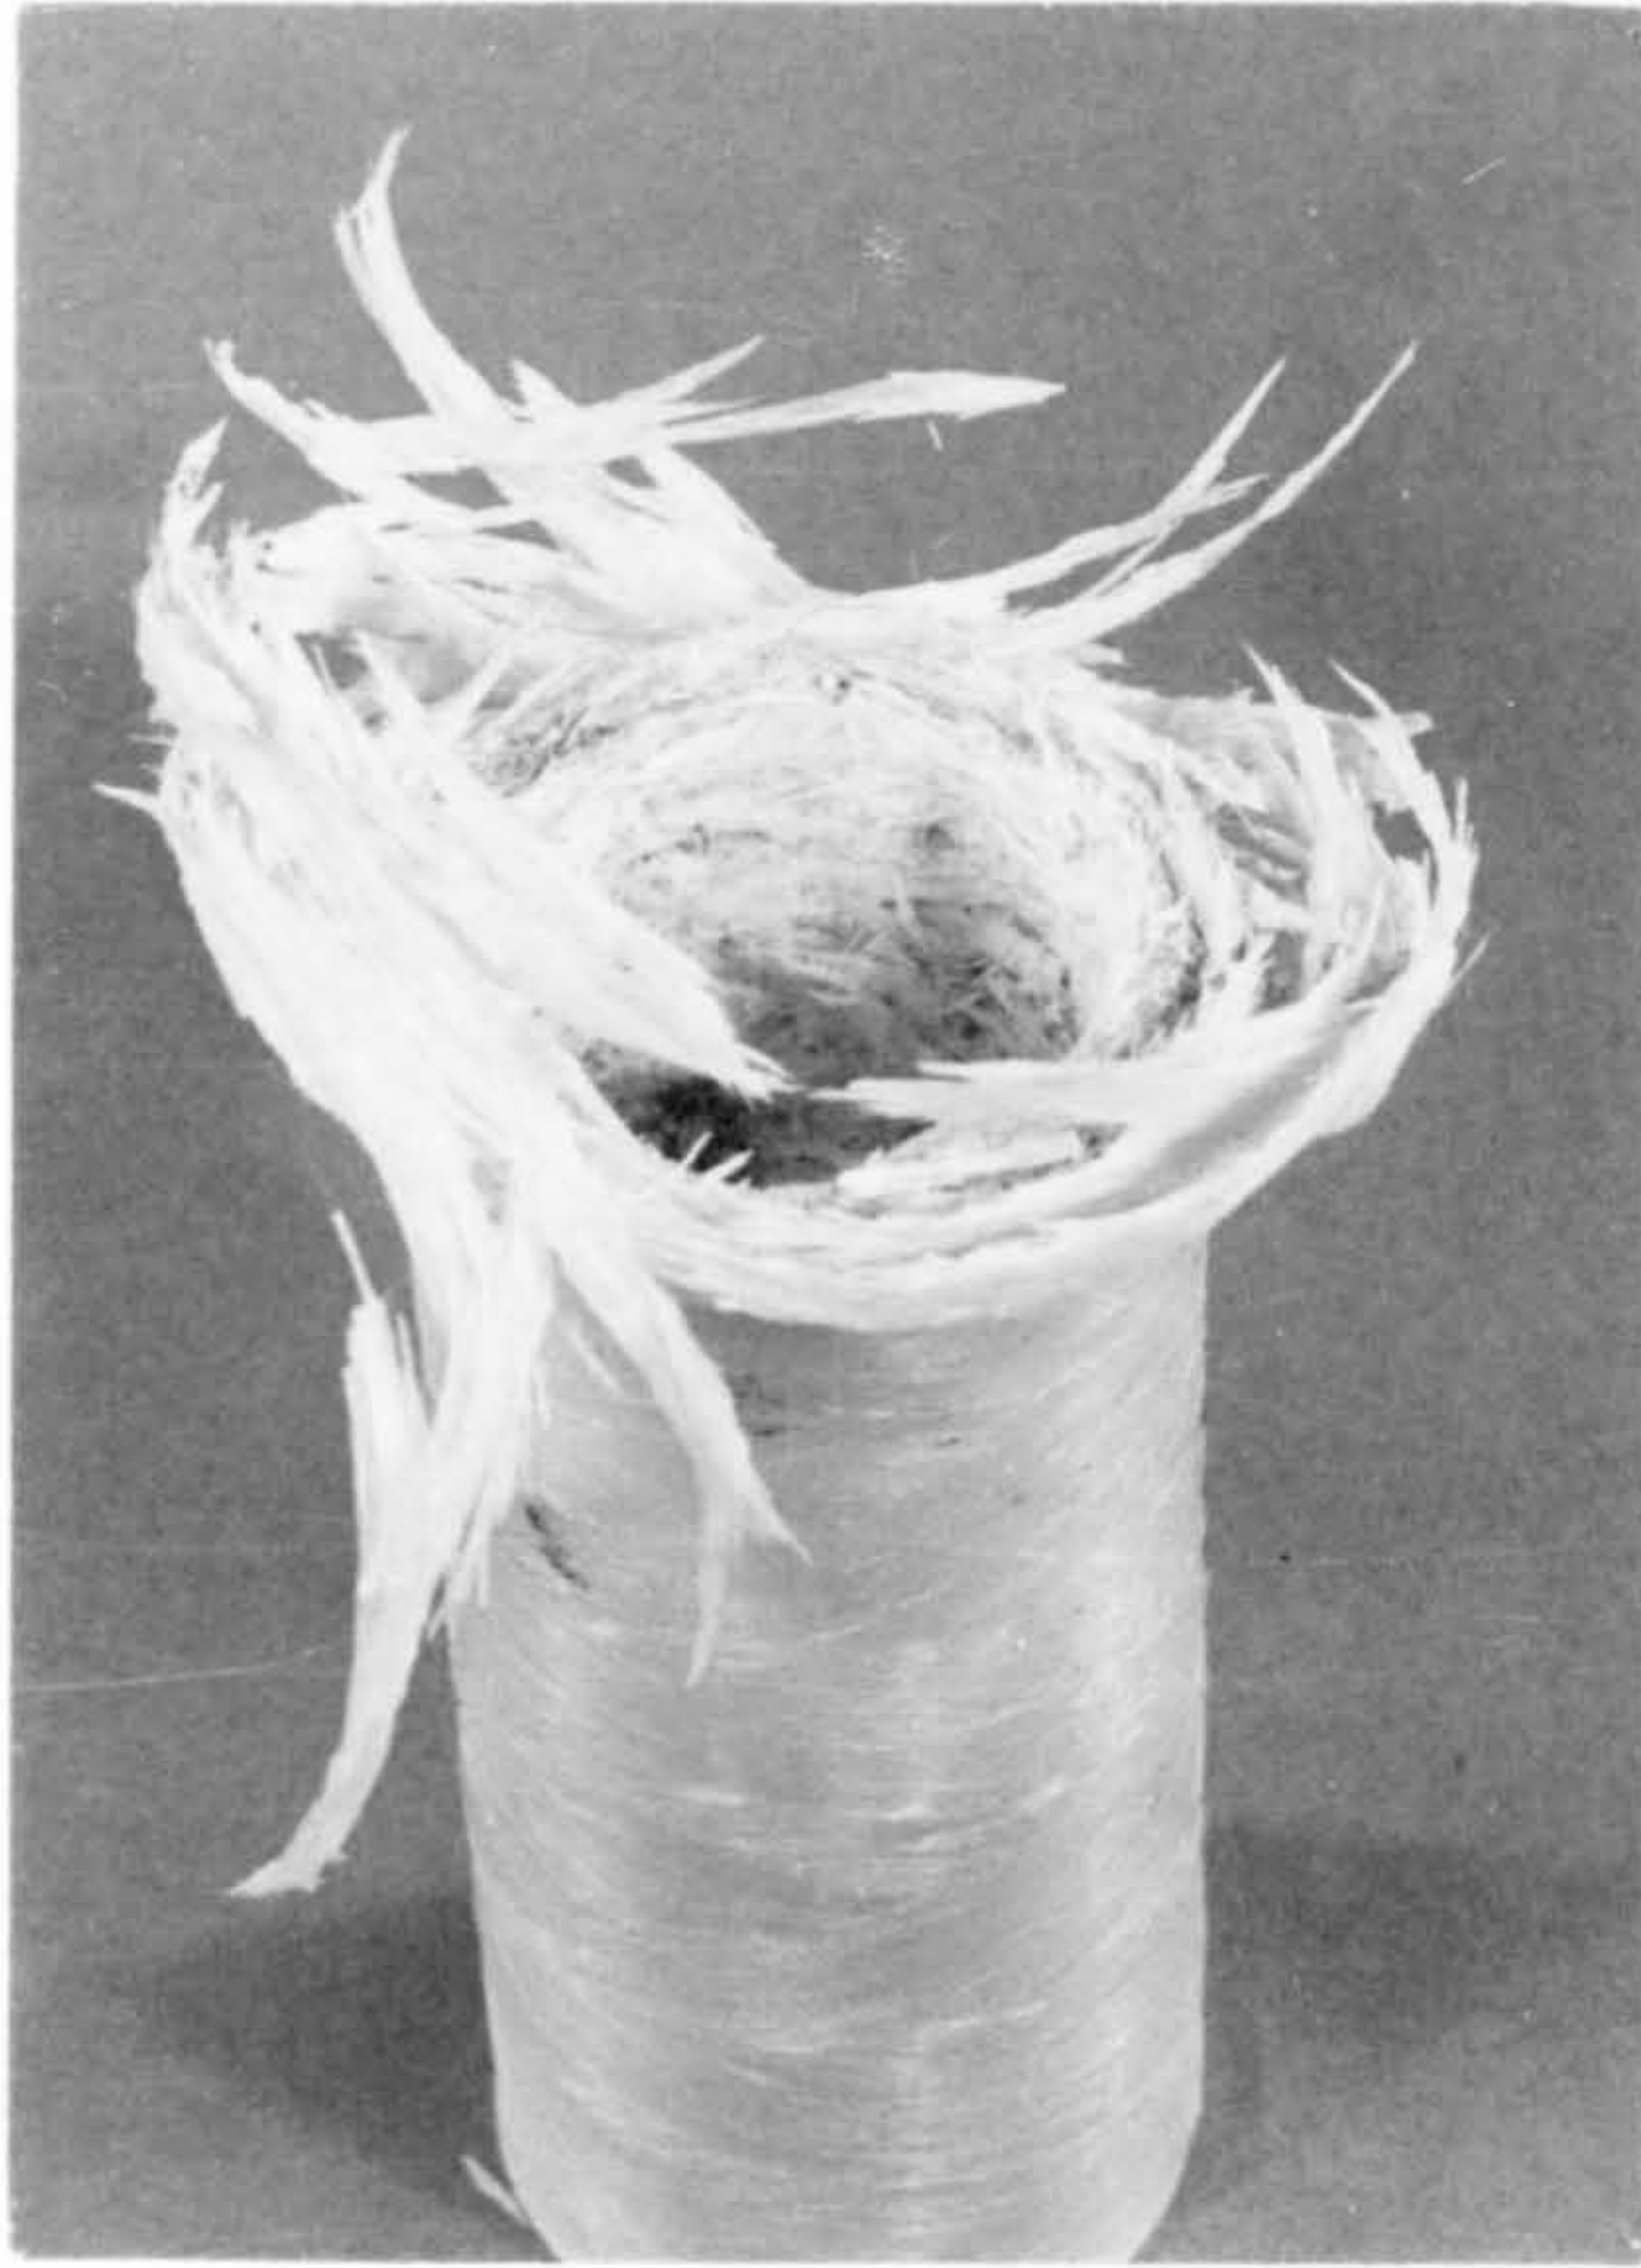
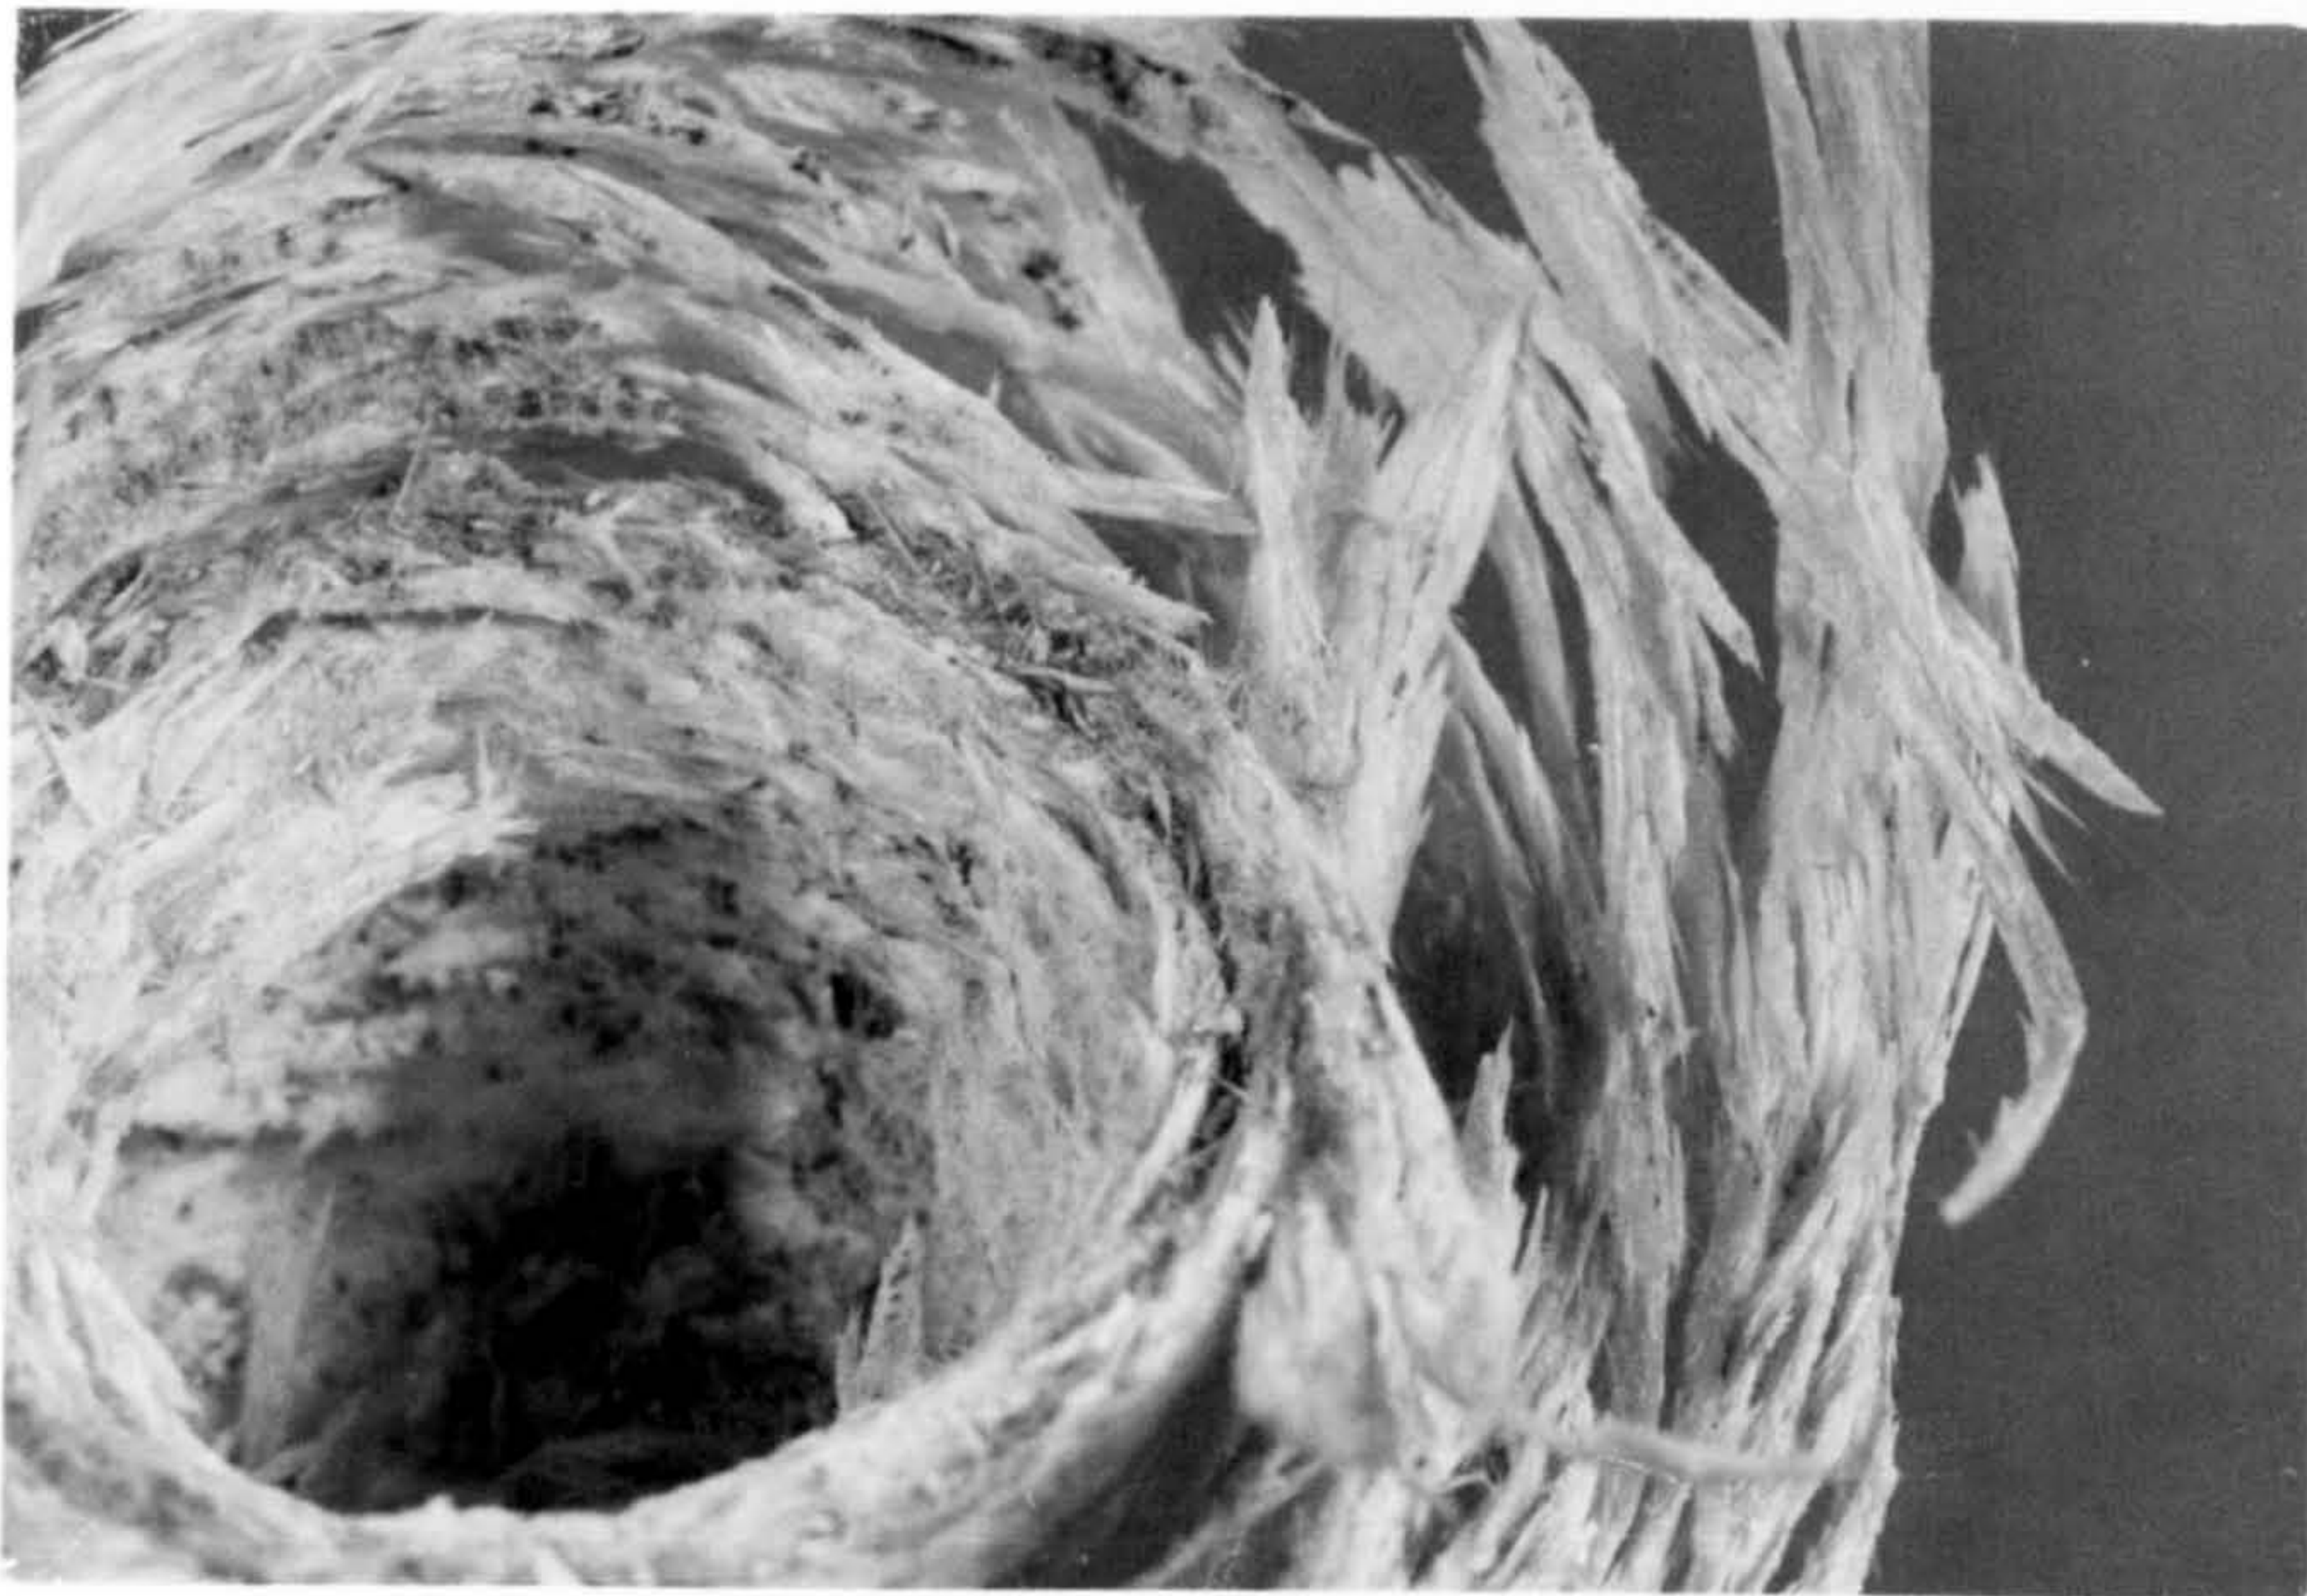
Fig.5.12. Crushed 75° angle-wound tube.

(a) General view of crush zone.

(b) Close-up of crush zone showing long detached fibre tows.

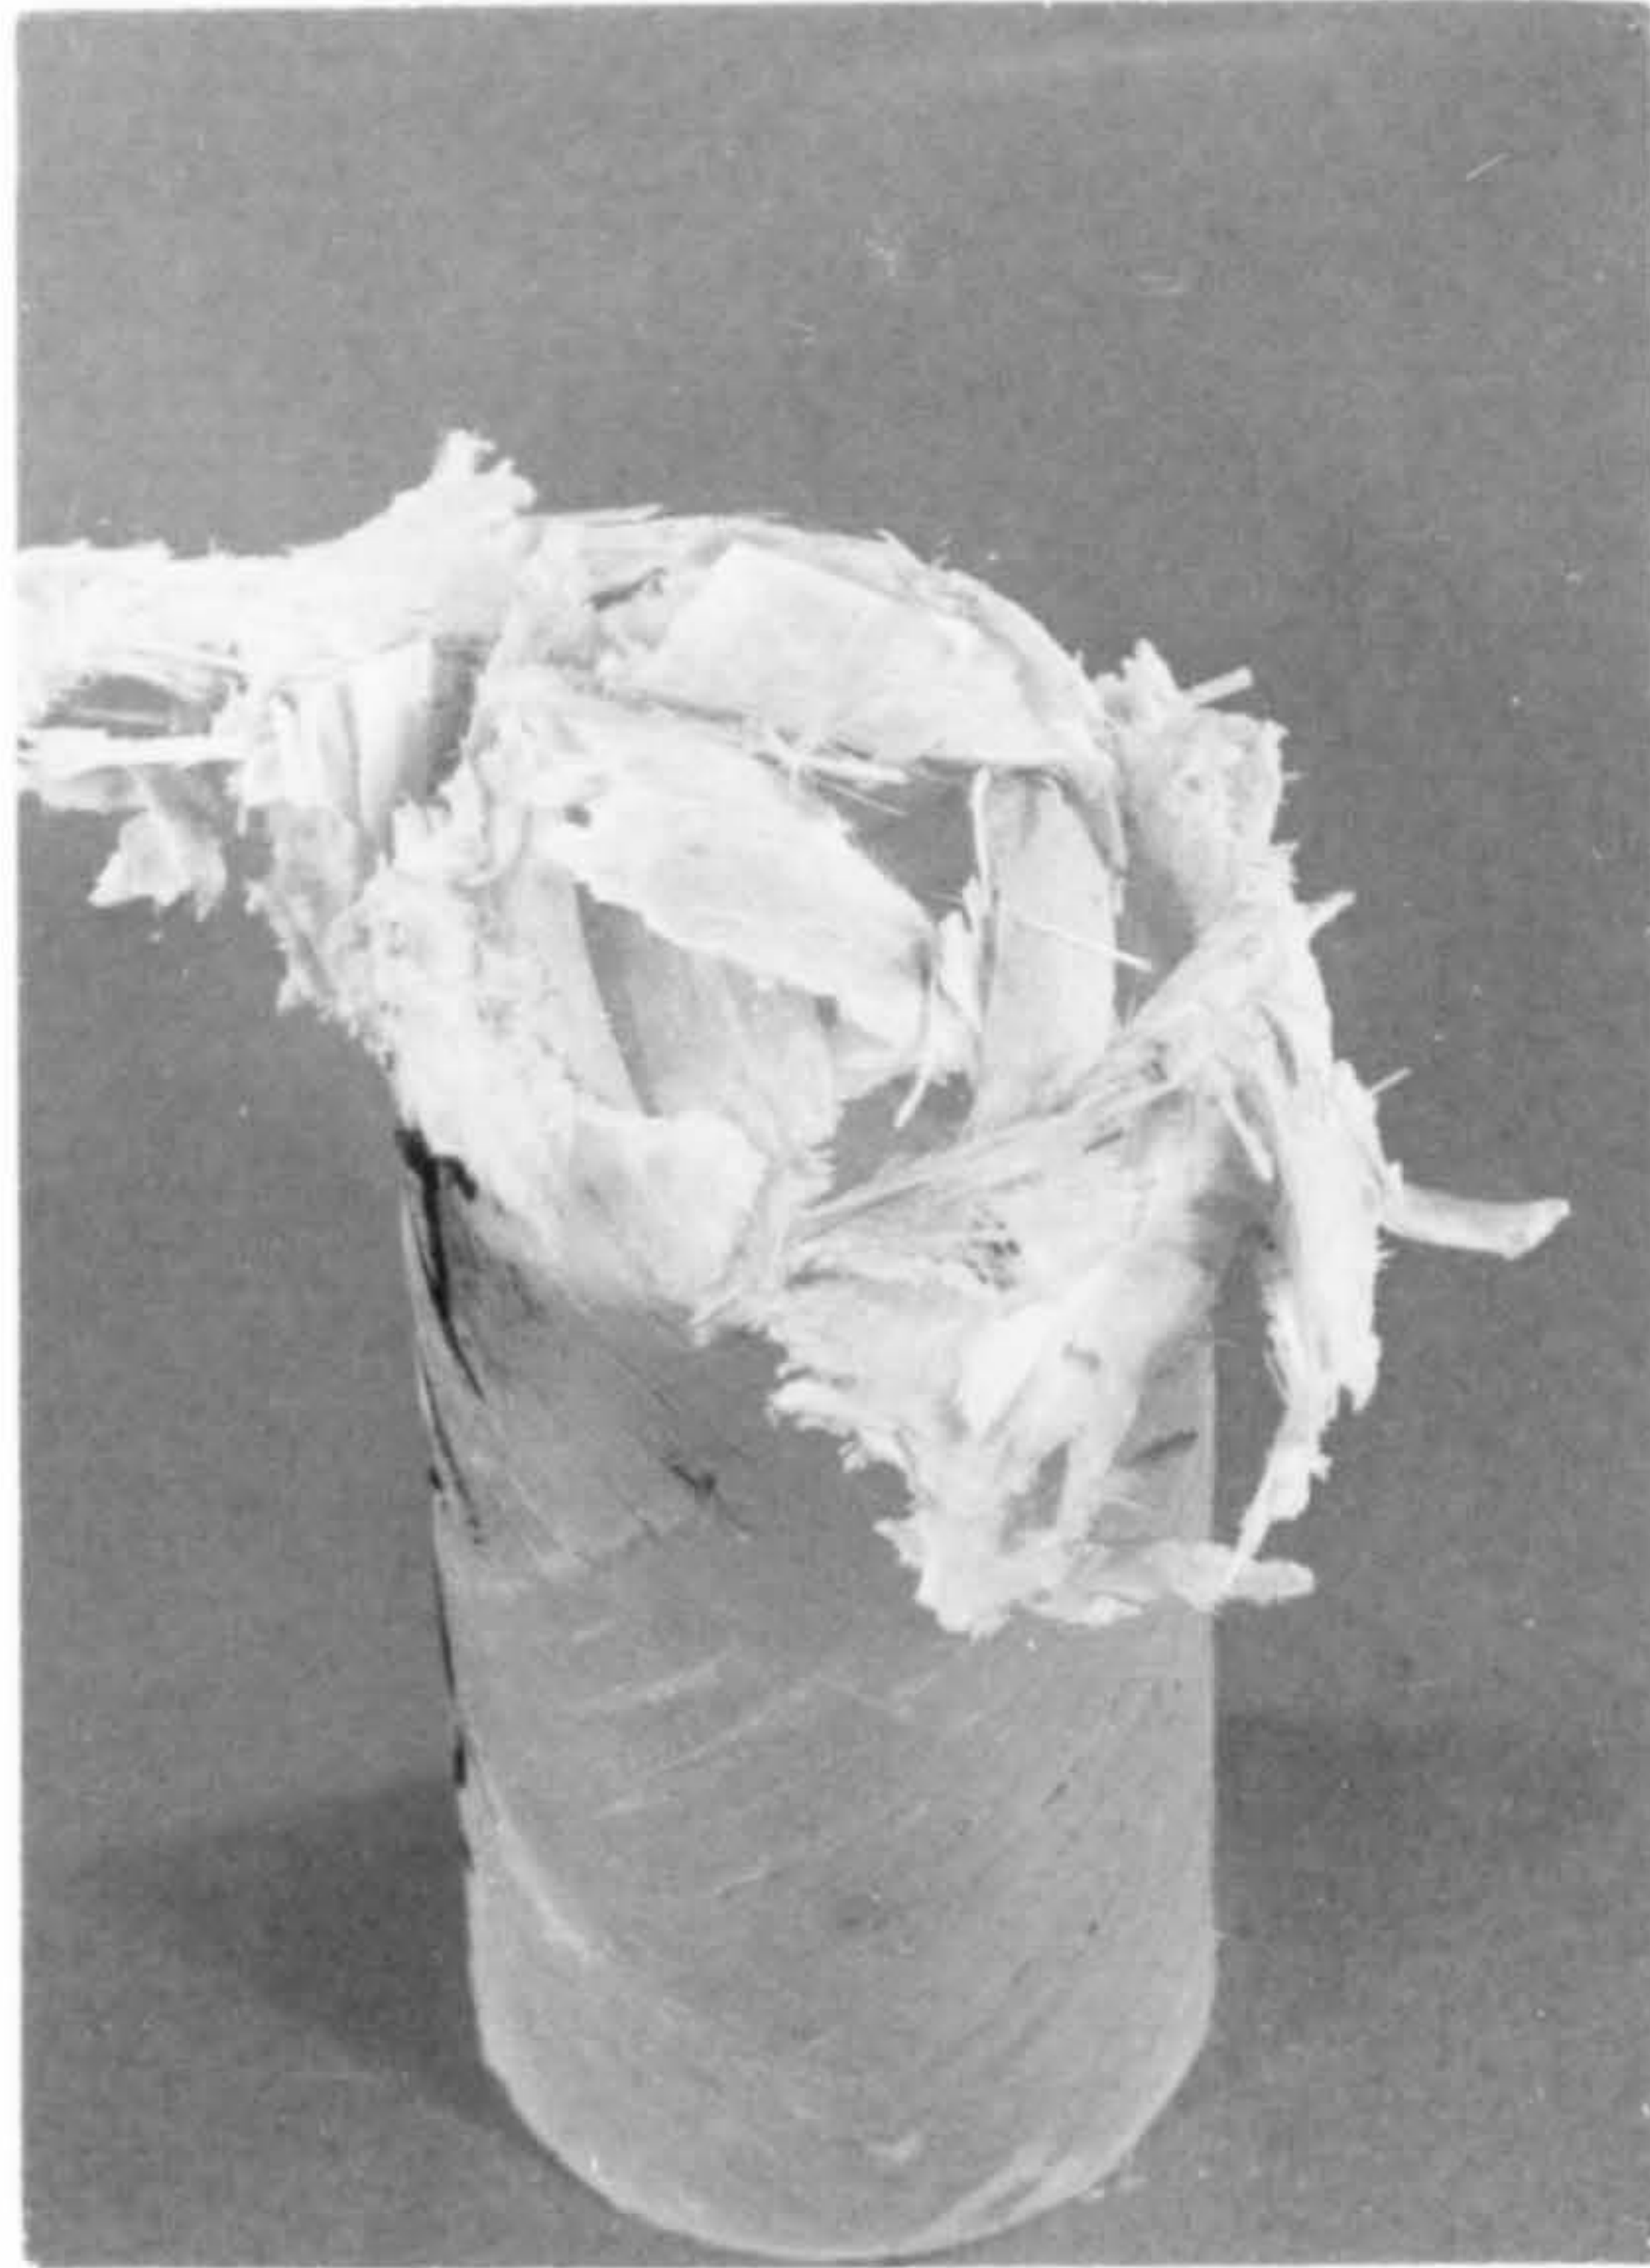
(a) General view of crush zone.

Figs. 5.14 and 5.15 show the typical appearance of the crush zone in 55° and 45° angle-wound tubes. Progressive failure occurred with large plates of laminae being detached from the tube wall as crushing took place. These plates were bent inwards and outwards. Fig. 5.14(a) is confusing as most of the tube wall appears to have been bent inwards. Observation of the specimen indicated that the outer lamina divided from the inner laminae, became bent outwards, then fractured at a point adjacent to the tube wall. This resulted in complete separation from the uncrushed tube wall and gave the misleading appearance. This fracture was thought to be most likely to occur at a cross-over point owing to the complex interweaving of the fibres.

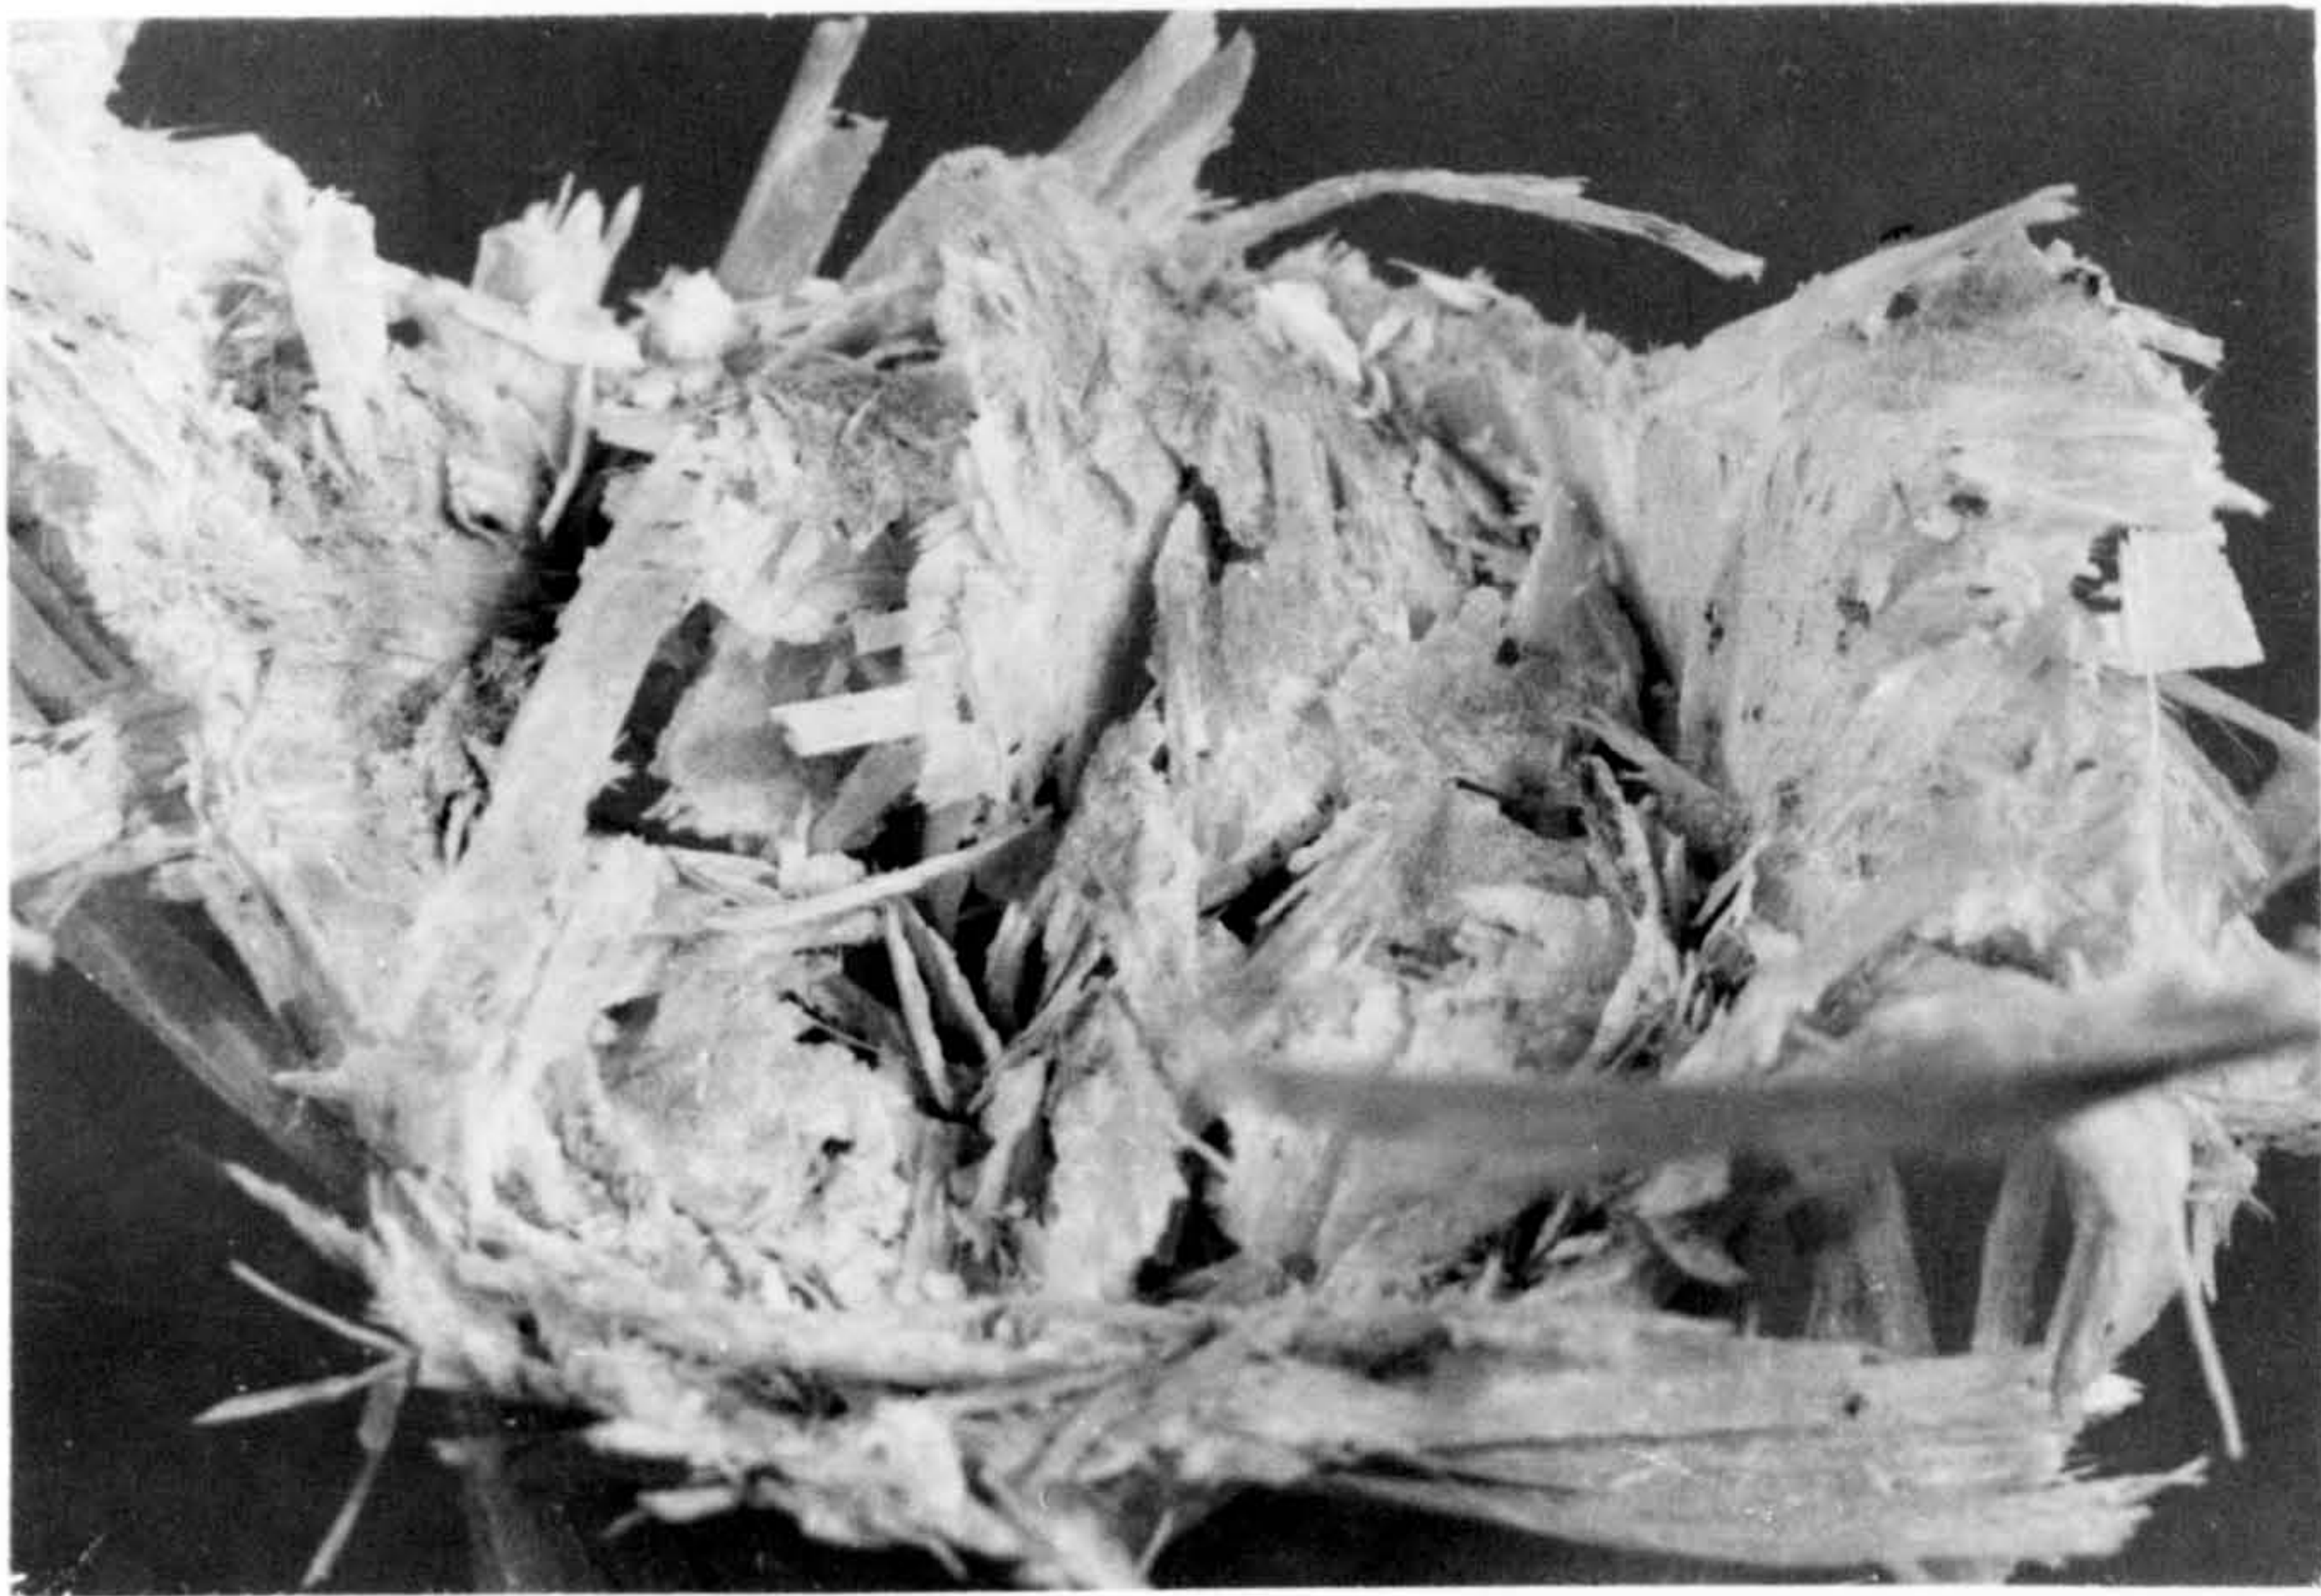
Fig.5.16. Crushed 35° angle-wound tube.

(a) General view of crush zone.

(b) Close-up of crush zone. Lamina plates bend inwards and outwards.

The crush zone of a 35° angle-wound tube is shown in Fig. 5.16. Progressive failure occurred from the bevelled end. A mixture of large plates and fibre bundles from the outer laminae bent away from the tube wall prior to complete detachment. The inner laminae were bent inwards and downwards into the tube void, fracturing into large plates of material which then fractured again (bending into) the tube cavity.

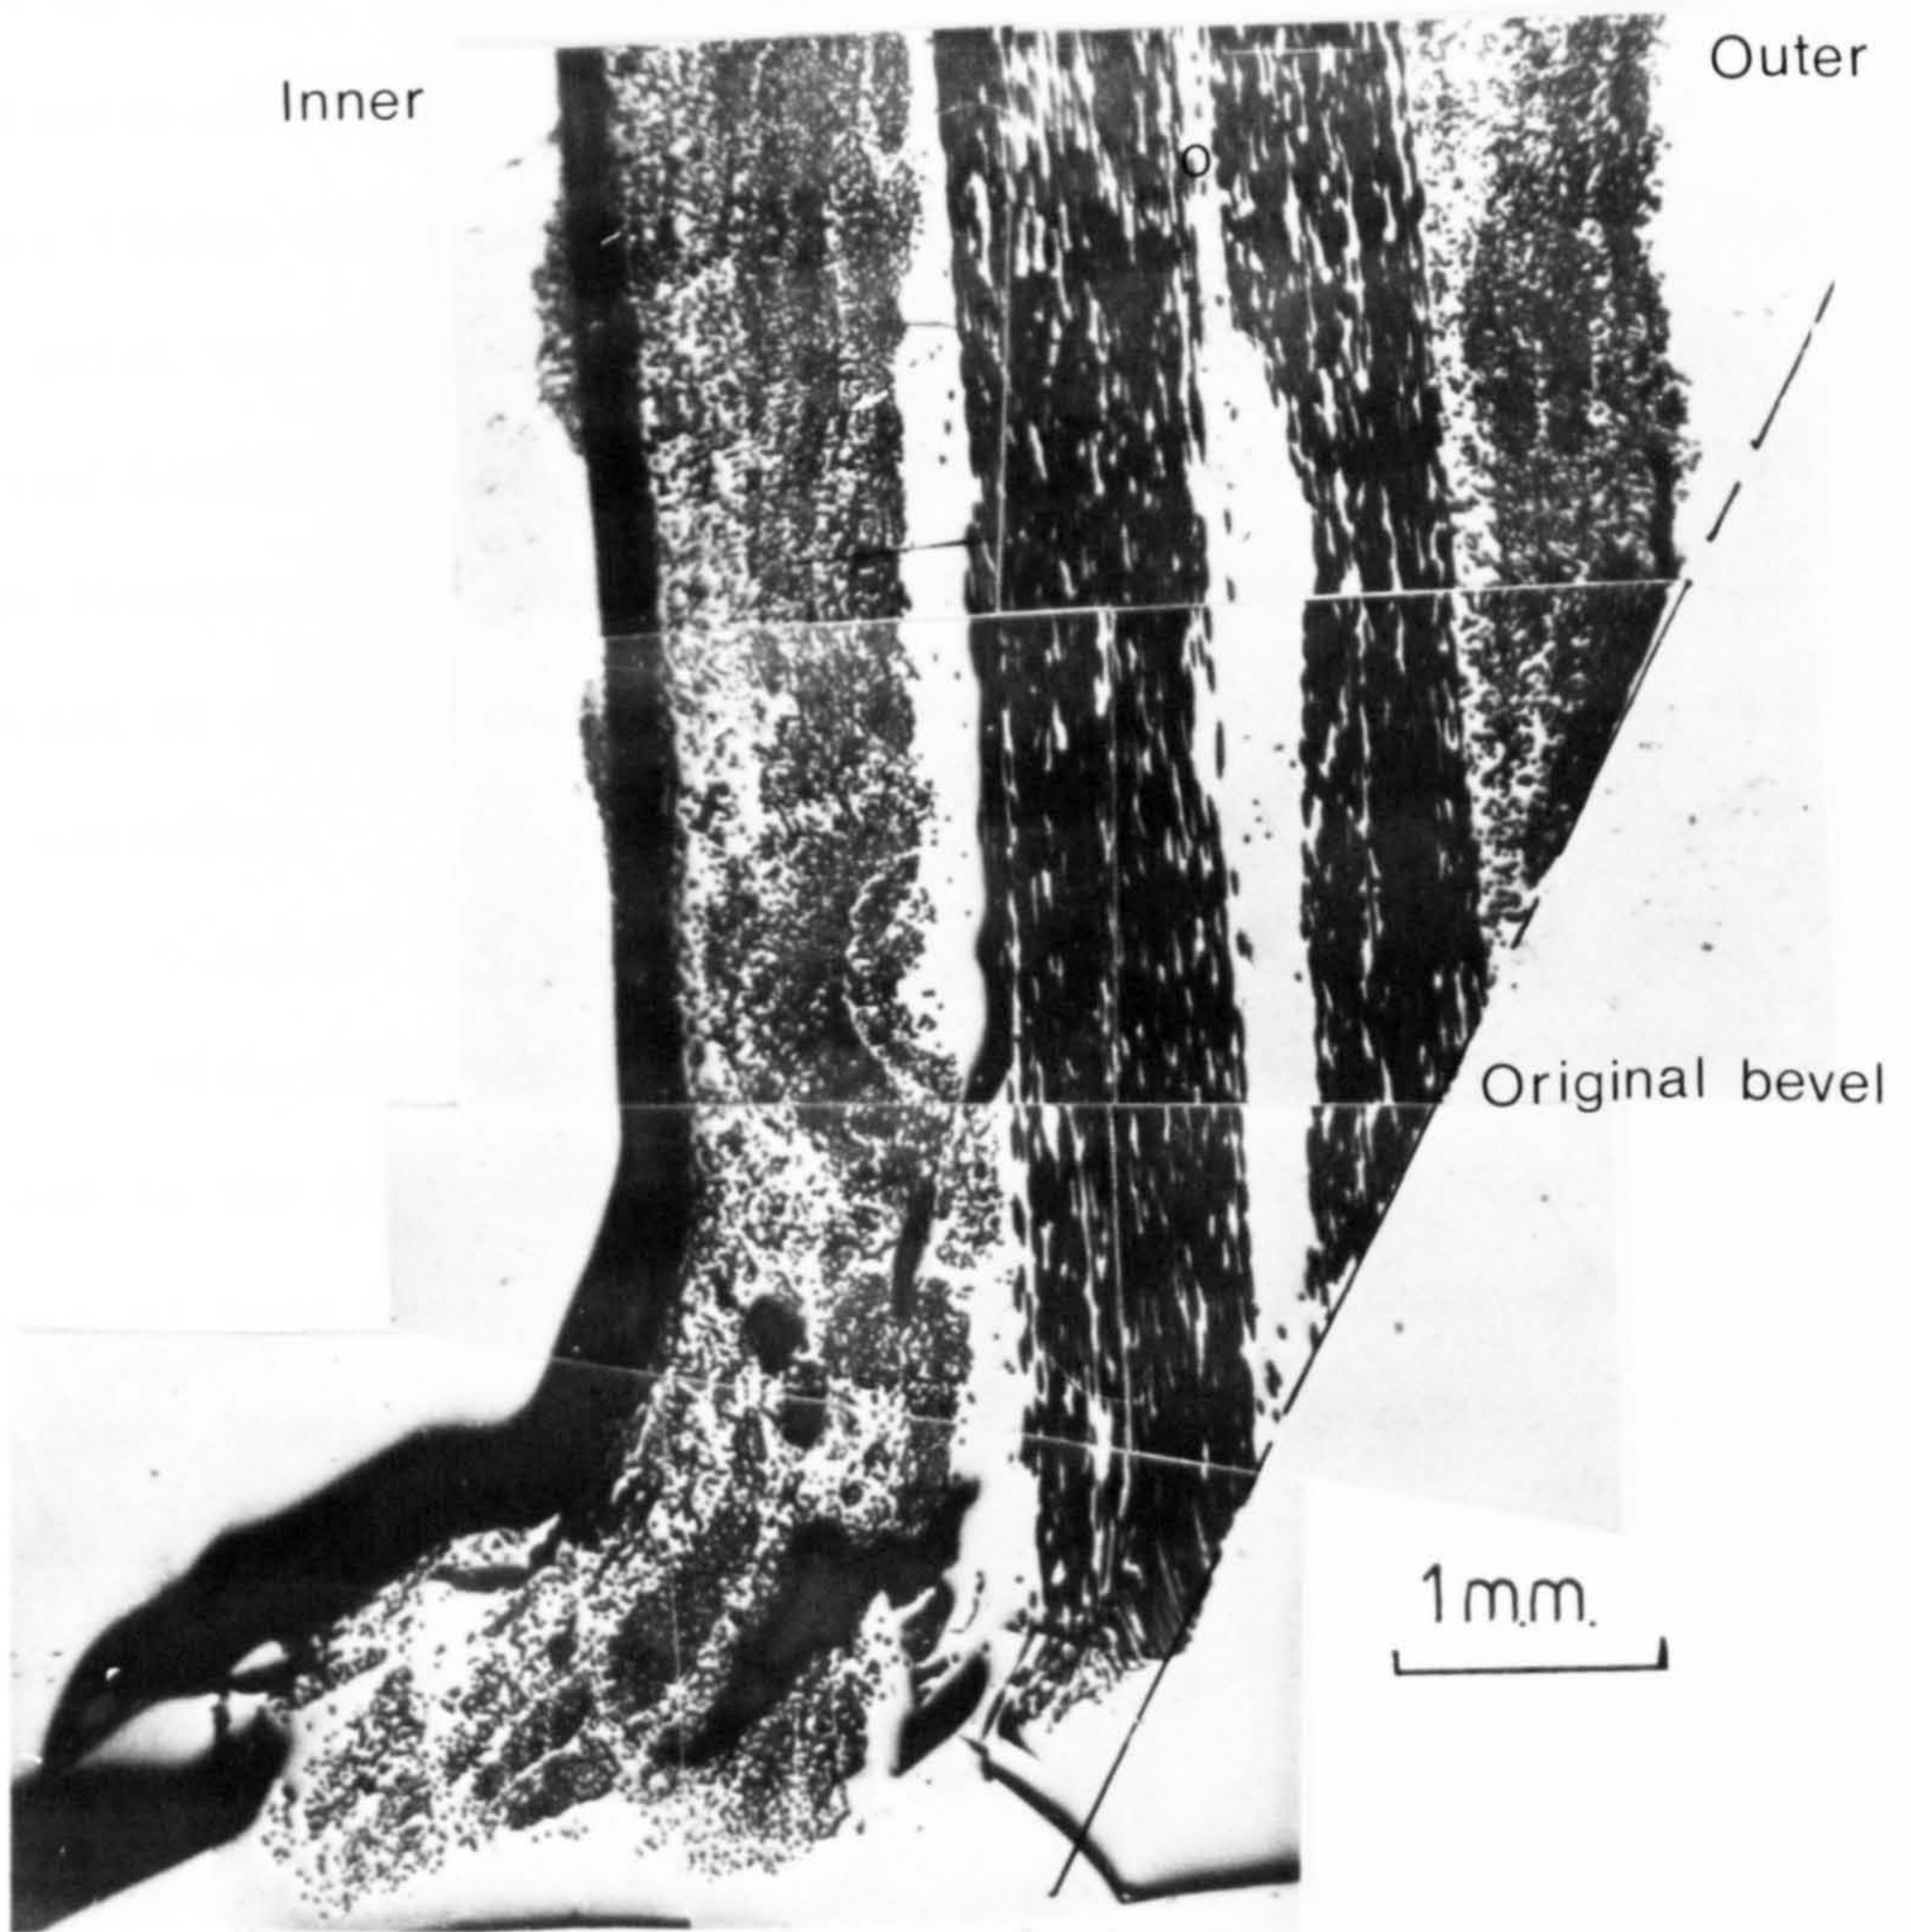
Fig. 5.18. Photomicrograph of a section through the wall of a 0/90 tube after 2.0 mm crush.

The initial crushing involved the compression of the inner hoop lamina normal to the fibre direction. The hoop windings became separated from the tube wall and moved inwards. This occurred when the hoop windings on the inside buckled circumferentially and cracked away from the inner axial lamina. At this stage, much of the work done is in bending the hoop lamina inwards, thus causing wide cracks which show as dark areas in the photomicrograph. A small
