POST FAILURE ENERGY ABSORBING MECHANISMS OF FILAMENT
WOUND COMPOSITE TUBES

Thesis submitted in accordance with the requirements
of the University of Liverpool for the degree of Doctor
in Philosophy by Robert Keal.

September 1983

Department of Metallurgy
and Materials Science,
University of Liverpool.

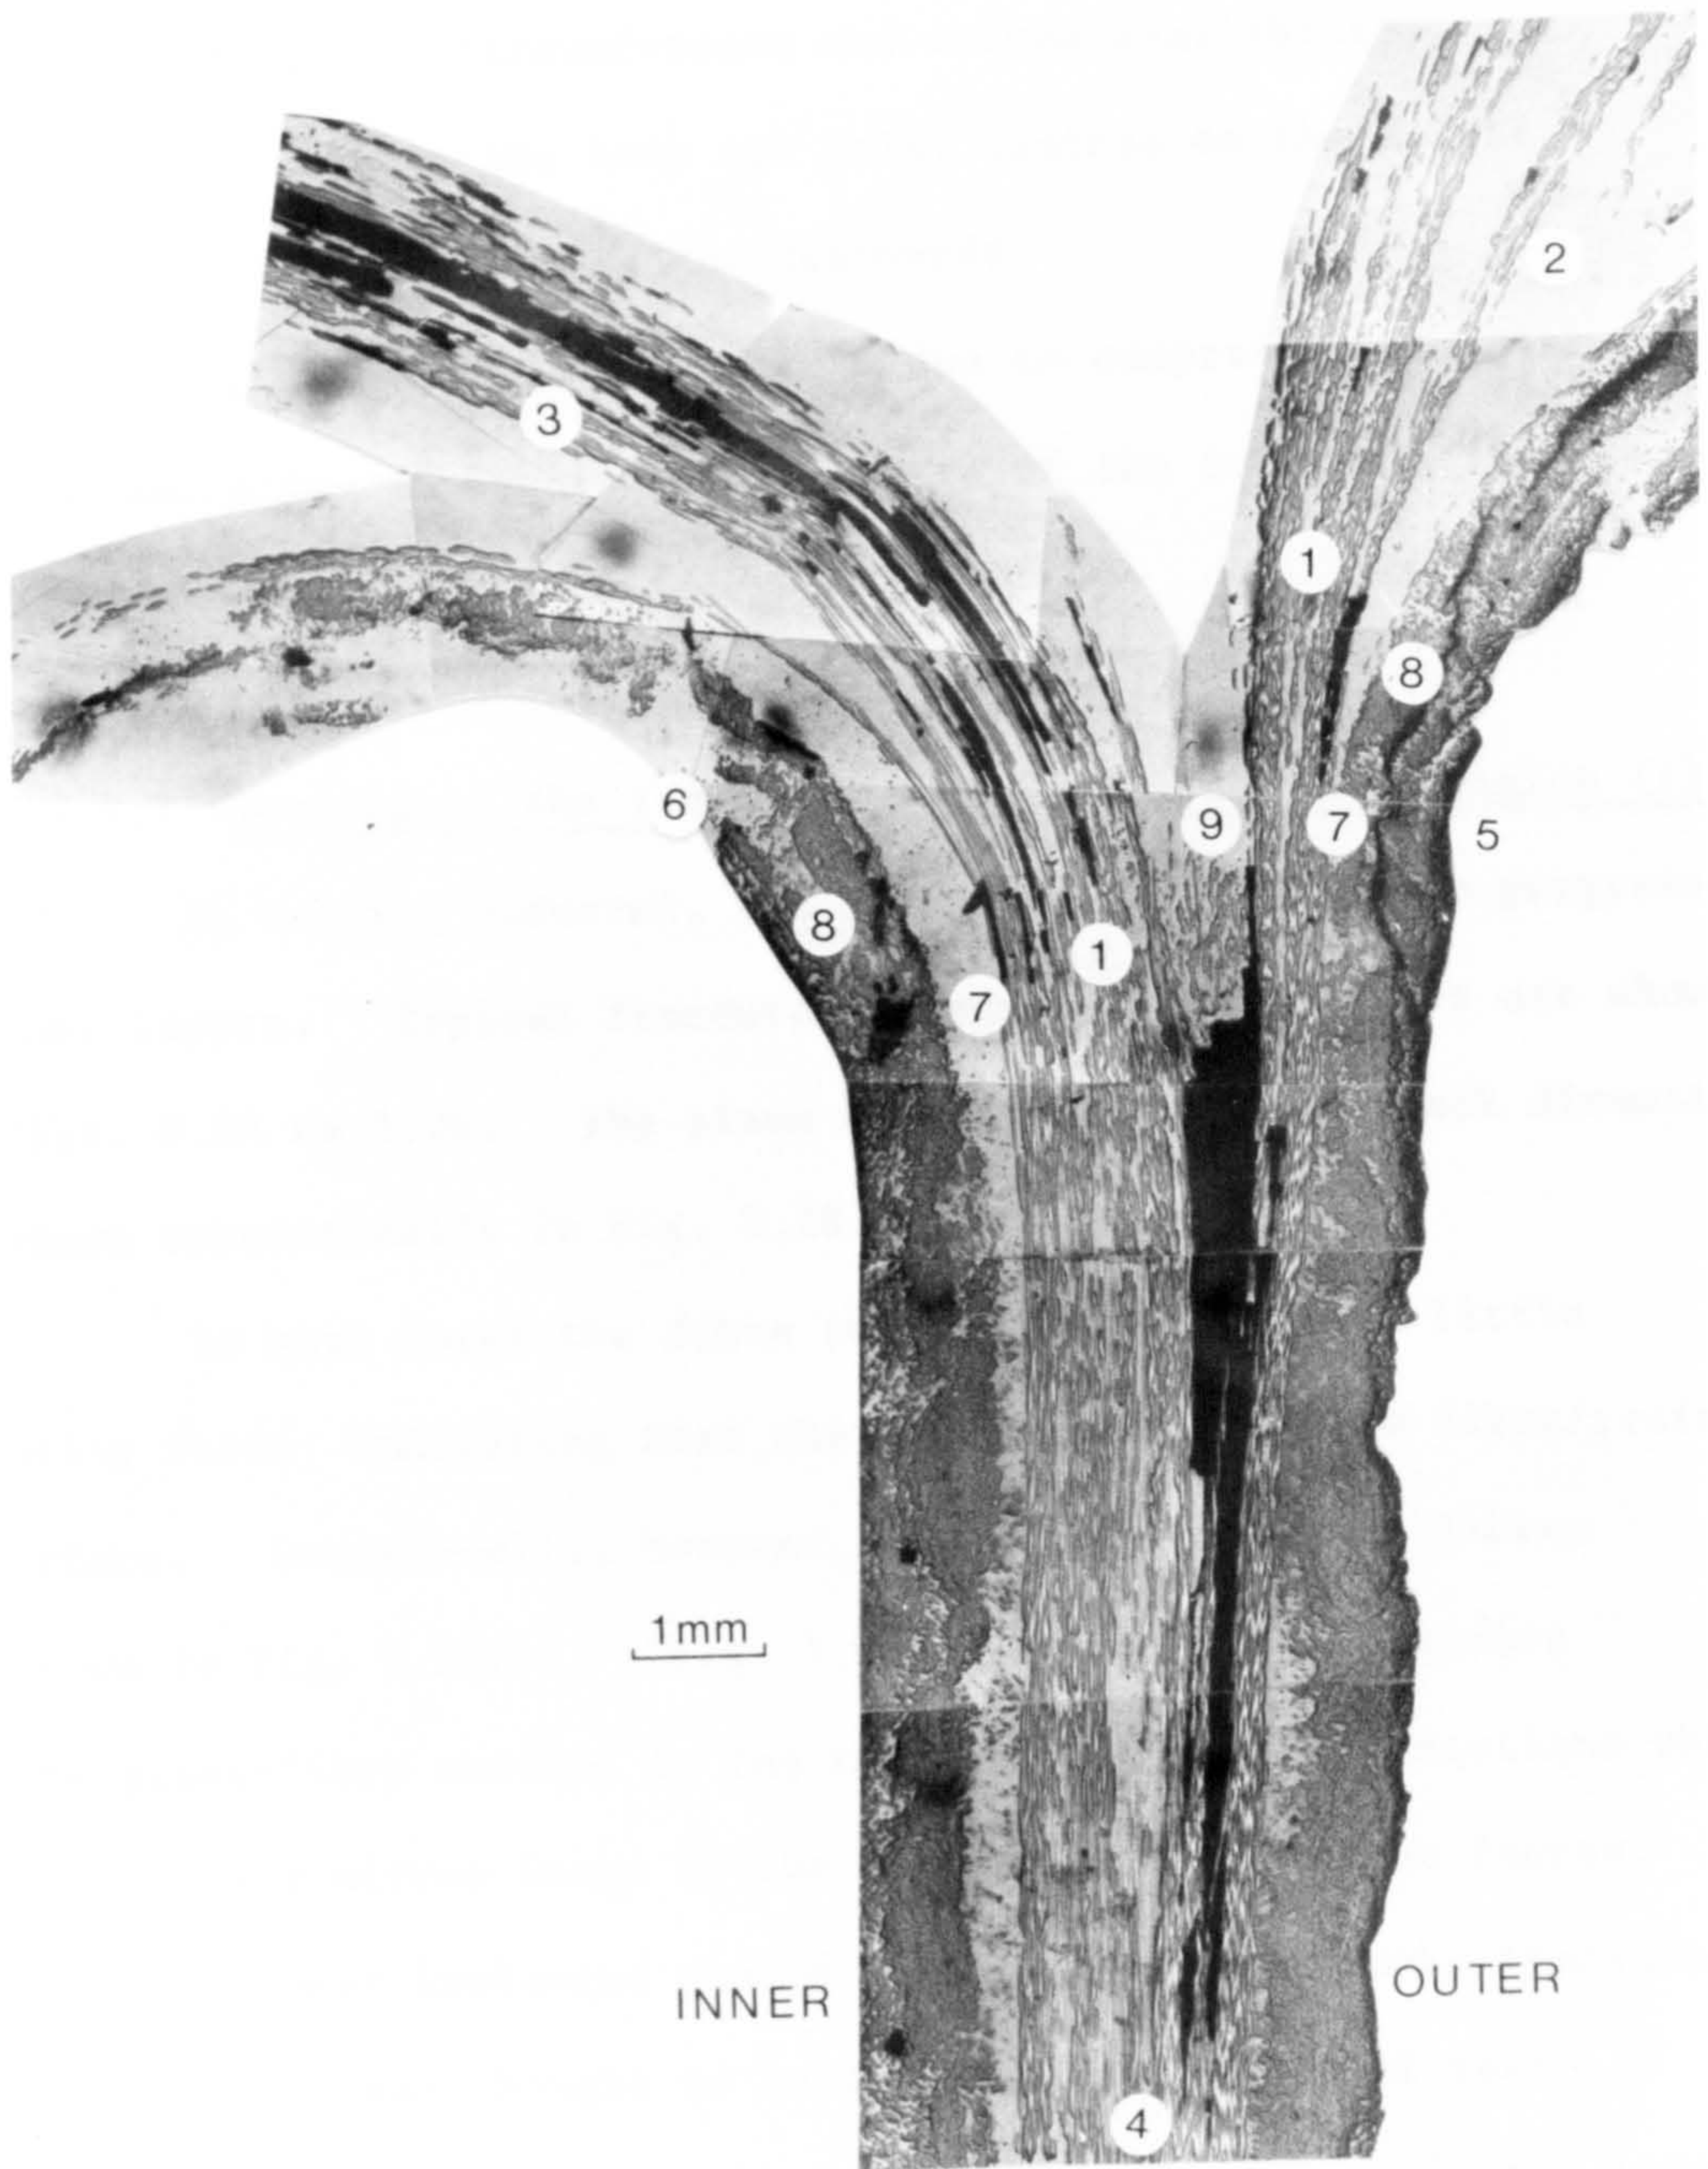
Fig. 5.23. Photomicrograph of a section through the wall of a crushed 0/90 tube indicating areas of individual failure mechanisms as described in the text.

1. Bending of the inner and outer axial laminae.
2. Splitting of the outer axial lamina due to increasing circumference.
3. Crushing and multiple fracture of the inner axial lamina due to reducing circumference and volume availability.
4. Cracking down the centre of the tube wall.
5. Tensile fracture of the outer hoop lamina due to increasing circumference.

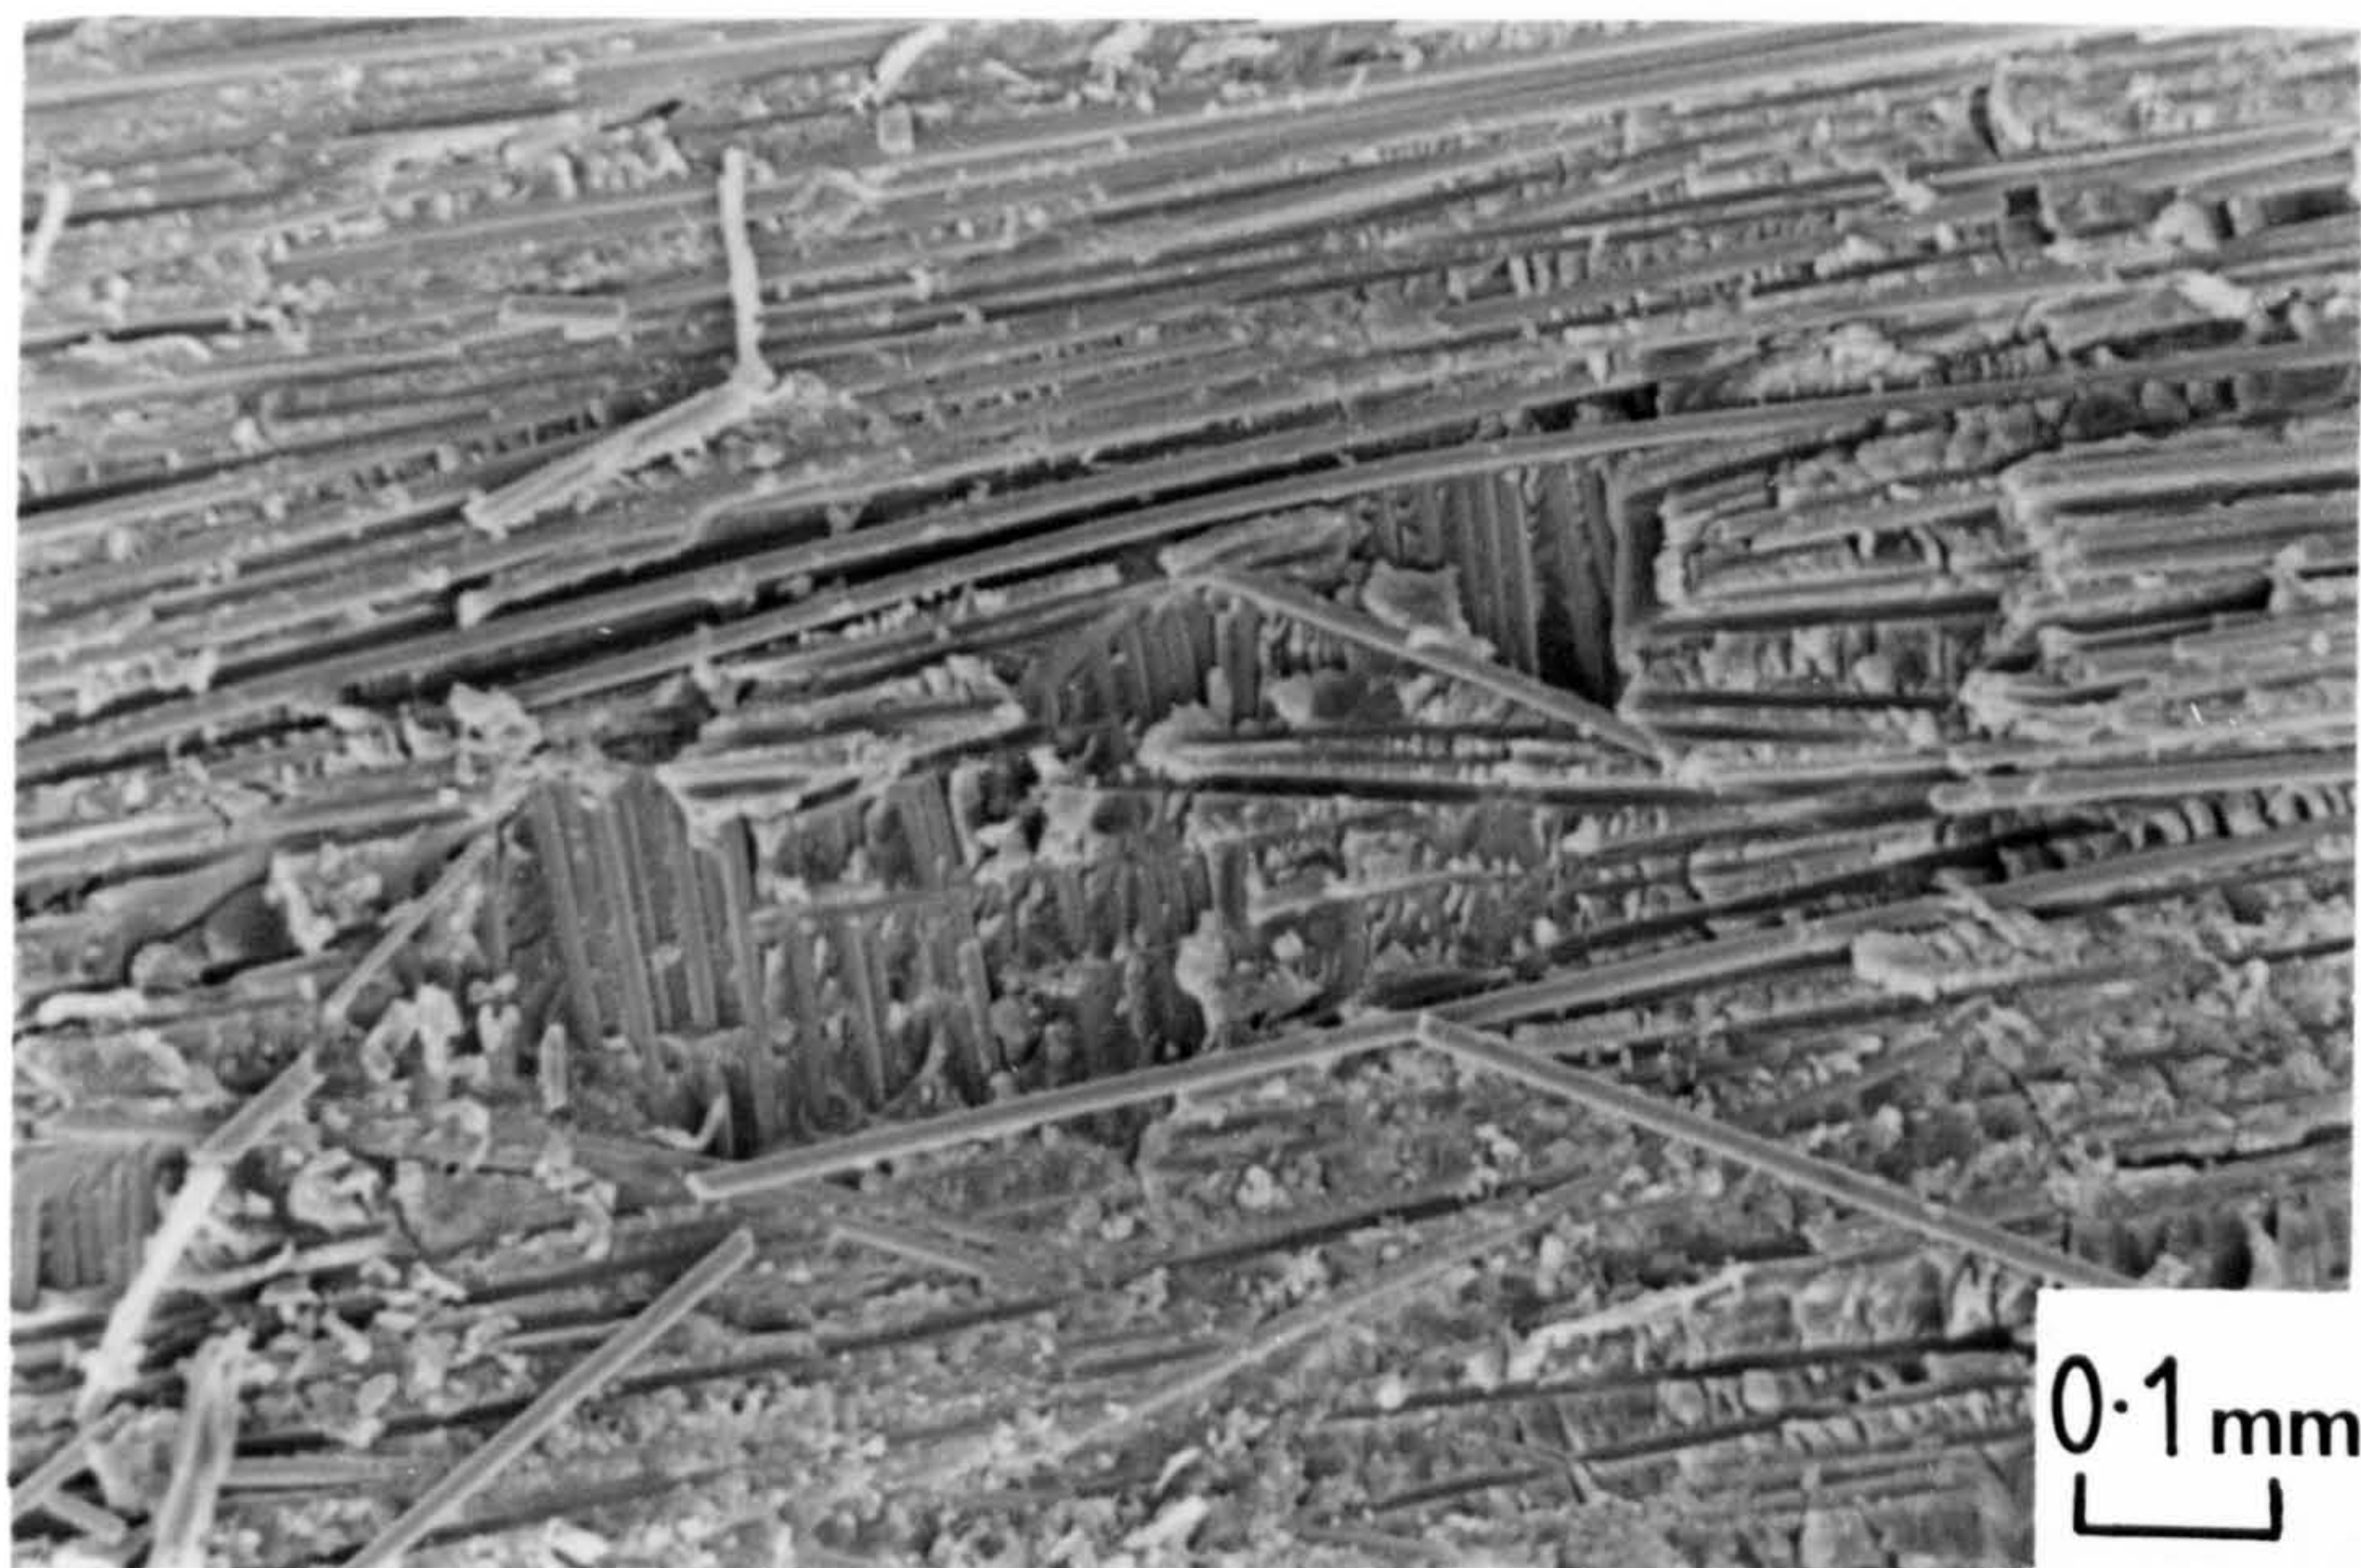
The hoop fibres underwent several different fracture mechanisms during the crush process. Tensile failure and hoop-to-axial interlaminar failure have been described. In addition to these mechanisms, bundles of hoop fibres, roughly corresponding to the dimensions of the original fibre tows, were compressed downwards and outwards from the tube wall, with cracking taking place

(a) General low magnification view.

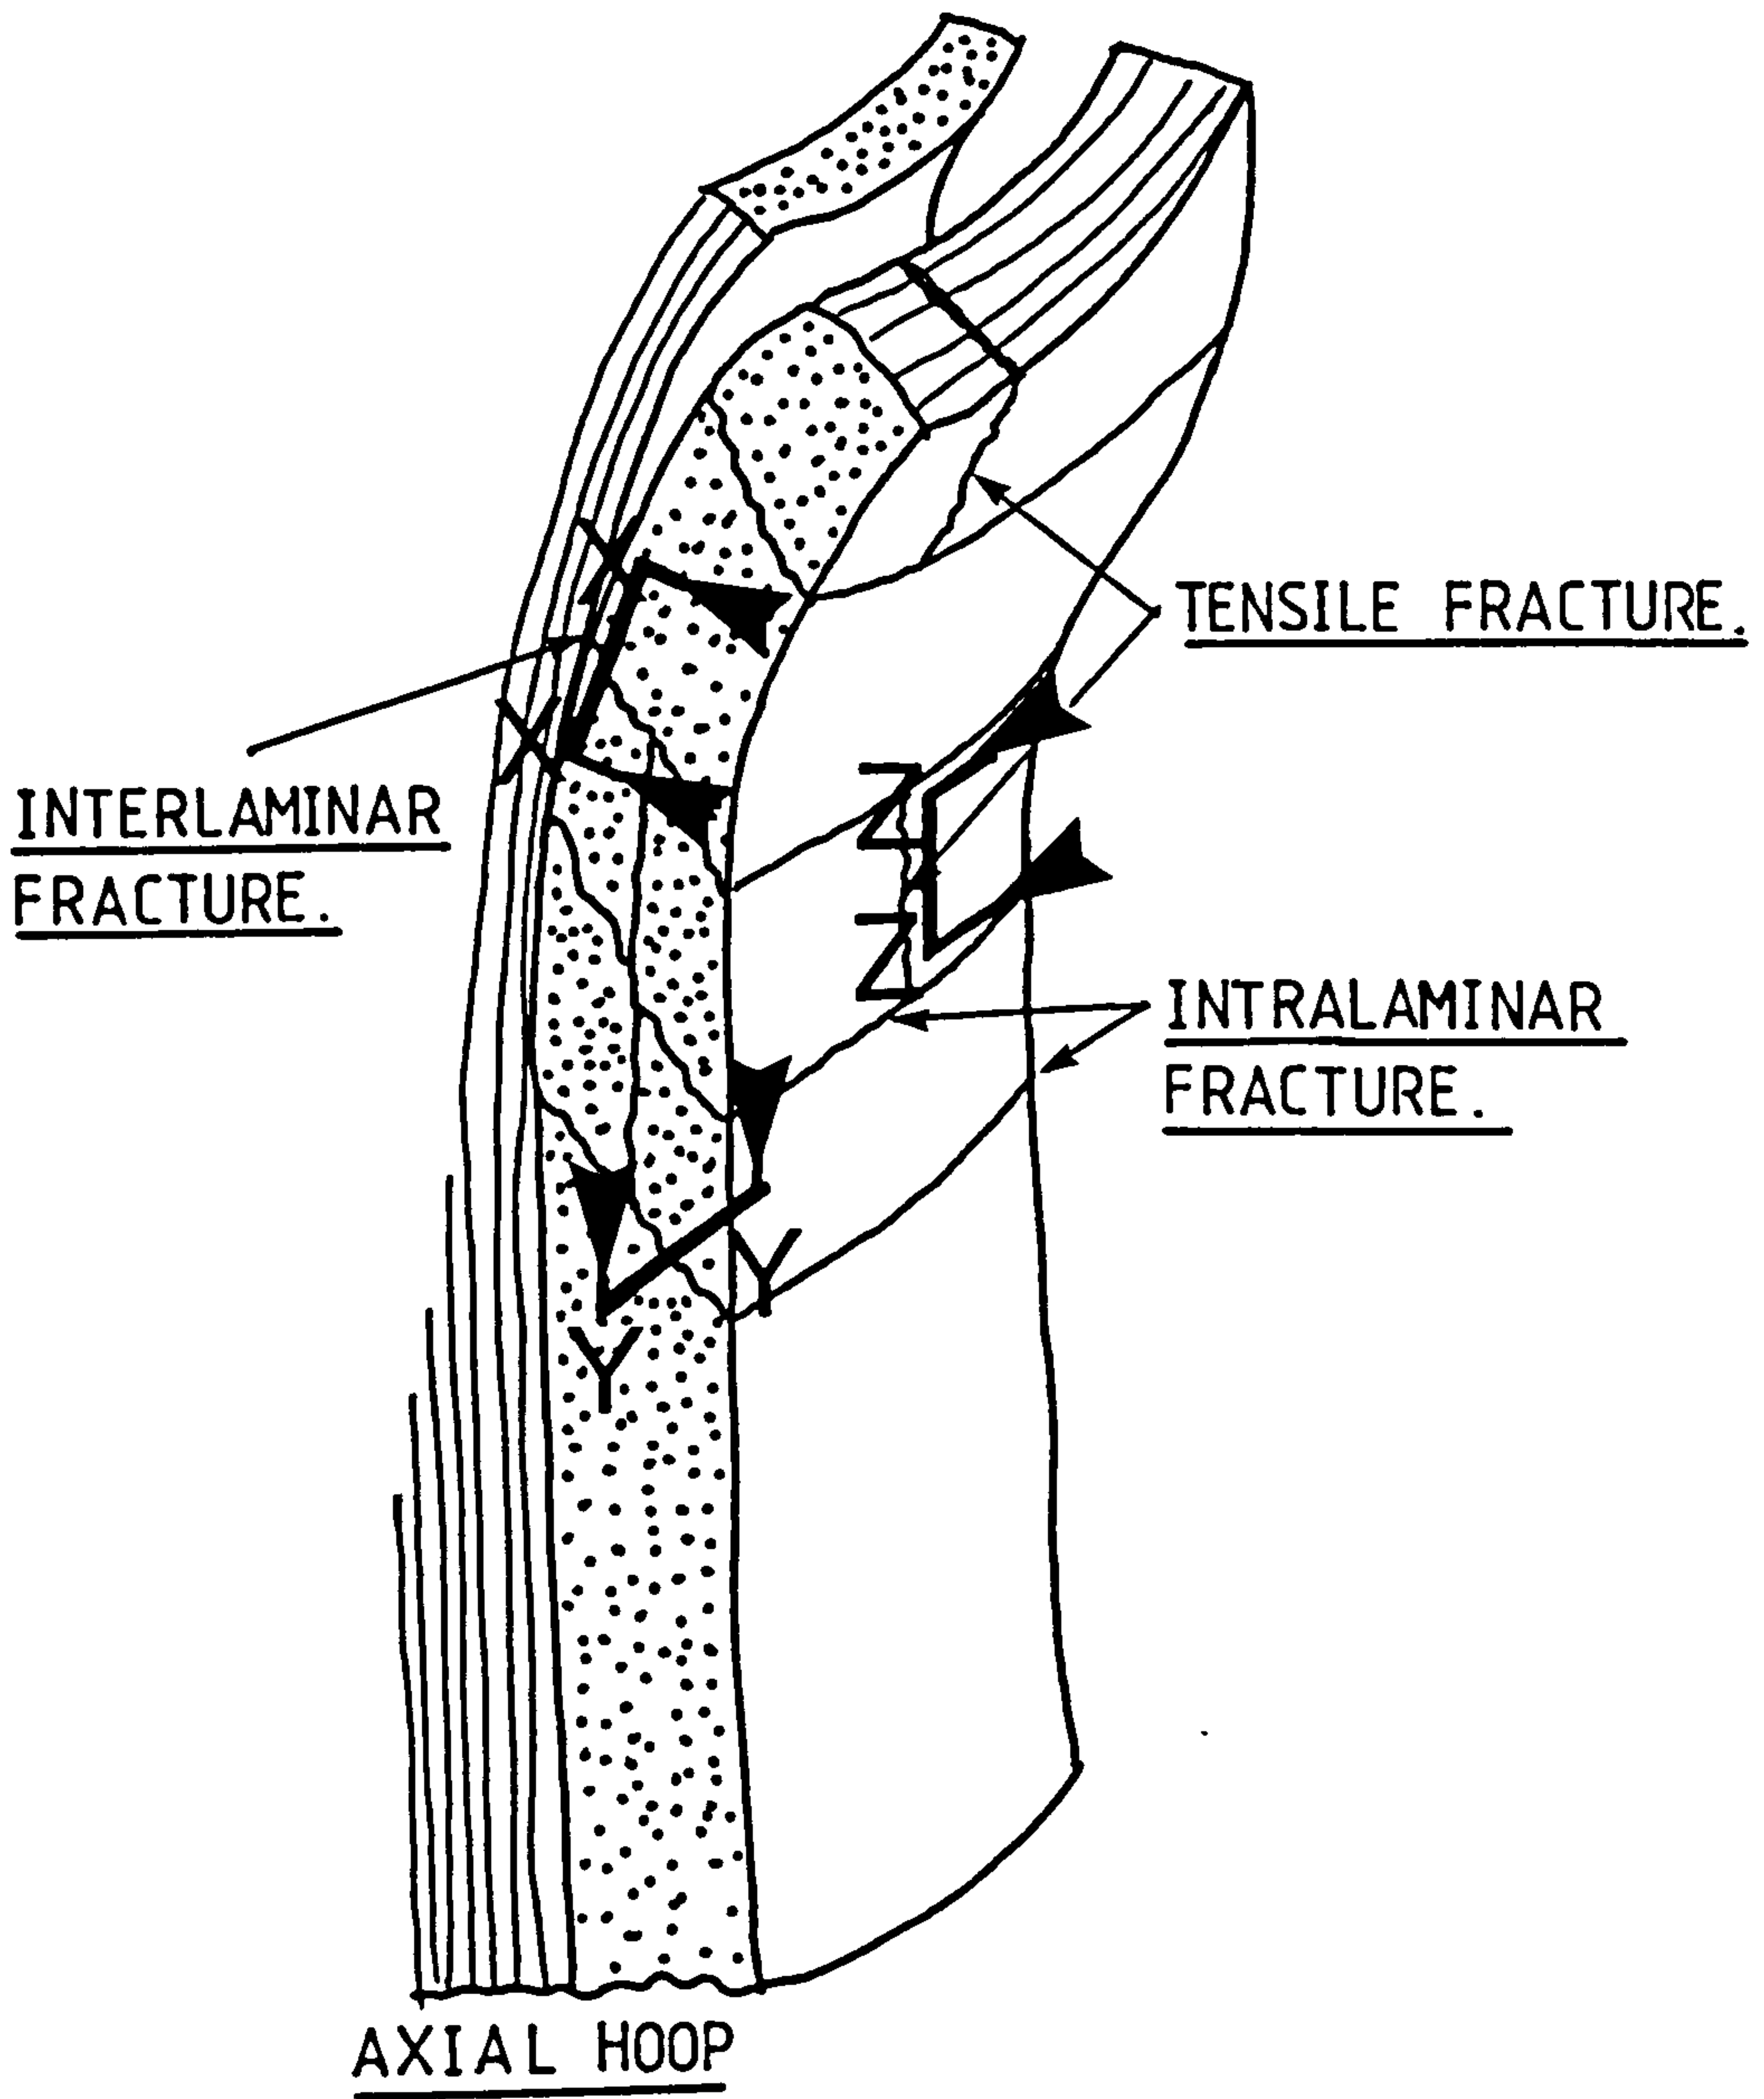
Fig. 5.41. Diagram of a segment from the crush zone of a 0/90 tube showing the three modes of fracture in the outer hoop lamina. The directions of view for scanning electron microscopy are indicated.

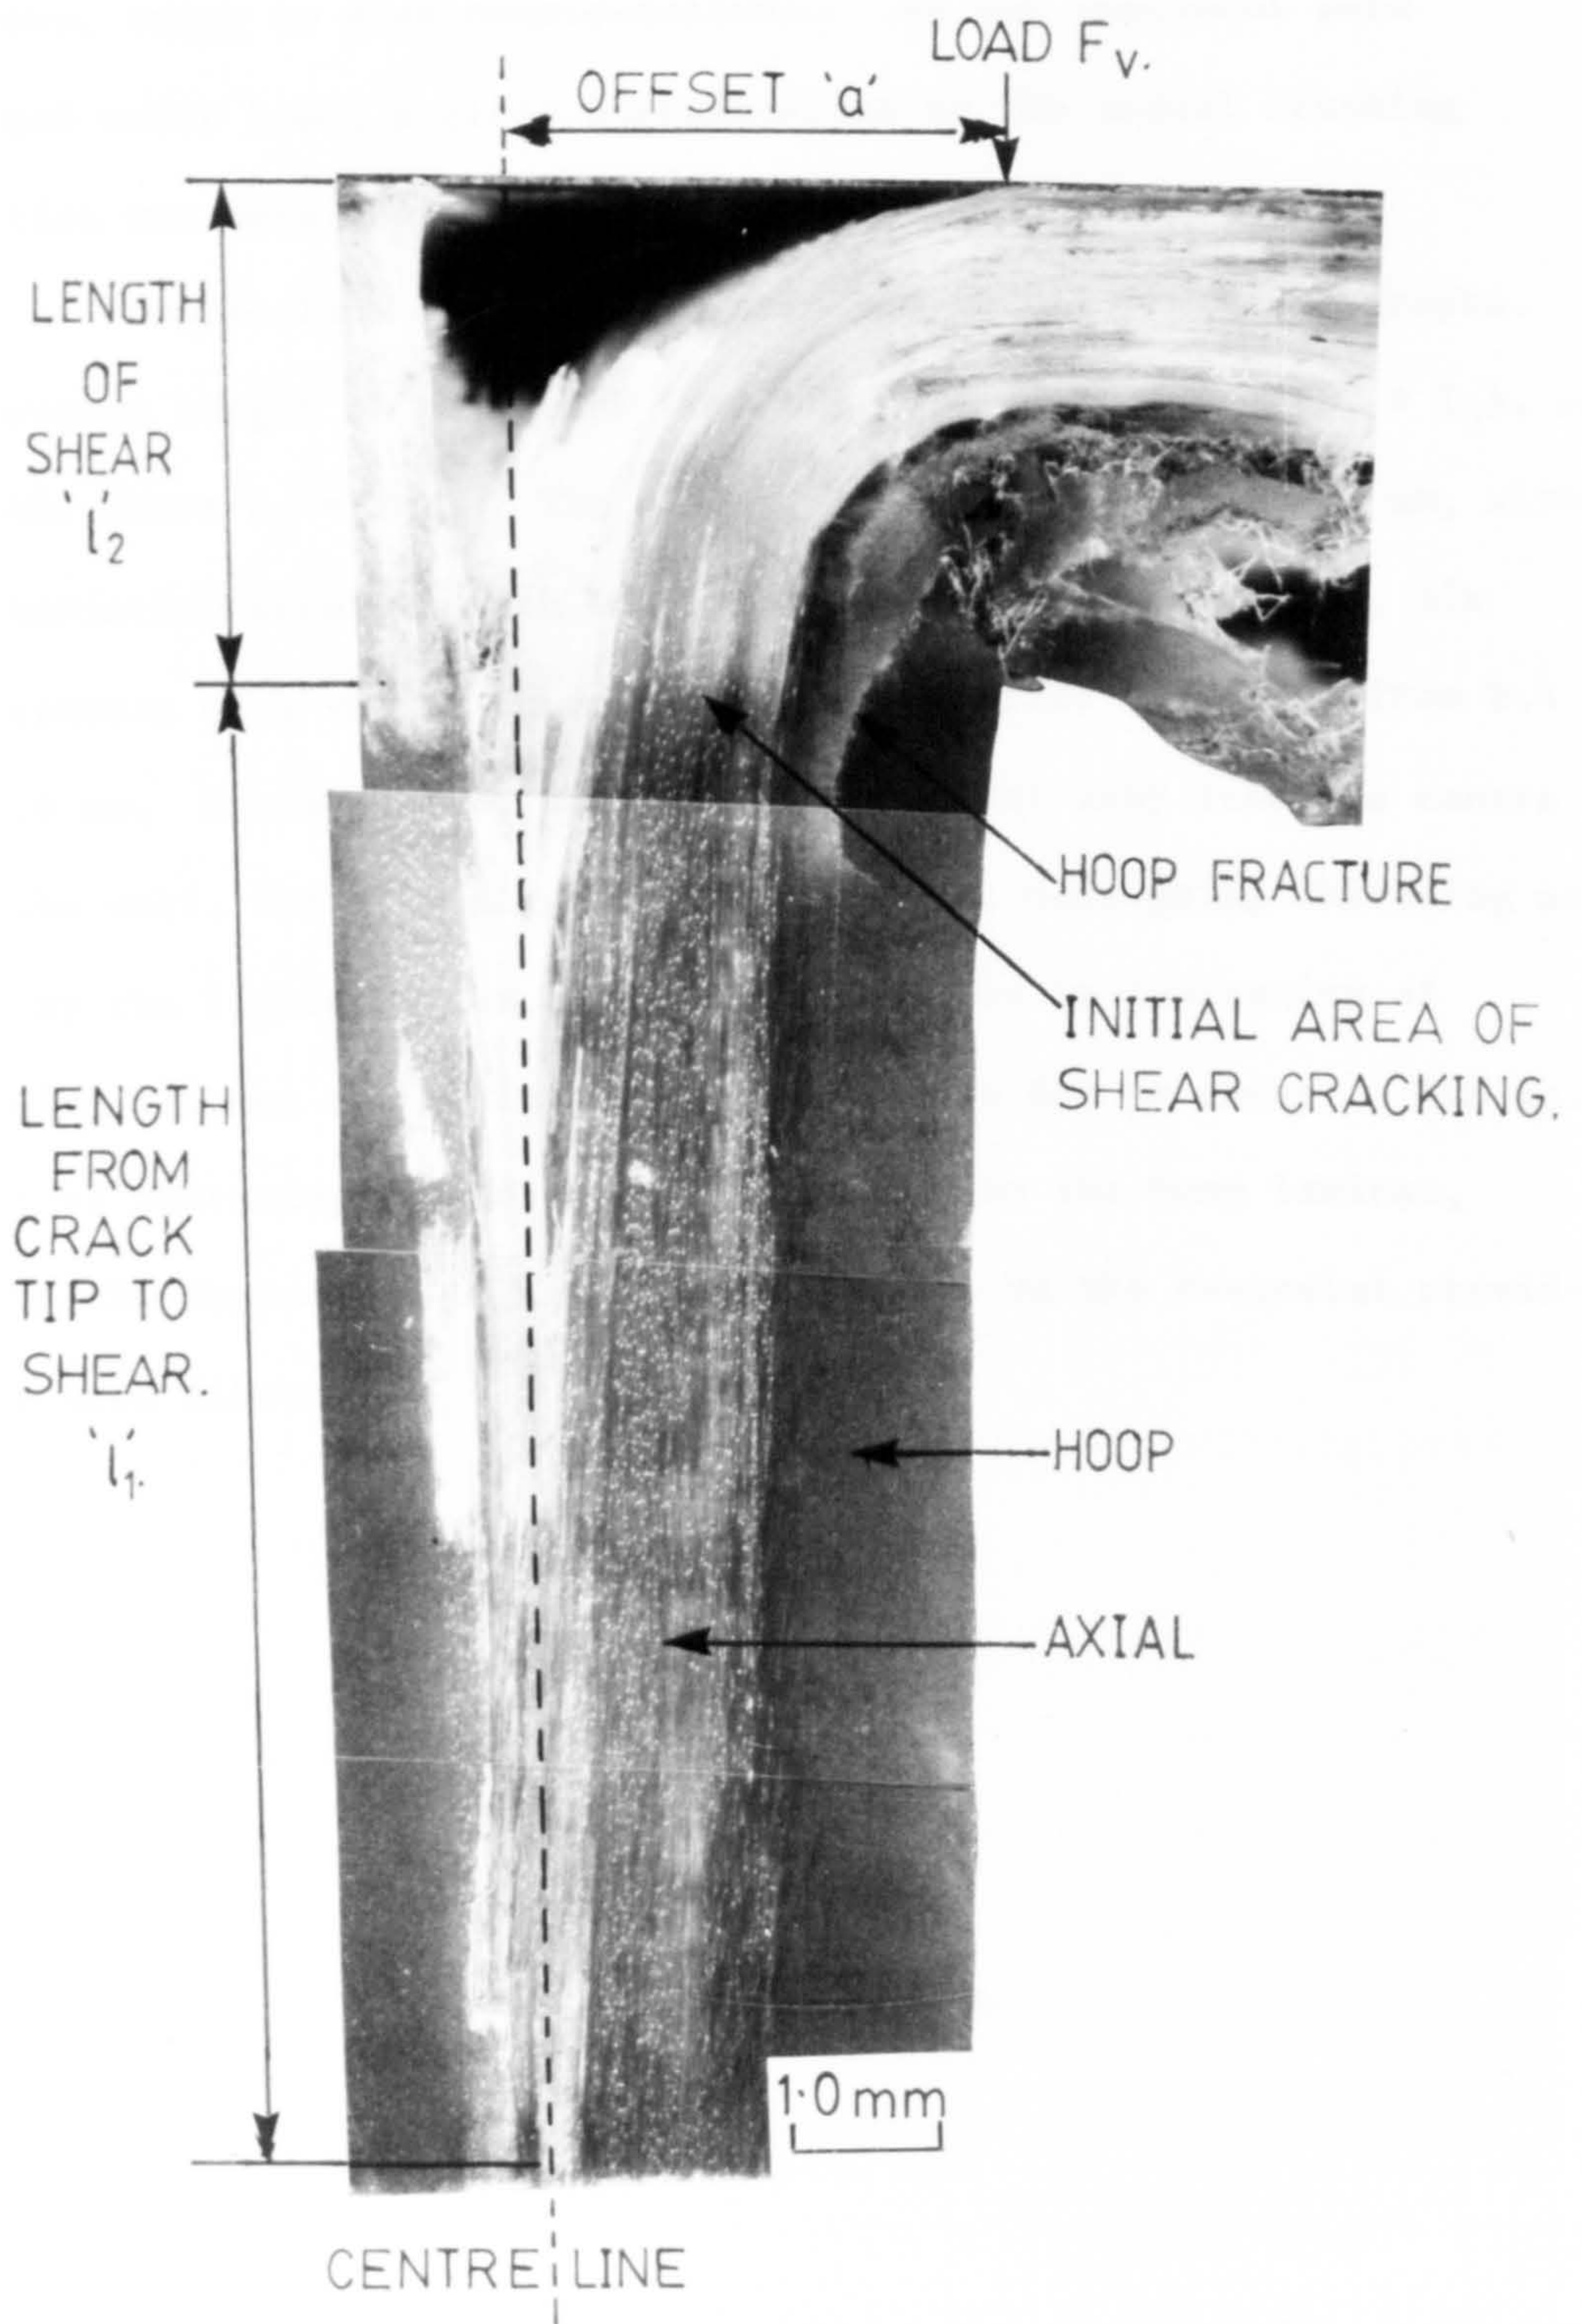
Fig.5.43. Photomicrograph of a crushed segment of a 0/90 polyester tube under load. Original test speed was $4 \times 10^{-3} \text{ ms}^{-1}$. Notations referred to in text.
