LOW VELOCITY TRANSVERSE IMPACT OF FILAMENT WOUND
E-GLASS/EPOXY RESIN PIPES.

Thesis submitted in accordance with the requirements of
the University of Liverpool for the degree of Doctor of
Philosophy.

by Kim Ainsworth

April 1990.

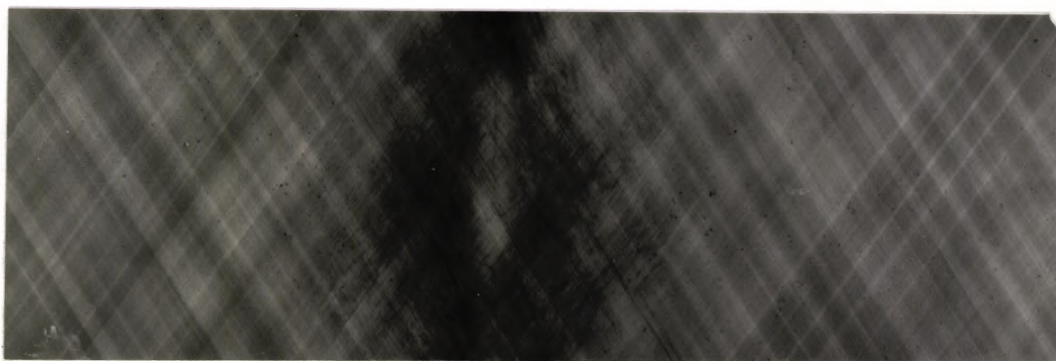
Fig. 4.3 Penetrant enhanced X-ray radiograph of T1.

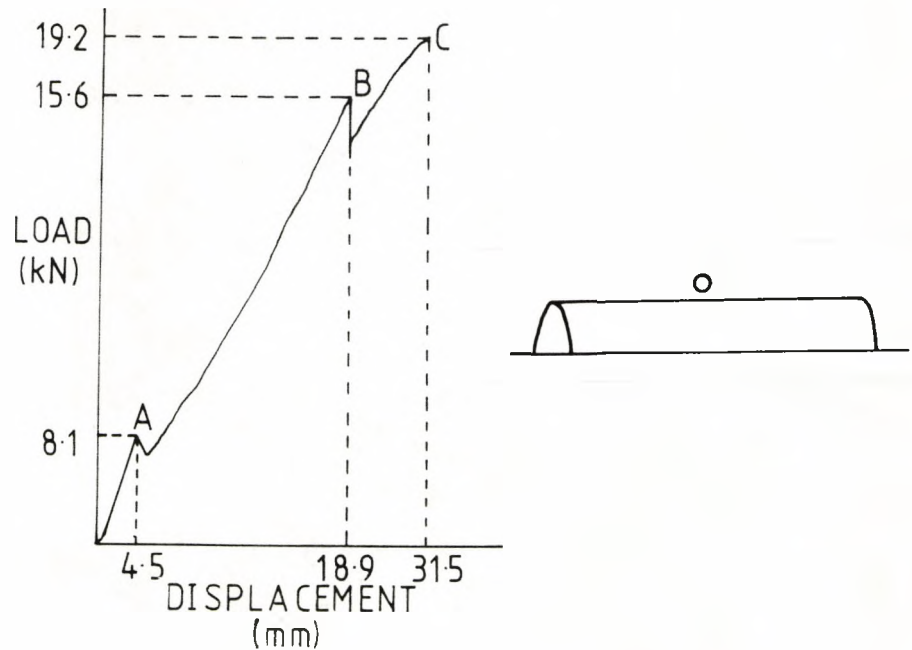
Fig. 4.4 Load/displacement plot for the half pipe tests.

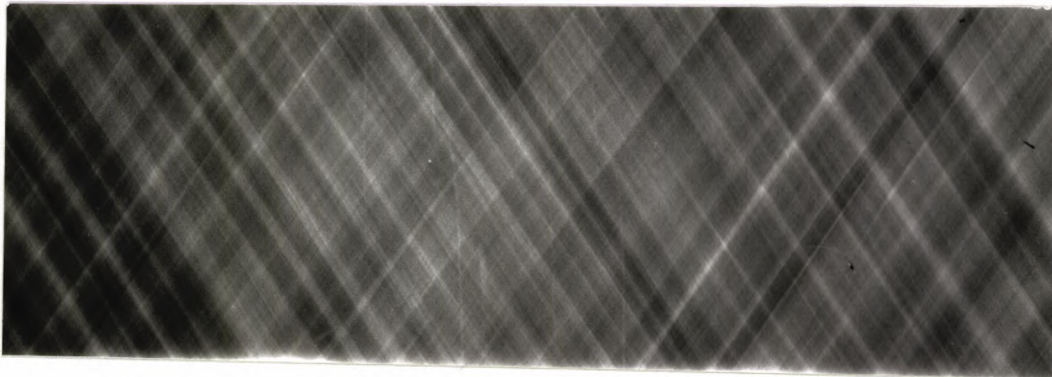
Fig. 4.6b X-ray radiograph of a 500mm test span specimen
(without zinc iodide X-ray opaque fluid).

benefits of adding the zinc iodide X-ray opaque fluid. Fig. 4.6b is an X-ray radiograph of the same specimen as in fig 4.6a without the addition of the penetrant and it can be seen that the damage is very difficult to discern. Secondly, these tests proved a useful means of comparing crush and flexural damage (see figs. 4.3 and 4.6a). Crush damage consists of a gel coat crater, resin cracking on both surfaces and delamination initiation. It is very localised. Flexural damage consists of lower resin cracks only and extends over a much larger area.

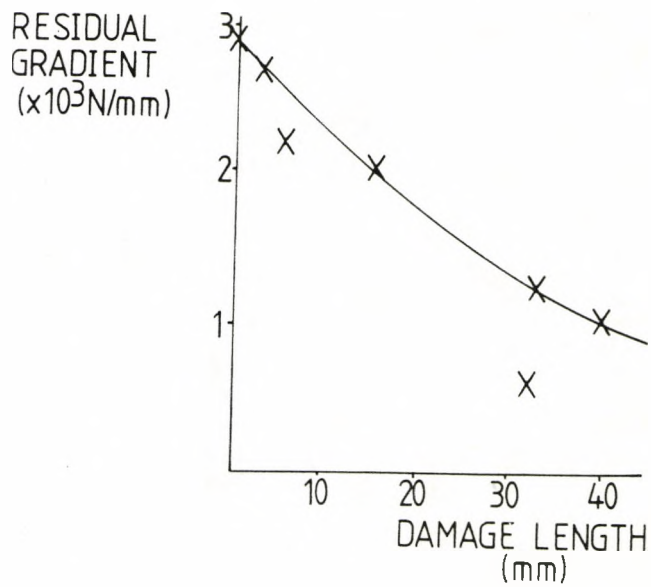
Fig. 4.10 Graph of residual gradient against damage length for the 65mm span tests.

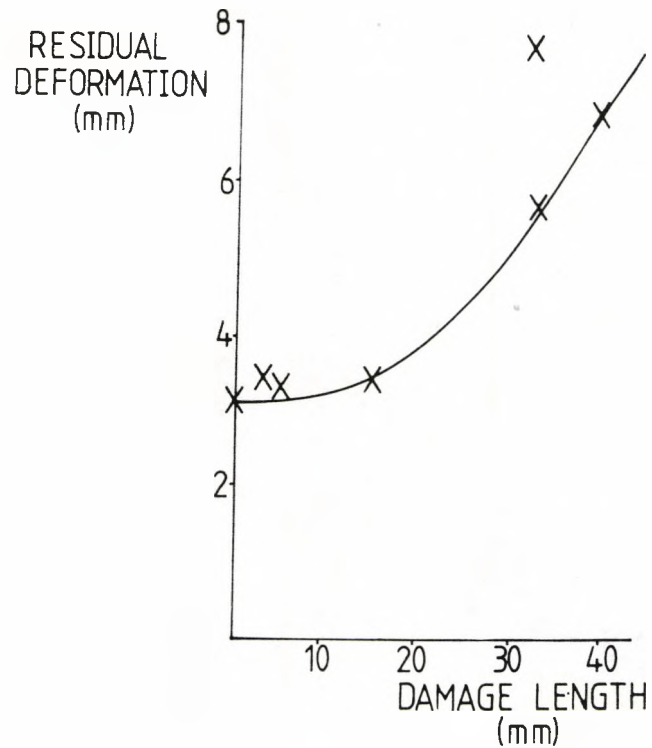
Fig. 4.11 Graph of residual deformation at peak load against damage length for the 65mm span tests.

thus indicating increasing damage resulted in reductions in both strength and stiffness (characterised by peak load and gradient respectively). Fig. 4.11 is a plot of the residual deformation at peak load against damage length. Here, the pattern was that there was a cut off point below which increasing the amount of damage had no effect. Beyond this point (about 12mm damage length), the deformation required to cause failure rose rapidly.

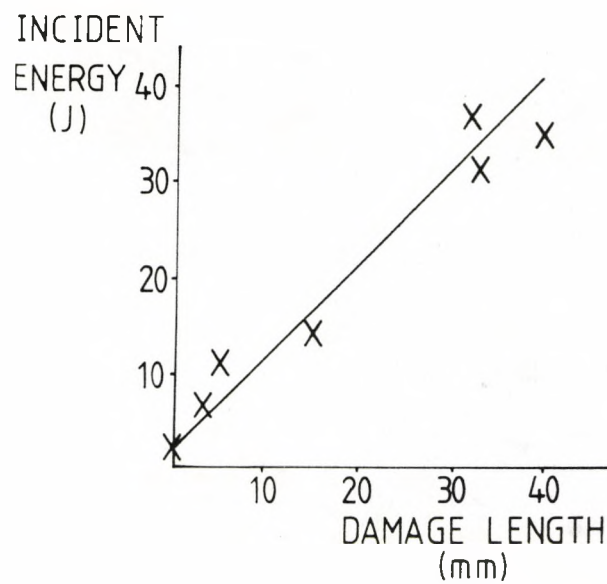
Fig. 4.12 Graph of incident energy against damage length for the 65mm span tests.

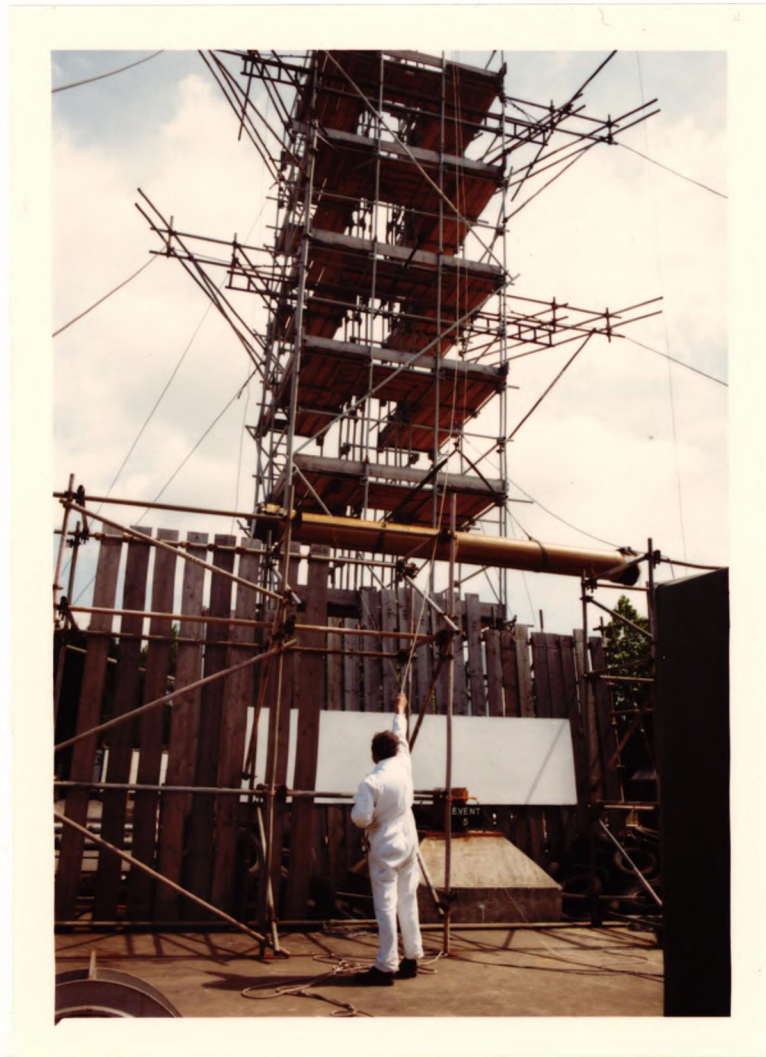
Fig. 5.6 Impact test rig.

7.67m/s and incident energies of 828.1J, 2145.2J, 3003.3J, 4290.4J and 5148.9J. The pipes were dropped onto the same nose as was used in the static tests for direct comparison. The position of the first and subsequent impacts was marked using white spraypaint.

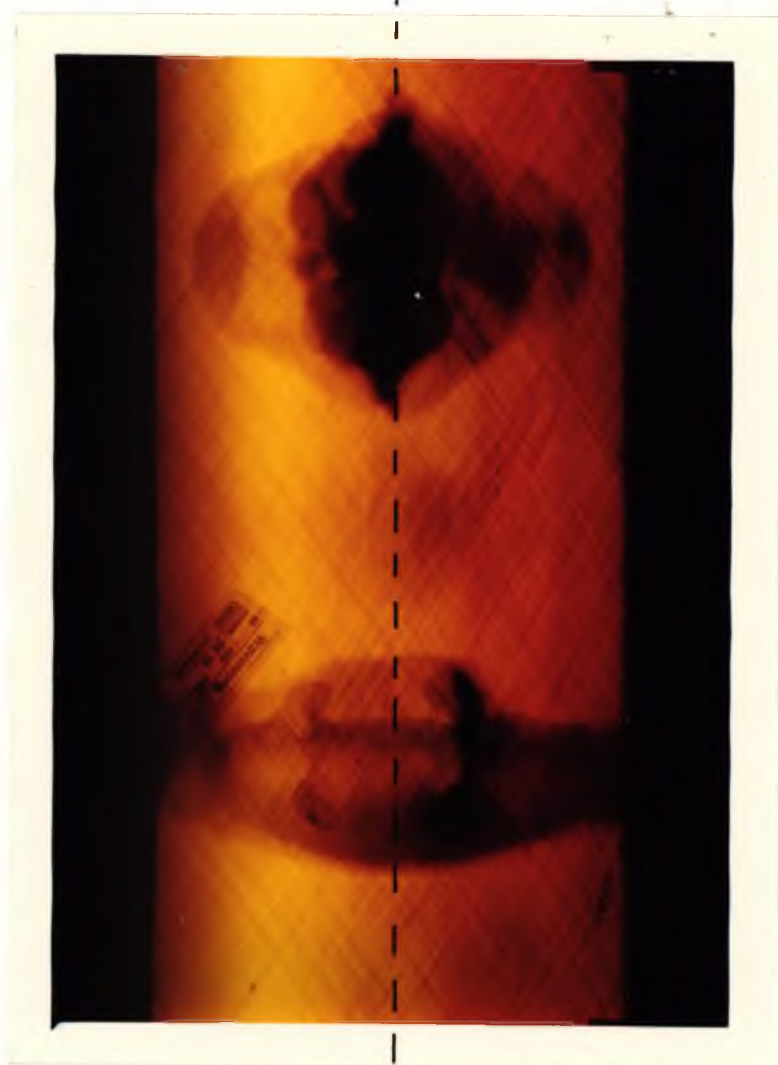
Fig. 5.13 Periphery photograph of the Preliminary damage
test.

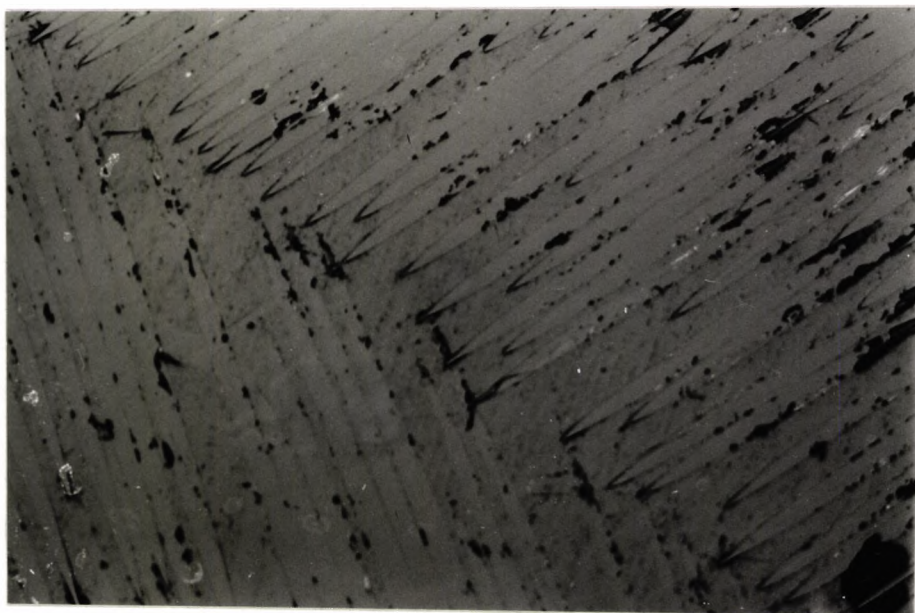
Fig. 6.4 Photomicrograph of a $\pm 55^\circ$ boundary in a light resin pipe specimen (x125).

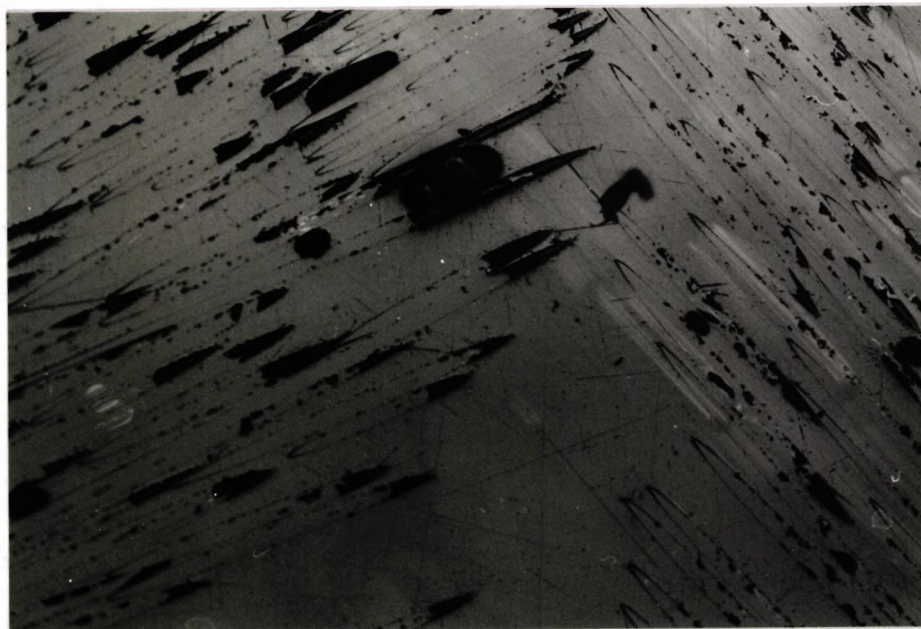
Fig. 6.5 Photomicrograph of a $\pm 55^\circ$ boundary in a medium resin specimen (x125).

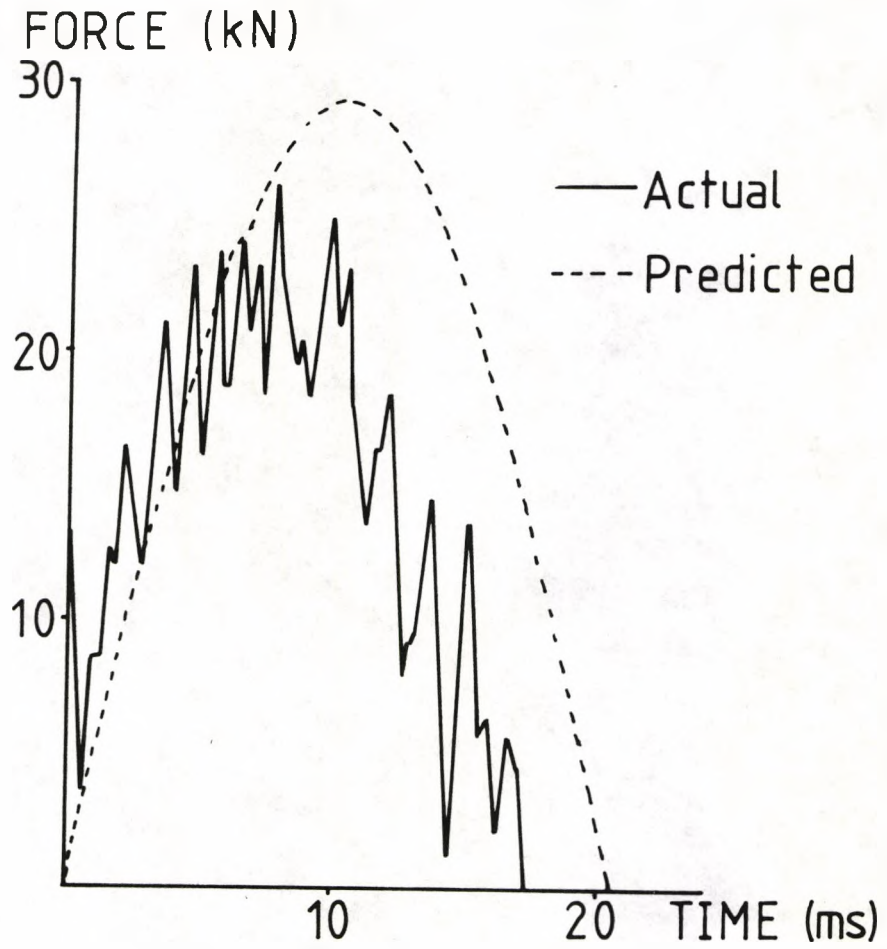
Fig. 7.25 Experimental and predicted force/time curves
for L4 using model A with a linear k value.

predicted force/time curves to see if, along with the trend of improved prediction of general behaviour characterised by improved F_M and T_r values, this method provides a more accurate means of modelling the force/time curve. Figure 7.26 shows the actual and predicted curves for IT11 (similar plots being obtained for all specimens), and reveals that varying the gradient does improve general behaviour predictions but only slightly.
