Flood impacts on vegetation and hydraulics in ephemeral channels and dynamics of recovery

Janet Hooke

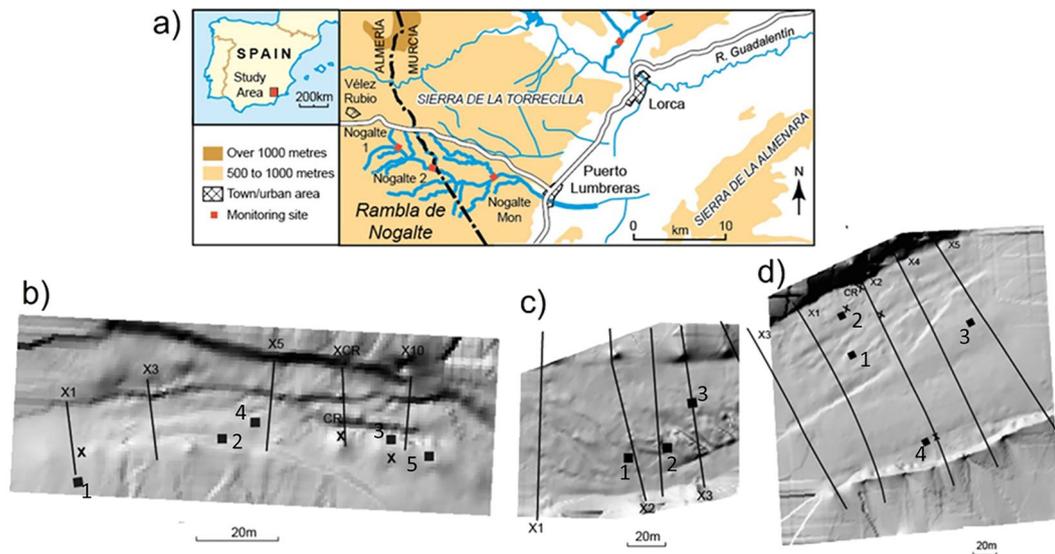
Figure 1. a) Location of the study sites; b) Nog 1, c) Nog 2, d) Nog Mon, with positions of cross-sections, quadrats (black squares) and crest-stage recorders (X) marked on DEMs derived from ground surveys.

Three reaches of the Rambla Nogalte in SE Spain (Figure 1) were established in 1996 as monitoring sites to measure the occurrence of flow events, changes in morphology and sediment characteristics, and variations in vegetation cover, in order to quantify these components for modelling effects of flows and hydrological variations and channel changes in these catchments of SE Spain and as part of wider research on desertification (Brookes et al. 2000; Hooke et al. 2005) in southern Europe. The Rambla Nogalte has a catchment area of 137 km² to Puerto Lumbreras at the downstream end of the channel. It has a catchment relief of >500 m and an overall channel gradient of 0.02 (Hooke and Mant 2002b). The area is composed of phyllite schist, producing a dominantly fine-medium gravel channel. The catchment land cover comprises natural patchy vegetation of Mediterranean shrubs on slopes and land use increasingly dominated by almond and olive groves on the steeper valley slopes. Mean annual rainfall is 250–300 mm but with high interannual variability. Flow in the main channel only occurs occasionally, and in only 14 of the of the 24 years of monitoring has flow been registered, with only four flows exceeding 0.5 m depth at the downstream site (Figure 2). The earlier period from 1996 to 2012

The channel itself is mainly composed of loose gravel and is braided along much of the course, with low-relief primary and secondary channels. The three monitored reaches, Nog1, Nog2 and NogMon, are located in the upper, middle and lower part of the course, with catchment areas of 6.9, 39.1 and 102.7 km^2 , respectively (Figure 1). Vegetation grows within all parts of the channel and

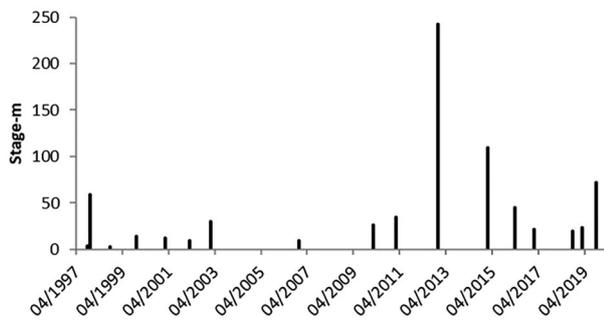
Figure 2. Stage levels measured on the Nogalte site NogMon, 1997–2020.

When the flood of September 2012 occurred the vegetation was in a state of profuse growth (Figure 2a) after a long period of low flow since the flood of 1997, which had damaged some plants (Hooke and Mant 2000; Sandercock and Hooke 2010). The peak flows on September 28 2012, in the Nogalte were the highest for at least 40 years. Flow stage reached average heights of 1.20 m, 2.13 m and 2.58 m in the sites Nog 1, Nog2, NogMon, respectively. The morphological effects were to produce some limited erosion, mainly in the inner channels/lowest elevation zones and much deposition on the bars (Figure 5). Maximum erosion was 0.64 m at Nog1, 0.83 m at Nog2 and 0.46 m at NogMon but such depths were not widespread. At Nog1 the maximum deposition was 0.42 m, 0.85 m at Nog2, and 0.91 m at NogMon (Hooke 2016). The overall discharges and average velocities, shear stress and unit

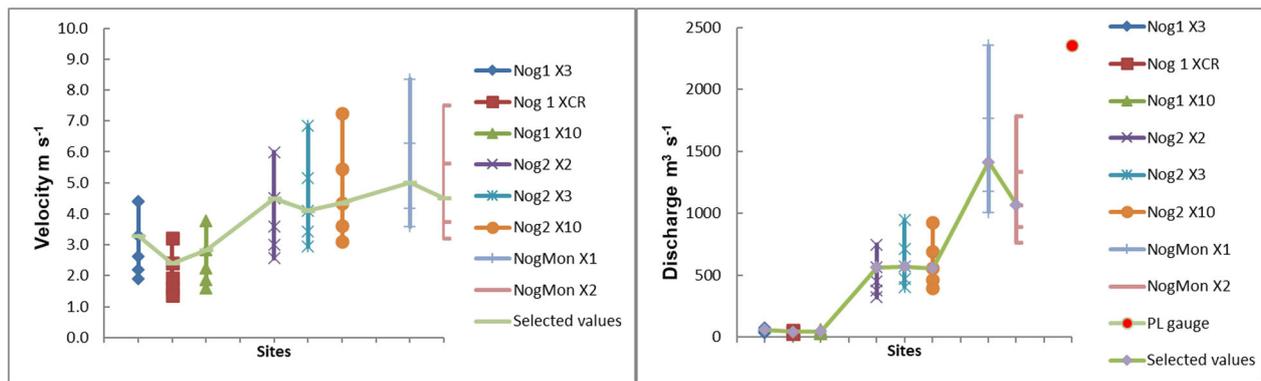
Figure 4. Values of velocity and discharge for range of values of Manning n 0.03–0.07, using pre-flood morphology at surveyed cross-sections in each site with most probable values selected.

The probable average velocities and discharge at each cross-section (Table 1, Figure 4) can be used to identify possible thresholds for destruction and mortality of plants. Destruction of *Retama* took place at Nog Mon where average peak velocities probably reached 5 m s^{-1} but *Retama* were also destroyed at Nog1 and Nog 2 in flows of 3 m s^{-1} . Herbs were removed in all quadrats and very few shrubs or perennials survived, an exception being some *Juncus*. Average cross-section shear stresses for *Retama* destruction were of the order of $300\text{--}400 \text{ N m}^{-2}$. However, these average hydraulic values for each cross-section do not indicate the forces on the plants in different zones, which differ significantly depending on the position and depth of flow and the amount of vegetation. To calculate the shear stresses in zones across the channel the cross-section profiles were divided into sub-zones according to morphology, and the shear stress calculated for the height of flow at that cross-section (derived from surveyed flood marks). The effects on the plants in each zone have been categorised from notes on the state as indicated by the categories of damage (Figure 10), in the zone taken during survey, from photographs across the profiles, and from vegetation quadrats located in or near the profiles. These categories are based on those of Sandercock and Hooke (2010), with the following effects on plants in the zone for which the shear stress is calculated: Bare = plant type absent; battered = leaves removed

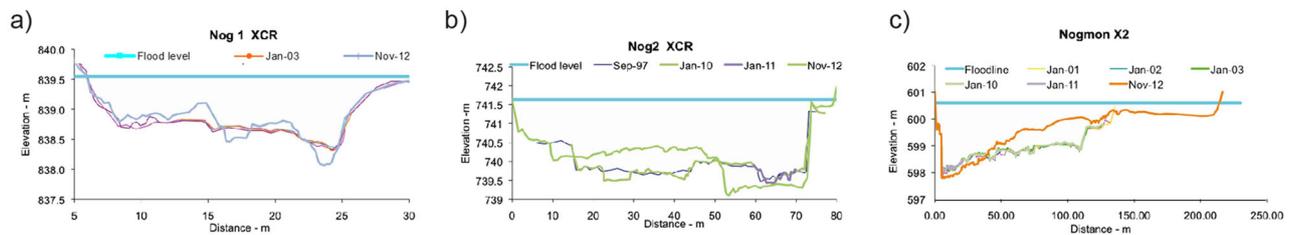
Figure 5. Representative cross-section profiles at each site surveyed before and after the 2012 flood, showing the morphological changes.

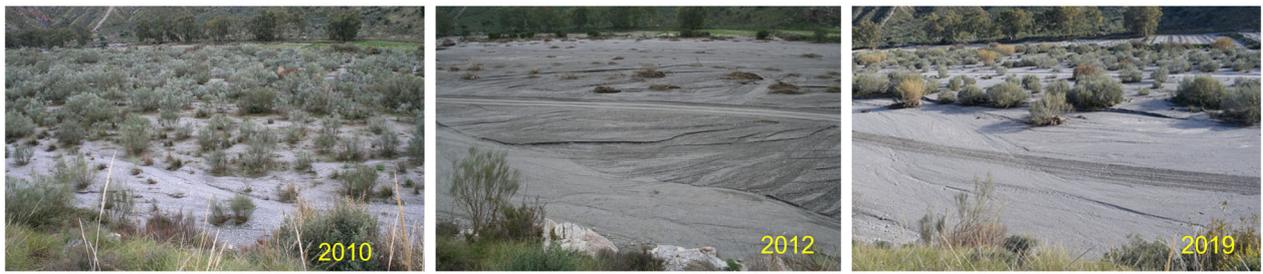
Figure 6. Nog Mon reach in 2010 (pre-flood), November 2012 (immediate post -flood) and 2019 (after regrowth).

in the main mature Retama zones (Figure 6) where coverage declined very strongly, with almost all vegetation removed but a few Retama branches remained as in VQ3 (Figure 7). In the two lower elevation quadrats (VQ1 and VQ2) pre-existing coverage was much less but some plants were

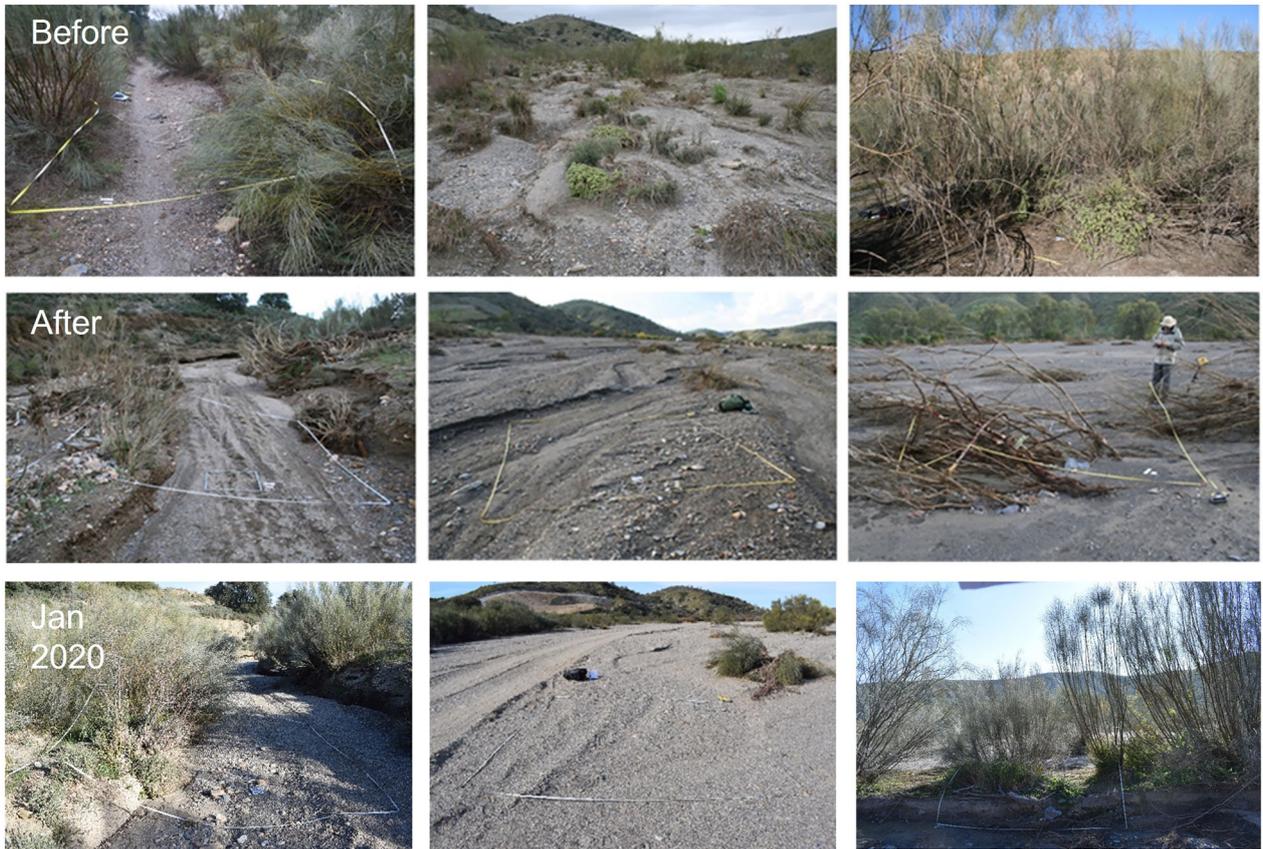
Figure 7. Comparison of example quadrats pre-flood (top row), post-flood (middle row) and in 2020 (bottom row) at Nog 1(left), Nog 2 (middle) and Nog Mon (right).

into a wide main channel in the flood (Figure 7). The third quadrat, on the bar, contained Retama, which was severely damaged and other vegetation was removed. This was mainly a depositional zone (Figure 5). At NogMon, again the quadrats on the higher bar and floodplain (VQ3 and VQ4) were those

flow (Hooke 2015), but the fact that this event, which was of such a short duration and had a remarkably rapid rise of the hydrograph, produced the observed effects on the plants demonstrates that here it was not the effect of long-continued submergence of the plants that caused mortality but of direct forces of short duration. In some of the Retama remains, large cobble-sized particles were found (Figure 3b) and this may have contributed to damage and mortality. However, the sediment accumulation within the plants was evidence of the slowing and trapping effect of vegetation. Lateral bank erosion was not a major mechanism in the unconfined, braided study reaches of the Nogalte because the banks were mostly very low and ill-defined, except at Nog1 VQ5, where there was a more defined and deeper main channel in the downstream part of the reach (Figure 7).

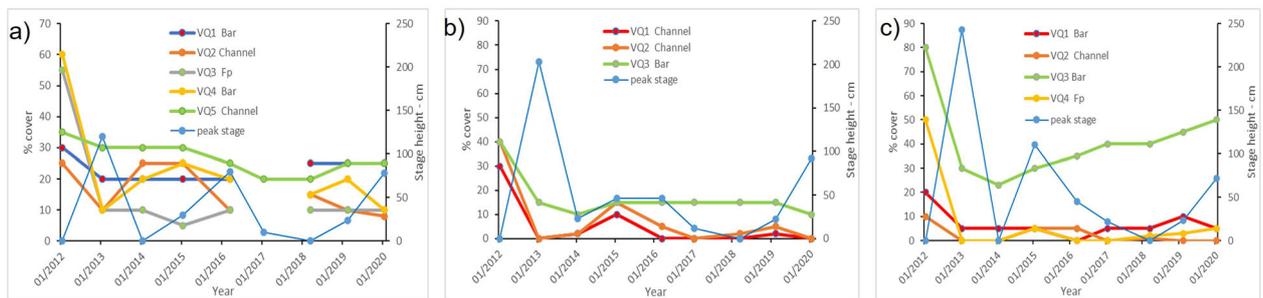
Figure 8. Changes in % vegetation cover, January 2012 (pre-flood) to January 2020, a) Nog 1, b) Nog 2, c) Nog Mon and peak flow occurrence. VQ = Vegetation Quadrat (as numbered on Figure 1).

The detailed effects of the flood flow on the % cover of all vegetation are seen on the individual quadrats (Figure 8). All show a steep decline as result of the peak flow. The position of each vegetation quadrat (VQ) in terms of whether in the inner channel, on a bar, or on the floodplain is indicated. At Nog1 the decline is much greater for VQ3 and VQ4 because these zones were much more densely vegetated before the flood. The VQ5 quadrat, although covering the channel also includes dense vegetation on the channel bank, which declined much less (Figure 7). At Nog2 the pre-flood vegetation was sparse, though with high biodiversity and some Retama (Figure 7). Quadrats VQ1 and VQ2 were on degraded small channels and parts of bars before the flood, which had experienced little flow for several years, but these quadrats were eroded

up to 2020 (Figures 8 and 9), in relation to maximum flow levels each year in the sites. The presence, number and heights of the three main groups of plants have been assessed for each quadrat on each date of observation (mainly January each year) and the changes recorded by comparison of quadrat mappings/notes and photos from each year to indicate growth, decline and stasis (Figure 11). At NogMon it can be seen that VQ3 quadrat has shown rapid revival and continuous growth since January 2013 (Figure 7). This was mainly by resprouting (Figure 3) but subsequently some seedlings grew. Not all remains resprouted. In some quadrats Retama have begun to grow but with much delay, not until 2016–17 in VQ1 and 2017–18 in VQ4 at NogMon (Figure 11). These are where growth has been by new seedlings. The other quadrats have shown very little revival. VQ4 has experienced little growth of any plants but the few herbs have a varied response that appears related to flows as an index of moisture since no flows after 2012 reached there. In other cases, revivals of plant growth have not persisted, but these are from herbs that are annual anyway. The herb growth in channel sites has been affected by even the low flows, as calculation of shear stresses at low flows also showed (Figure 10b). At Nog2 VQ3, on the bar and with remains of Retama present after 2012, plants revived and started growing but only in 2014. The Retama was affected again by the relatively high flow in 2020 (Figure 9b). The other quadrats at Nog2 show variable development but all at low levels of coverage, with some relation to flow, except 2020 which was strong enough to destroy the plants. The revival is entirely from herbs, and few shrubs have recolonised the quadrats, though some have grown nearby, in spite of this being a zone with a variety of shrubs pre-flood. At site Nog1 VQ1, the Retama remains did start sprouting soon after the flood but showed slow growth and were bent in the 2020 flow. There was some delayed growth of an understorey of shrubs and herbs, and their growth and health has

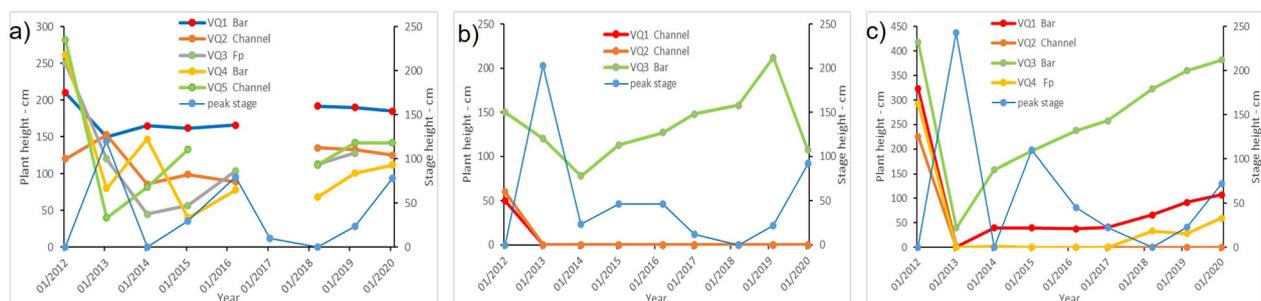
Figure 9. Changes in maximum height of plants, January 2012 (pre-flood) to January 2020, a) Nog 1, b) Nog 2, c) Nog Mon and peak flow occurrence.

The heights of the tallest plant in each quadrat are plotted in Figure 9. The tall plants of >1.50 m are all *Retama* and show large declines. Mostly, the main aerial parts were destroyed; some were “removed,” in others flattened, brown main branches, looking dead, remained (Figure 3b,c). These prone branch clumps averaged 0.4–0.5m, so still offered some frictional component to subsequent flows. The quadrats containing only shrubs and herbs, or only very small seedlings, declined to zero in site Nog2 and NogMon but a few survived at Nog1, partly by sheltering effects from *Retama*.

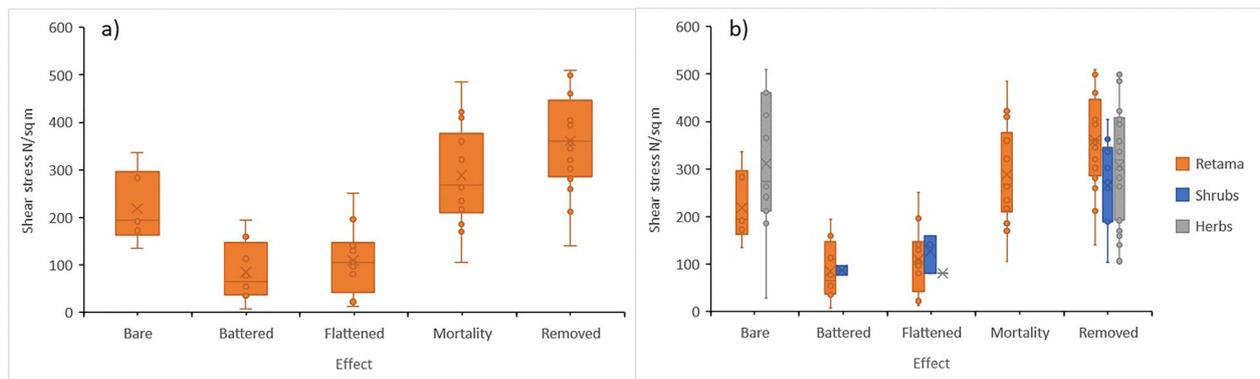
Figure 10. Values of shear stress calculated for sub-zones within cross-sections for different effects on the plants of the 2012 peak flow, a) Retama, b) Retama, shrubs and herbs.

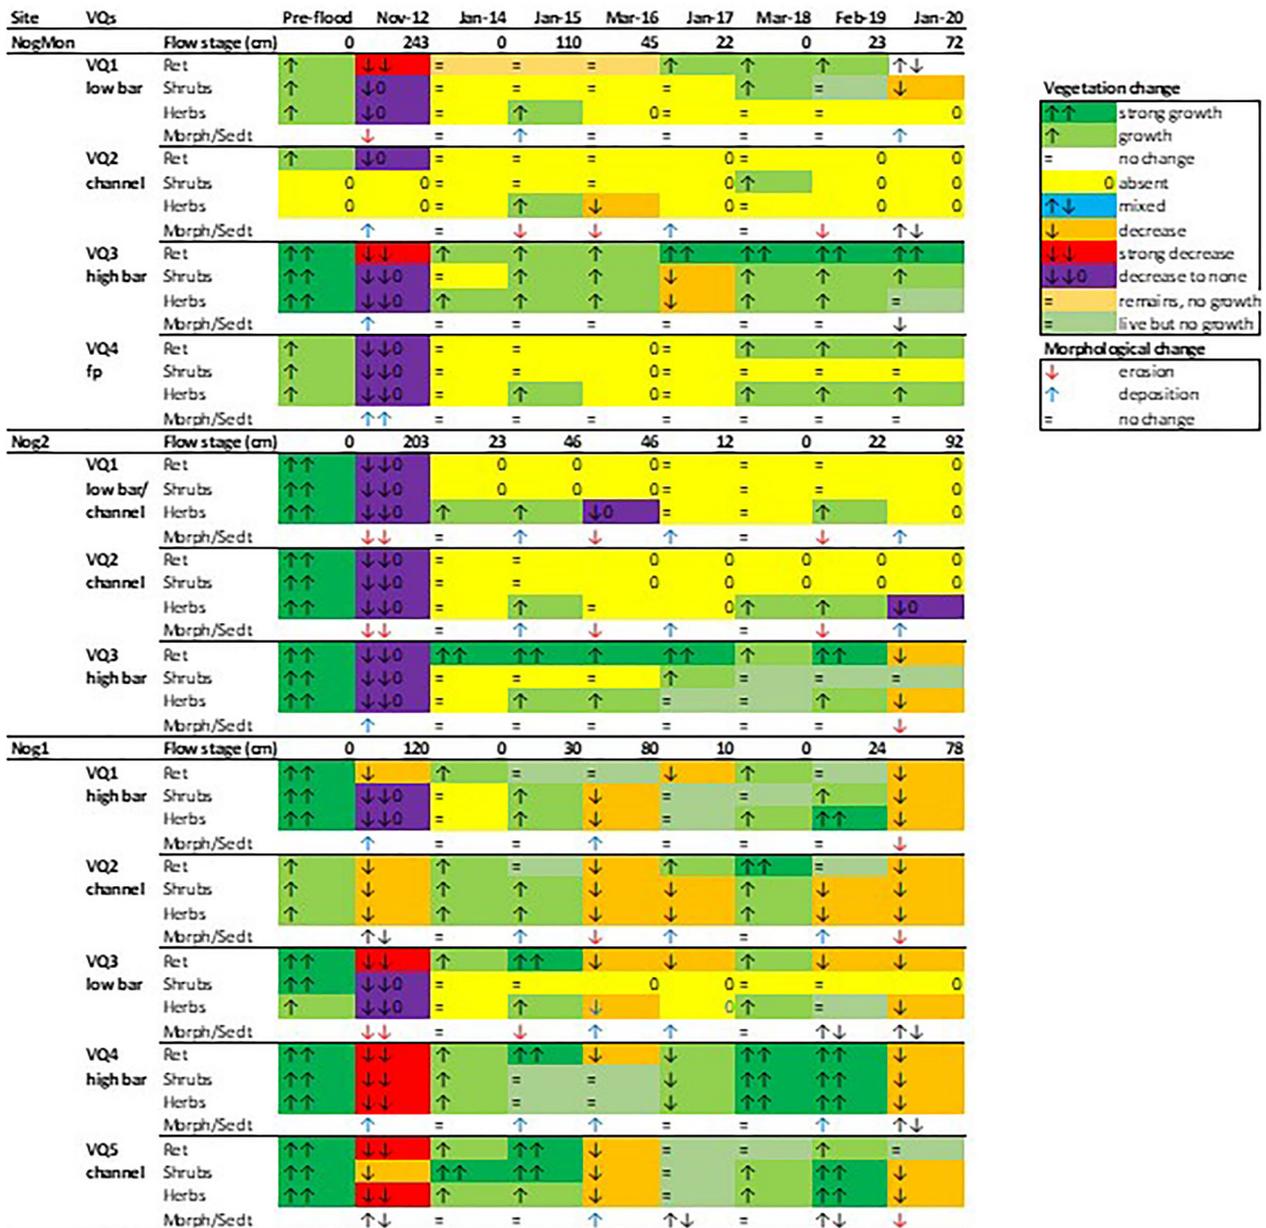
Figure 11. Changes in state of plants in vegetation groups, Retama, shrubs and herbs, recorded on each vegetation quadrat in the three study sites in the period January 2012-January 2020.

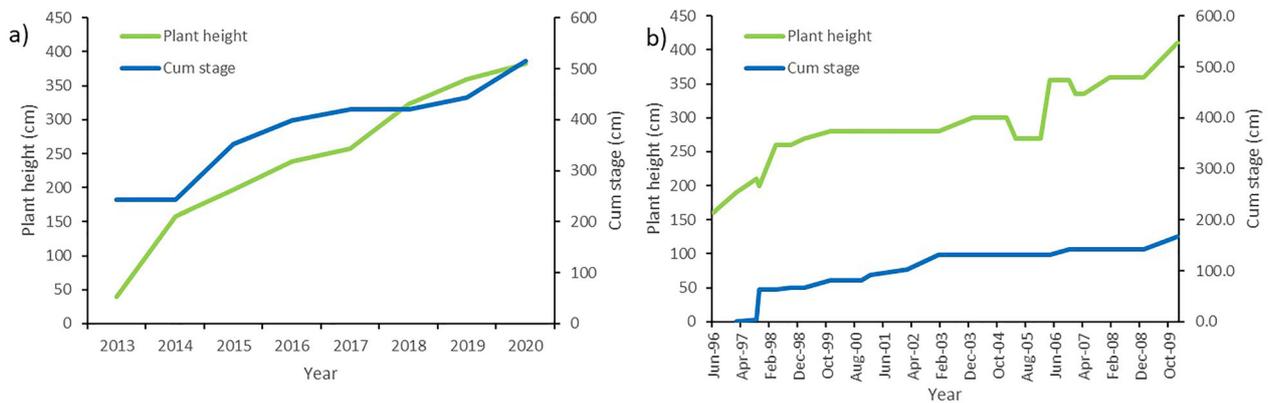
Figure 12. Growth in a *Retama* plant on one vegetation quadrat at site NogMon in relation to cumulative amounts of flow as measured by peak stage recorder at the site, a) 2012–2020, b) June 1996–January 2010 (after Hooke and Mant 2015).
