Electrical and Thermal Performance of Different Core Materials Applied in Wind Turbine Blades under Lightning Strikes

Abstract

Keywords: Lightning strike, wind turbine blade, core material, breakdown, material damage, molecular simulation

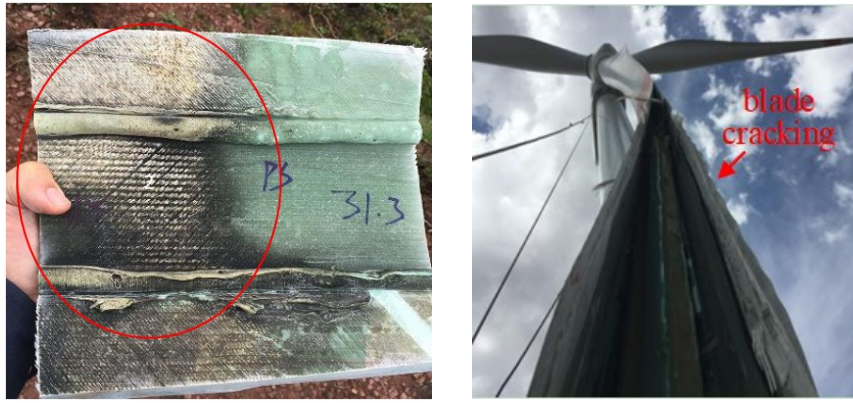
a) materials carbonization

b) blade cracking

Fig. 1. Blade damage resulting from lightning strikes.

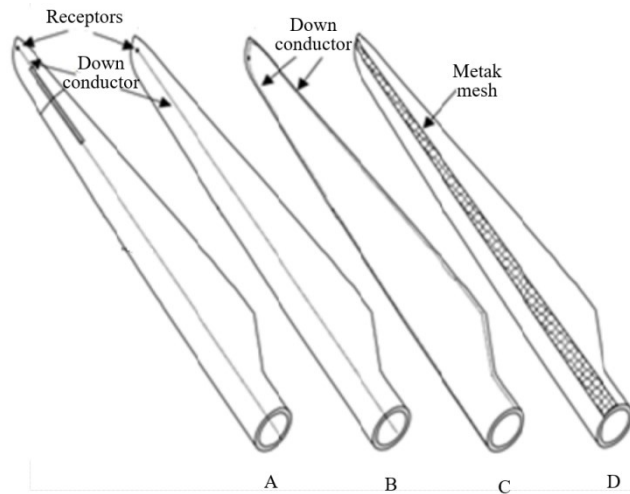
Fig. 2. Schematic diagrams showing different designs of lightning protection for wind turbine blade.

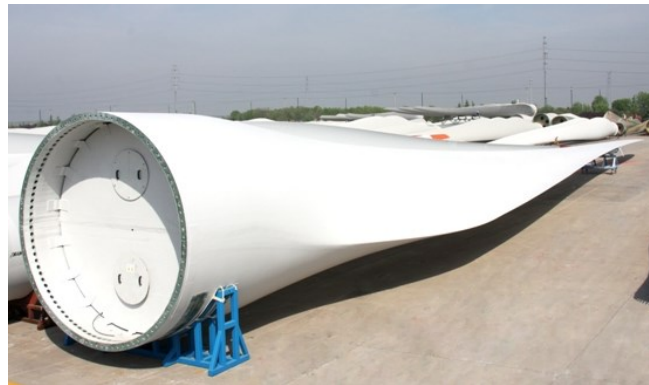
a) Real blade

b) Cross-sectional view of the blade

Fig. 3. The structure and constituting components of a typical wind turbine blade.

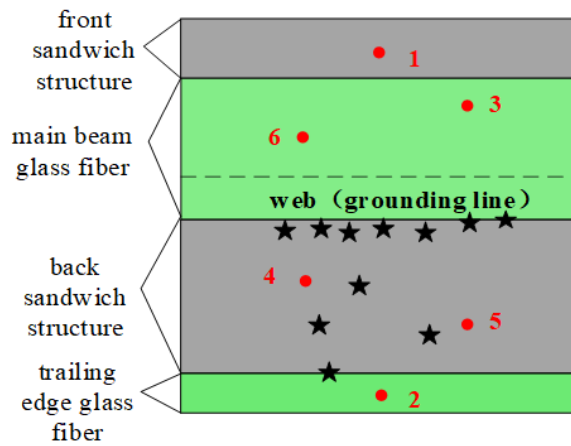
a) Sample A

b) Sample B

c) Sample C

Fig. 8. Breakdown point distribution under positive voltage for different electrode positions (black stars).

All the breakdown points under negative and positive polarities are shown in Fig. 7 (black stars show breakdown points) and Fig.8. Since the breakdown voltage of a sandwich structure containing PVC, PET or balsa wood was much lower than that of the thick main beam and the trailing edge glass fiber, most breakdown points located in the sandwich area, especially near the intersection arena between the thick glass fiber and the sandwich structure, which is the area near the trailing edge of a real blade. This finding can be verified by CIGRE 578 and real lightning strikes data on wind turbine blades. However, there was only slight difference on the number of breakdown point and their positions between negative and positive voltages.

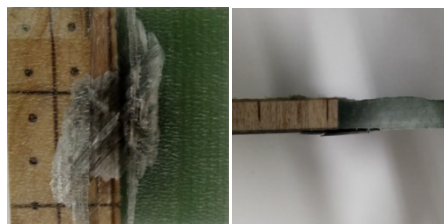
a) Balsa wood combination 199.5J

b) Balsa wood combination 1795.5J

c) Balsa wood combination 3192J and the cross section

Fig. 15. Damage morphology of the balsa wood combination

As can be seen from Fig. 13, 14 and 15, for the combined samples, most damaged parts are located at places where porous materials are present in the sandwich structure. When the impulse current energy increased to 3192J, the glass fiber began to layer apart. However, the layering area of the three samples showed different ratio values, as can be seen in TABLE IV. The balsa wood sample still performed the best among all the three samples, while the PVC combination sample showed the lowest tolerance ratio by experiments.
