Puncture Position on Wind Turbine Blades and Arc Path Evolution under Lightning Strikes

Keywords: wind turbine blade; sandwich structure; lightning strikes; puncture position; arc path

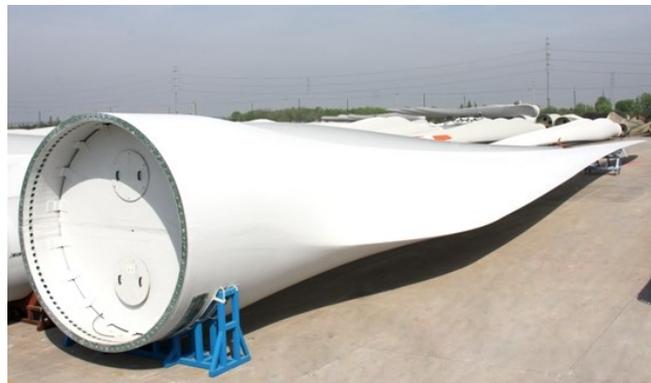
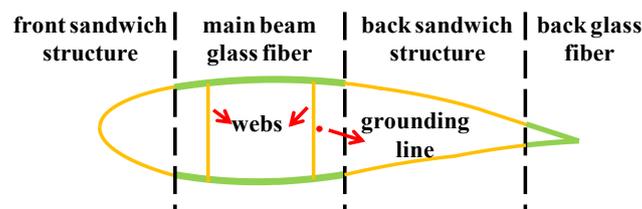
Fig. 2 Blade structure

The typical blade structure is a sealed chamber with two stuck shells, and its cross-section is shown in Fig. 2. The green parts are the main beam and back edge made of very thick glass fiber reinforced epoxy resin to guarantee blade strength. The yellow parts are sandwich structures, and their outside covers are usually made of several layers of casted glass fiber, with PVC or other porous materials in the middle to reduce its weight. Blade structure changes when it gets closer to the blade top which will be introduced in experimental samples. There are also two webs (sandwich structure) inside the chamber to hold up the blade structure, and the grounding line is usually laid along the right web.

a) Real blade

b) Cross-section of blade

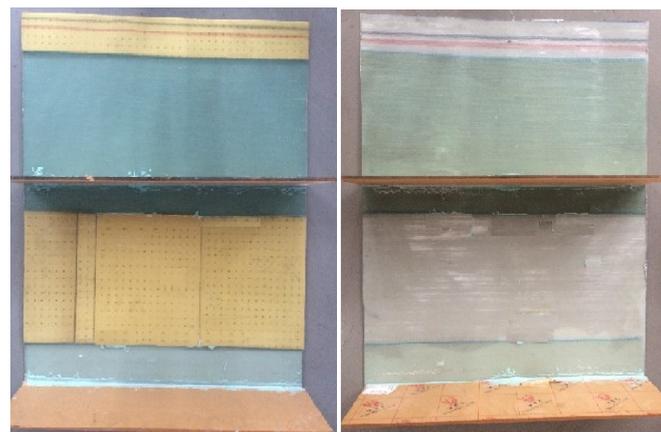
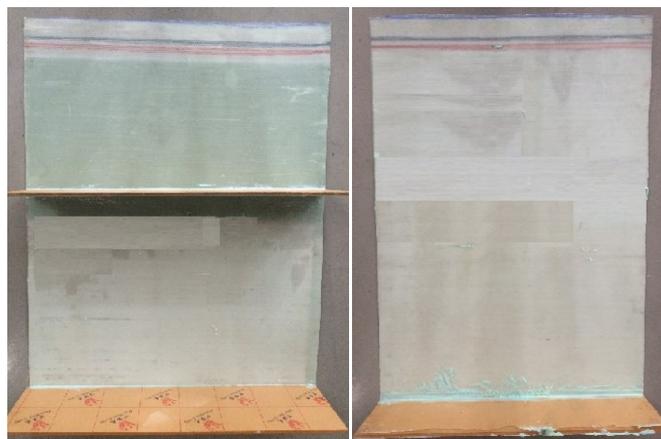
Fig. 3. Experimental samples

In the impulse voltage experiments, the blade was simplified into an F-structure with only one web (the one in the main beam position) and L-structure without web, and there is also another baffle stuck to the back glass fiber to hold back the arc path developing along the inside surface of the blade materials. Samples simulating different parts of the blade are shown in Fig. 3. The layers of the glass fiber was reduced to 1/2 of the real one considering the limits of the voltage generator, as can be seen in TABLE I (for the sandwich structure, there are 2 layers of glass fiber in all, and only one in each side). Sample

A shows blade structure a little far from blade top which has PVC sandwich structure; when it gets closer to the top, PVC disappears, only was glass fiber cover left in its initial position as shown in b). Layers of back edge and main beam reduce gradually; layers of back glass fiber and main beam reduced to the same number as the cover in c) and d) finally. Web also disappears at last in Sample D. The whole size of all samples is $80\text{cm} \times 99\text{cm}$, the width of each part are 10cm, 42cm, 35cm, and 12cm respectively (up to down). 99cm was set to simulate a real blade used in a 3 MW wind turbine, and 80cm was to leave enough space to achieve breakdown of blade materials instead of surface arc developing along the cutting edge. To evaluate dimensions vs results, smaller samples named E, F, G and H with size of $80\text{cm} \times 49.5\text{cm}$ were made for comparative analysis.

a) Sample A (with PVC) b) Sample B (removed PVC)

c) Sample C(removed back glass fiber) d) Sample D (removed main beam and web)

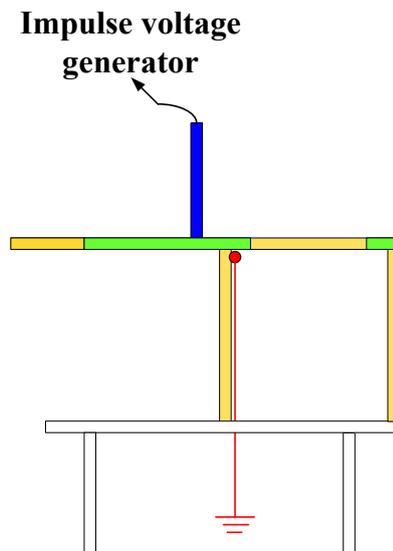
Fig. 4. Experimental setup A

Both experiment A and experiment B were conducted in the State Key Lab of Alternate Electrical Power System with Renewable Energy Sources in North China Electric Power University. Experimental setup A is shown in Fig. 4. Samples were supported to 50cm high by a wood desk. The upper electrode connected to the generator was cylinder with a diameter of 1cm, and the lower electrode stuck on the web was connected to ground to simulate the grounding line in blade.

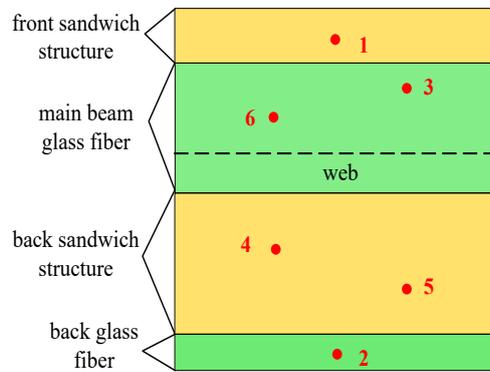
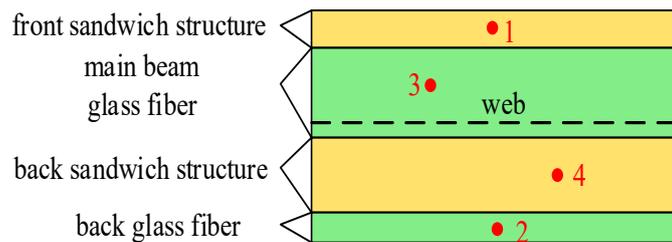
Fig. 5 Upper electrode positions for experiment A
(Electrodes of samples without PVC and thick glass fiber were also located in corresponding positions)

Compared with 6 electrode positions for larger samples, only 4 electrode positions were chosen for comparative analysis considering the limited space.

a) Upper electrode positions of larger samples

b) Upper electrode positions of smaller samples

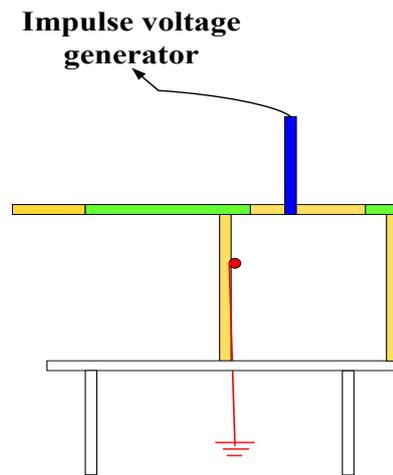
Fig. 6 Experimental setup B

positions were studied in experiment B, and setup is shown in Fig. 6. Blade materials were drilled in electrical weak areas, and the upper electrode was set to pass through the hole. The lower electrode was still connected to the grounding conductor, but it has a specific distance from the material surface to simulate the real blade structure.

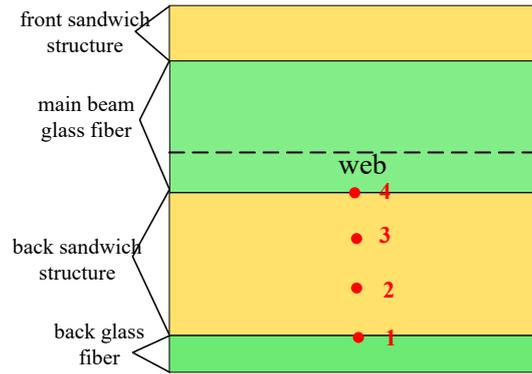
Impulse voltage experiments were conducted with different voltage peak values, voltage polarities and electrode positions which are shown in TABLE III (the electrode position is shown in Fig. 7). Fig. 7 involved different puncture positions even for smaller samples, so its results could be applied both in larger and smaller samples.

Fig. 7 Upper electrode positions for experiment B
(Electrodes of samples without PVC and thick glass fiber were also
located in the corresponding positions)

For the other samples, the experimental positions were set to 1,2,3,4 in Fig. 7.

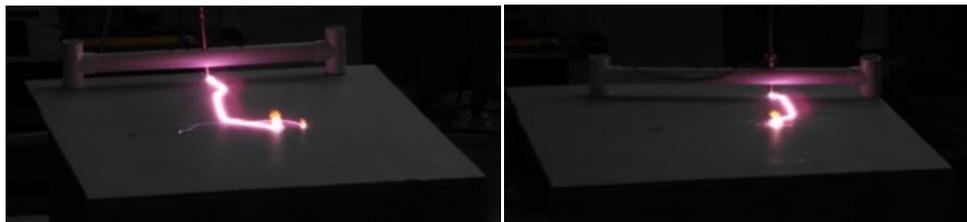
Fig. 8 Surface arc path

All the breakdown paths consisted of surface arc and arc inside the materials, as are shown in Fig. 8 (breakdown at the end of the arc). In some cases, there were more than one arc path in a single experiment. But there were no obvious evidence for the connection between the multi-paths phenomenon and the experimental conditions.

a) Point 1, 340kV, negative(sample A)

b) Point 2, 350kV, negative(sample B)

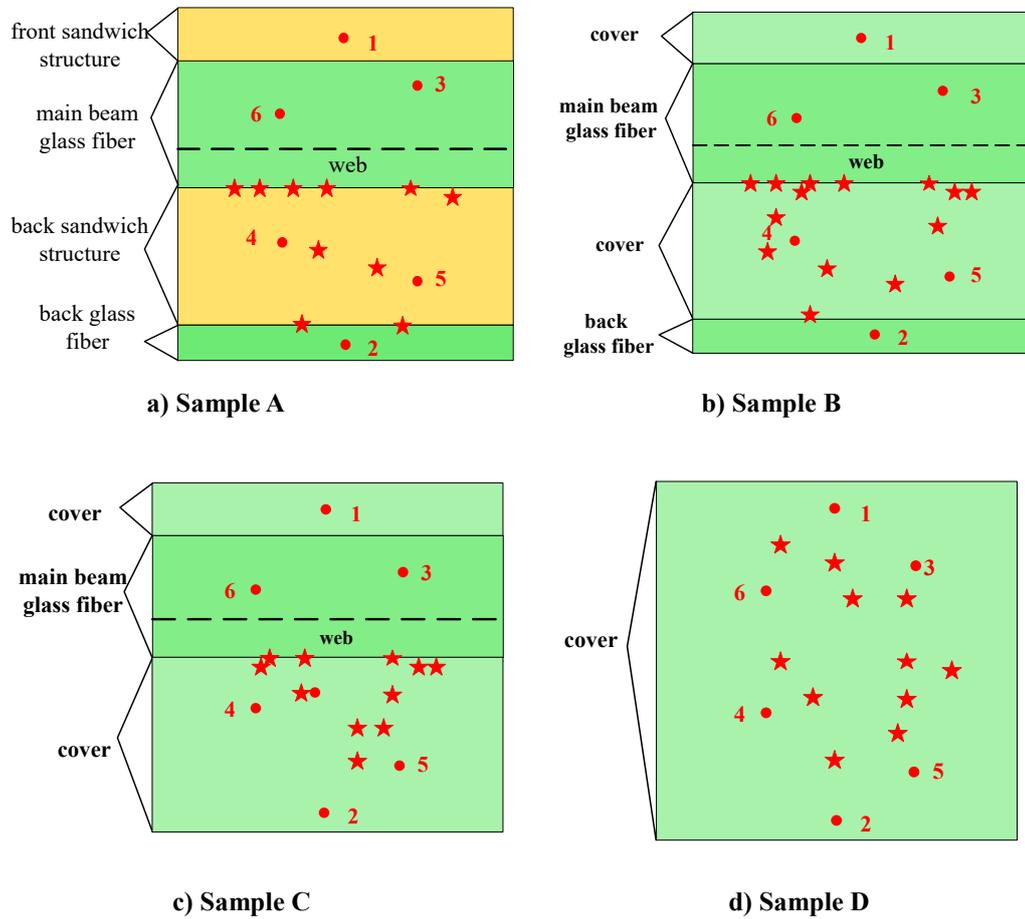
Since the breakdown voltages of sandwich structure and thinner glass fiber cover were much lower than the thick main beam and back glass fiber, all puncture points gathered in the back sandwich structure or lower cover for the larger samples, as is shown in Fig. 9. In the case of smaller samples, nearly all the puncture points fell near the intersection between main beam and back sandwich structure (or lower cover). There is only one puncture point fell inside cover area near electrode position 2 in sample G. All

Fig. 9. Puncture points distribution of larger samples
(Red star is puncture position, and red dot is upper electrode position)

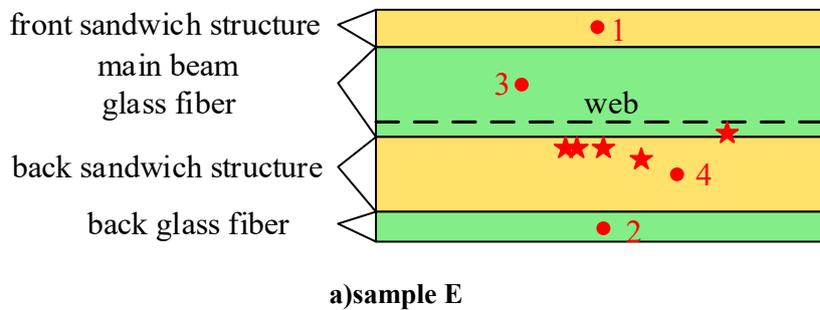
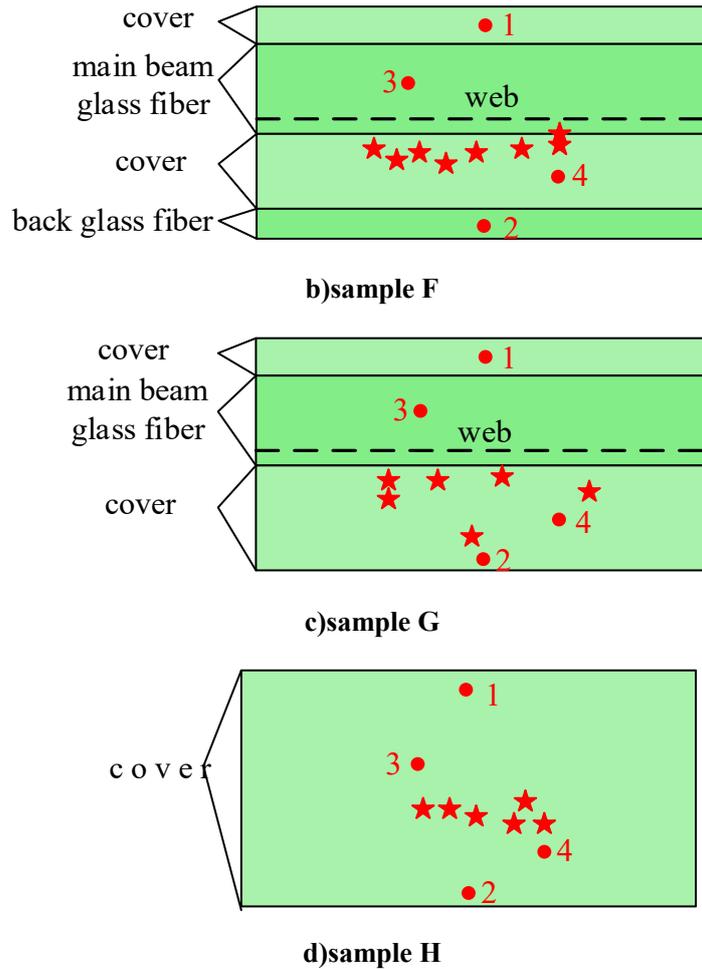
the puncture points gathered on the intersection area for the small samples, and the influence of voltage types and environmental humidity is not obvious. So the roles of polarities, peak values, surface humidity and electrode positions will not be introduced for smaller samples in the following parts.

Fig. 10. Puncture points distribution of larger samples

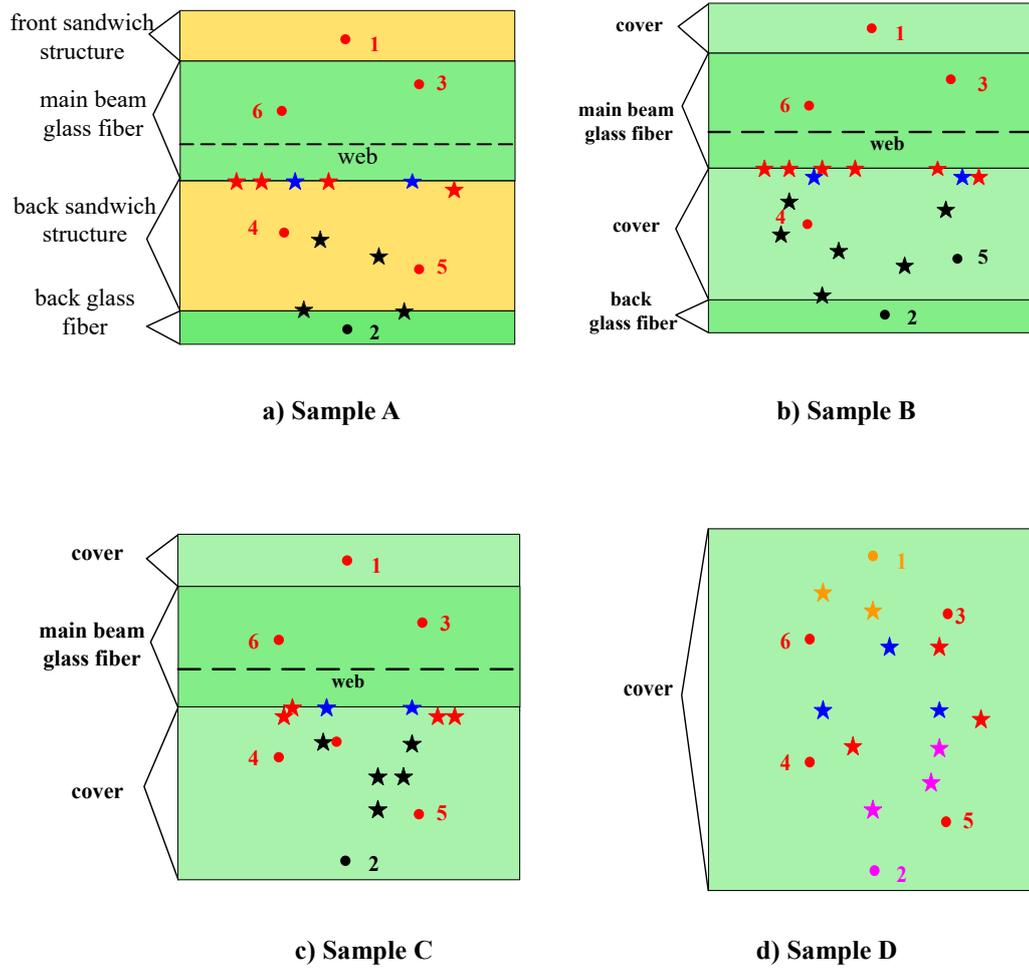
Puncture position changed with the upper electrode location in the case of larger samples, as is shown in Fig. 11. When the electrode was put on position 2, it intended to breakdown in the back sandwich structure (or lower cover). Also a few of puncture points fell on the intersection between back glass fiber and back sandwich (or lower cover). However, most puncture points fell near the intersection between main beam and back sandwich (lower cover) when electrode was put in the other positions. For the case of sample D, puncture points distributed on the whole materials because all the structure was made of only two layers of glass fiber.

Fig. 11. Puncture points distribution under different electrode positions of larger samples (The star color is in accordance with its corresponding dot color, and the blue stars are the common puncture points for electrode in different positions)

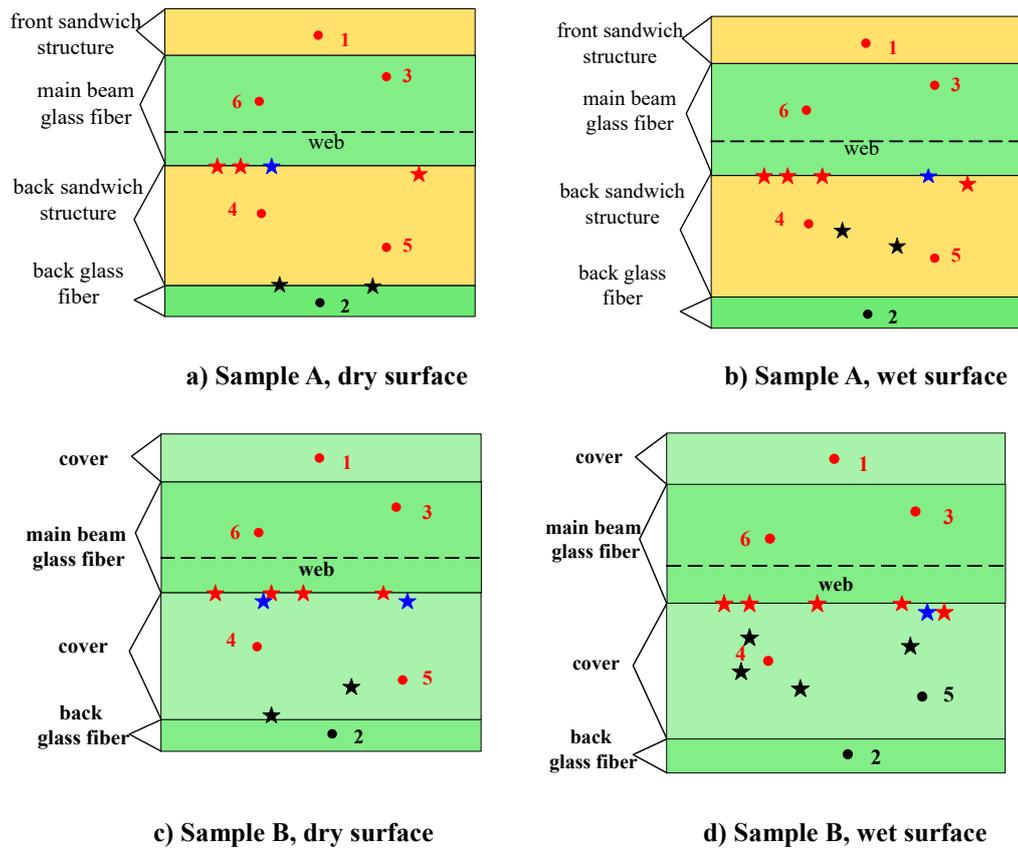
Fig. 12. Puncture position distribution under different water moisture

Surface humidity had significant influence on the puncture position distribution, as can be seen in Fig.12. When the surface was dry, all the breakdown occurred in the intersection line between main beam and the back sandwich (or cover area). However, the inside sandwich areas easily got breakdown when water was sprinkled on it. What was more, the breakdown voltage was much lower when the surface was wet.

It can be supposed that when sprinkling water on the blade surface, surface flashover voltage decreased greatly and was easy to develop a longer distance [18-20]; what's more, since non-uniform water column formed on the surface, the electric field distribution was distorted; especially when a large amount of electric charges gathered in the water column, the electric field intensity increased to a high value even under a lower voltage, which caused breakdown of sandwich materials under a much lower voltage.

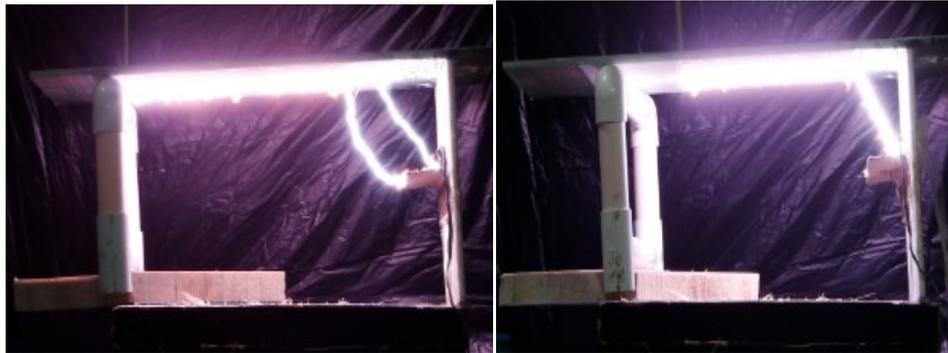
Fig. 13 Inside arc paths (grounding electrode 12cm)

All the arc paths consisted of surface-arc and air-arc, as is shown in Fig. 13. In some cases, there were more than one arc path in a single experiment.

a) Point 1, 400kV, negative

b) Point 2, 500kV, positive

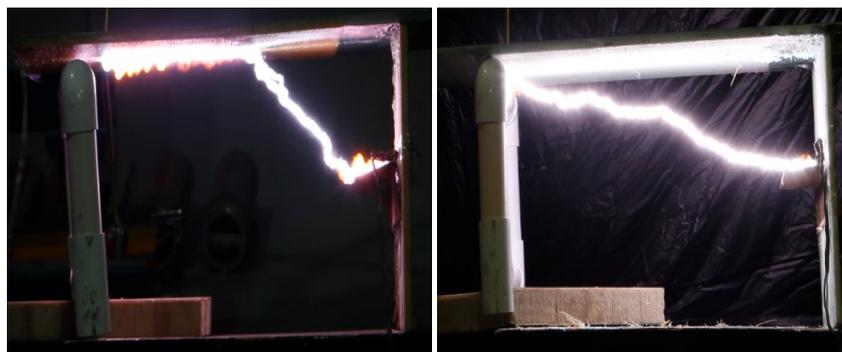
The initial breakdown voltage was obviously lower when positive voltage was applied. It can be seen in Fig. 14 that, when negative voltage was applied, arc intended to develop along the material surface, while air arc occupied a larger portion in the positive voltage experiments. As is known that positive breakdown voltage of air is much lower than negative one. So it is supposed that in the competing process of all arc paths, the air arc has a higher possibility to get a successful development under positive voltage. The statistics of surface arc length is shown in TABLE IV and TABLE V.

a) Negative voltage b) Positive voltage
Fig. 14 Arc paths under different voltage polarity
(Point 1, grounding electrode 12cm, 360kV)

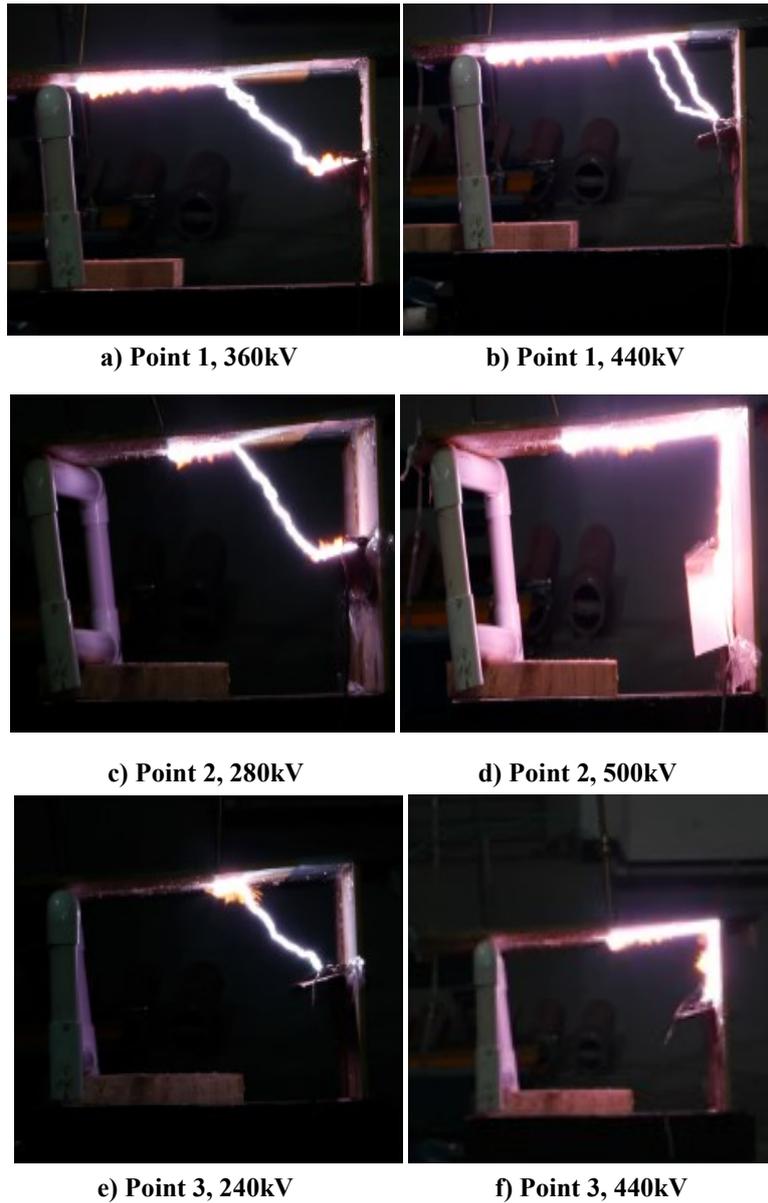
As can be seen in Fig. 15, the inside arc consisted of surface-arc and air-arc. The arc intended to go through air when the peak value was lower, but it intended to go along the surface (take the negative voltage experiments for an example) when the peak value increased. One possible theory can explain this phenomenon: when larger impulse voltage was applied, a huge vertical component of electrical field intensity made the charged particles impact the blade material strongly. The impact resulted in temperature increasing near the blade surface, which in turn leads to gas thermal ionization. This process accelerated the arc developing along the blade surface [21].

**Fig. 15 Arc paths under different peak value of applied voltage
(Grounding electrode position 12cm)**

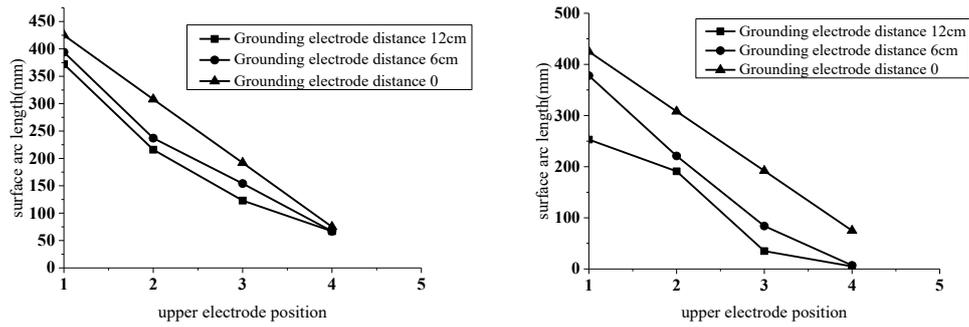
Fig. 16 Arc paths under different electrode positions

Puncture position definitely influence the art paths, as is shown in Fig. 16. As the upper electrode got nearer to the web position and the grounding electrode went far away from the blade materials, surface arc length decreased gradually. The arc types (air arc or surface arc) and arc length may have different damage to the blade.

a) Surface arc length under negative voltage b) Surface arc length under positive voltage
