Assessment of Existing Steel Frames: Numerical Study, Pseudo-Dynamic Testing and Influence of Masonry Infills

Keywords: Existing steel frames; Seismic performance; Pseudo-Dynamic Testing; Masonry infills; Single-strut model.

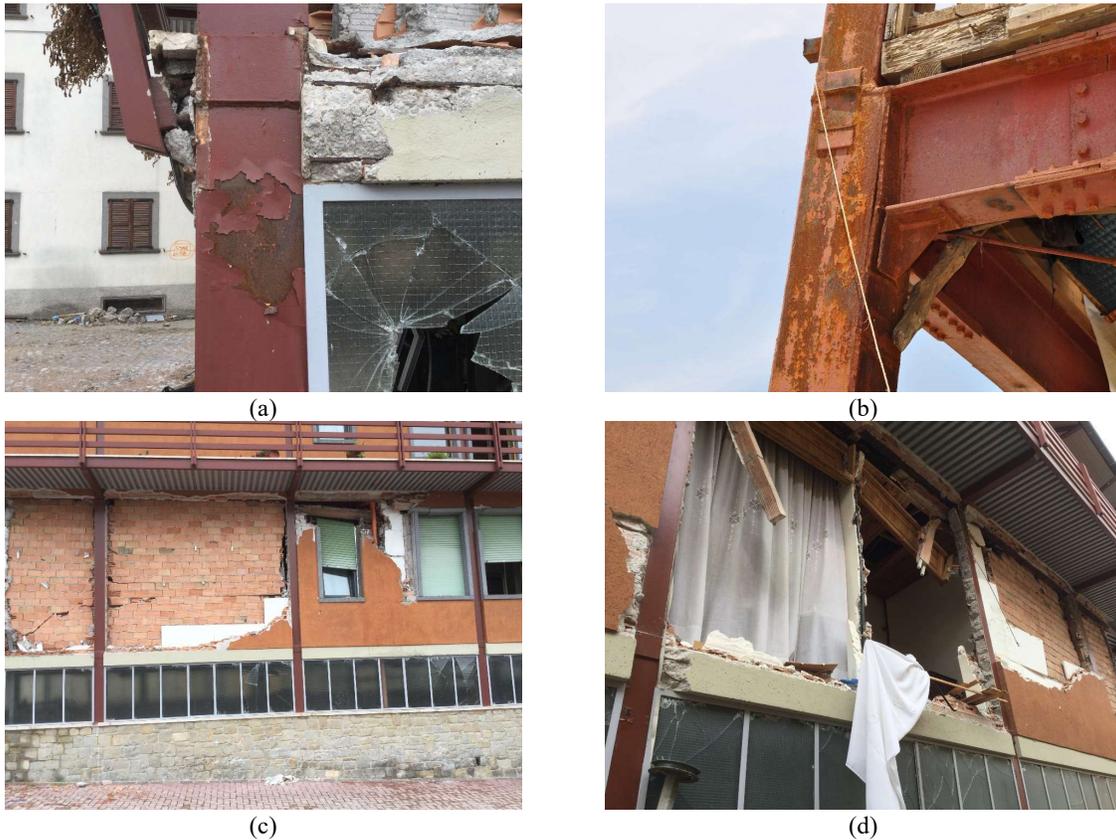
Figure 1. Typical damage on existing steel MRFs: (a) yielding of structural components; (b) fracture (ultimate failure) of structural components (from Ricles *et al.*, 2011 [35]); (c) cracking of masonry infills; (d) collapse (out-of-plane failure) of masonry infills.

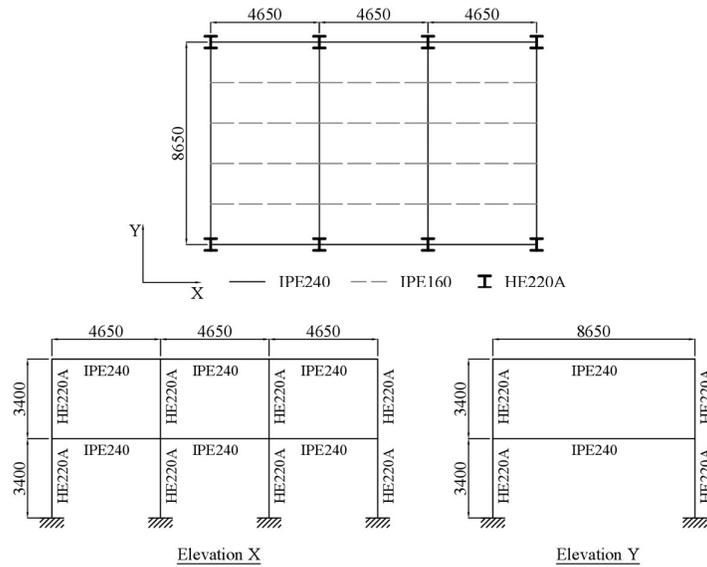
218
 219 Figure 2. Global geometry of the prototype building: plan view and elevations (unit: mm).
 220

204 The prototype building is characterised by storey height of 3.4 m, with slight variations between the two stories. The span
 205 is 8.65 m and 4.65 m along the longitudinal and transverse direction, respectively. An overview of the structural system
 206 both in plan and in elevation, including the main geometric parameters and section members, is reported in Figure 2. The
 207 steel profiles are HE 220 A, IPE 240 and IPE 160, respectively, for columns, primary and secondary beams. The steel
 208 grade is S355 ($f_y = 355$ MPa) for all beams and columns. All external beams are connected to columns through full
 209 penetration welds, and fully rigid beam-column connections are considered in this study. The floor system was designed
 210 as a composite slab, with a cold-rolled steel sheet base ($t = 1.25$ mm) and a 200-mm-deep concrete slab with M19 shear
 211 studs at each valley or 300 mm, depending on the steel sheet rib orientation. Lastly, the masonry infills consist of two

212 parallel layers of perforated bricks separated by insulation materials, each of which has a thickness of 58 mm. According
 213 to the final design and considering the EC8-1 [41] seismic combination, the building's storey mass is equal to 117.0 and
 214 95.0 tons, respectively, for the first and second storey. In order to investigate the performance of the structure in its weaker
 215 and more deformable direction, the steel frame was tested under a horizontal load in the x -direction, as indicated in Figure
 216 2, where the columns are oriented with their weak axis.
 217

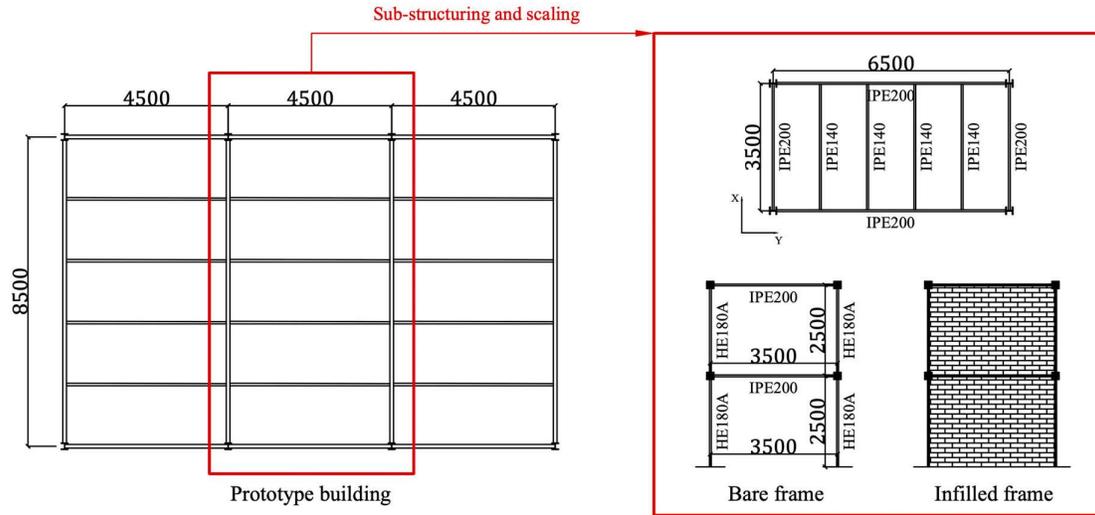
Figure 3. Plan and side views of the test specimens (unit: mm).

229
 230 The test mockup consisted in the central-bay sub-structure of the 75% scaled (*i.e.*, scaling factor $\lambda = 0.75$) model of the
 231 prototype building, *i.e.*, the two-storey, three-bays by one-bay steel MRF. The model scaling is based on the material and
 232 acceleration scaling identity [48], and the scaling factor was selected considering the laboratory constraints and
 233 accounting for that usually a scaling factor larger than 0.6 is adequate to allow the test to correctly reproduce the seismic
 234 response of steel frames. The use of unit scale factor for material stress is a common and convenient choice, as it allows
 235 to overcome difficulties in the replication of every mechanical property of the prototype building (*e.g.*, Poisson ratio,
 236 failure strain, etc.). Table 3 reports the list of the scaling factors of similitude between prototype building and test frame.

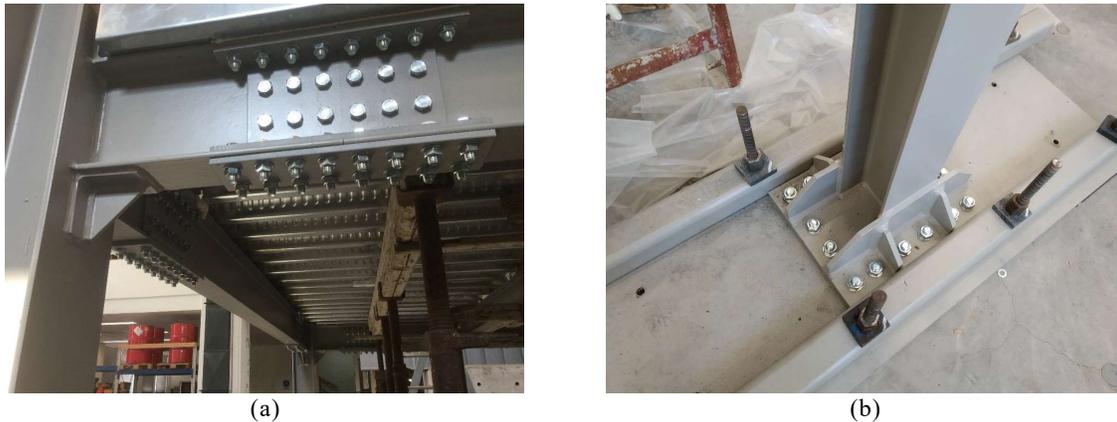
Figure 4. Positions of stiffeners at (a): beam-column connections and (b) column bases.

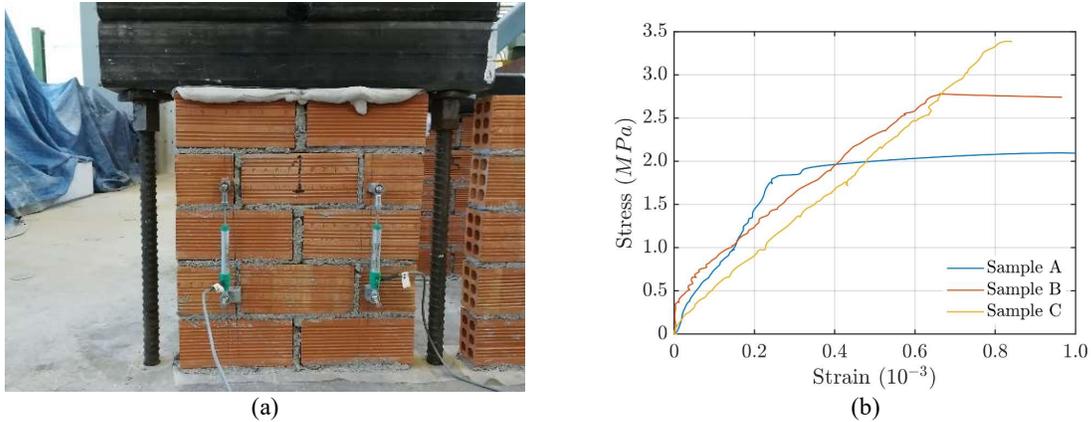
Figure 5. (a) Typical setup for masonry compression test; (b) Strain-stress for different masonry compression test specimens.

294 Material properties for masonry infills were investigated through masonry compression tests according to the EN 1052-1
 295 [50] recommended by Eurocode 6-Part 1-1 [51]. The typical test setup is shown in Figure 5(a), while the stress-strain
 296 curves are reported in Figure 5(b).
 297

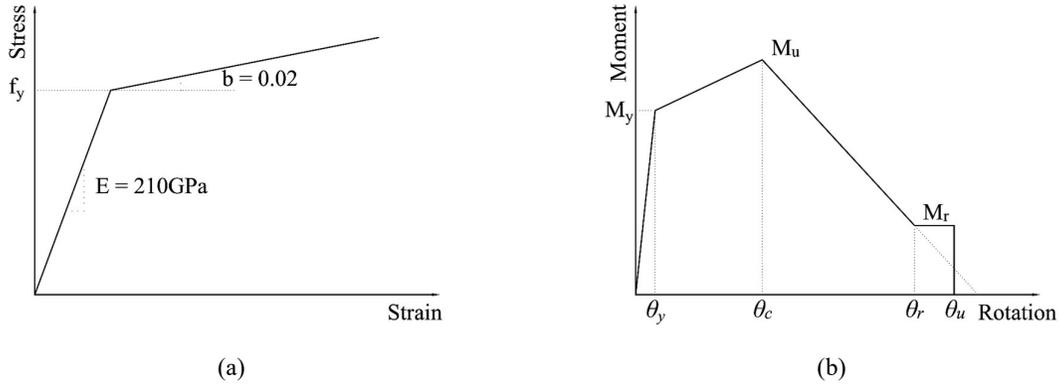
Figure 6. Material properties: (a) S355 steel; (b) Model of the beam plastic hinges (See values in Table 10).

322 were modelled with zero-length elements, whose properties were initially calibrated using the moment-rotation
 323 relationship proposed by Lignos and Krawinkler [53] and were further modified based on Zareian and Medina [54] (See
 324 Figure 6(b) and Table 10). Connections were considered fully rigid due to the welded connection type and the stiffeners
 325 placed at beam-column joints. Besides, since the tests were performed in the direction along the columns' weak axis, the
 326 flexibility due to the shear behaviour of the column panel zones was neglected. All column base nodes are fixed to the
 327 ground, and a rigid diaphragm is used to simulate the presence of the composite slab. Gravity loads were applied on the
 328 beams by considering the seismic combination of the Eurocode 8 [1], while the storey masses were equally distributed at
 329 the beam-column connections.
 330

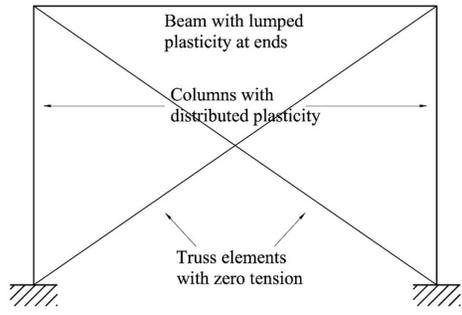
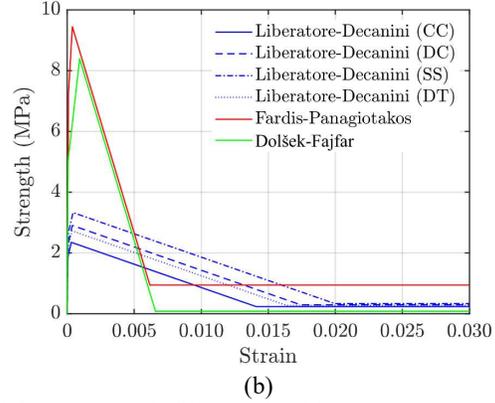
Figure 7. Schematic view of the single strut model for masonry infills and backbone curves.

422 alignment with the backbone curves of masonry struts in Figure 7(b), the Fardis-Panagiotakos model provided the largest
 423 estimate of ultimate strength of the prototype building, which was 2766 kN at 0.07% roof drift ratio, while the Liberatore-
 424 Decanini model had the lowest ultimate strength, which was 1115 kN at 0.04% roof drift ratio. The ultimate strength
 425 provided by the Dolšek-Fajfar model was 2497 kN at 0.13% roof drift ratio. Despite the considerable differences between
 426 the pushover curves, the three approaches achieved good agreement in terms of the seismic demands and capacities, as
 427 illustrated in Table 15. In general, the presence of masonry infill was beneficial to the resistance of the prototype building.
 428 The points of seismic demand were all at smaller top storey drifts than their corresponding points of capacity, hence the
 429 infilled frame was considered to fulfil the performance requirements of all limit states defined in EC8-3. Nevertheless,

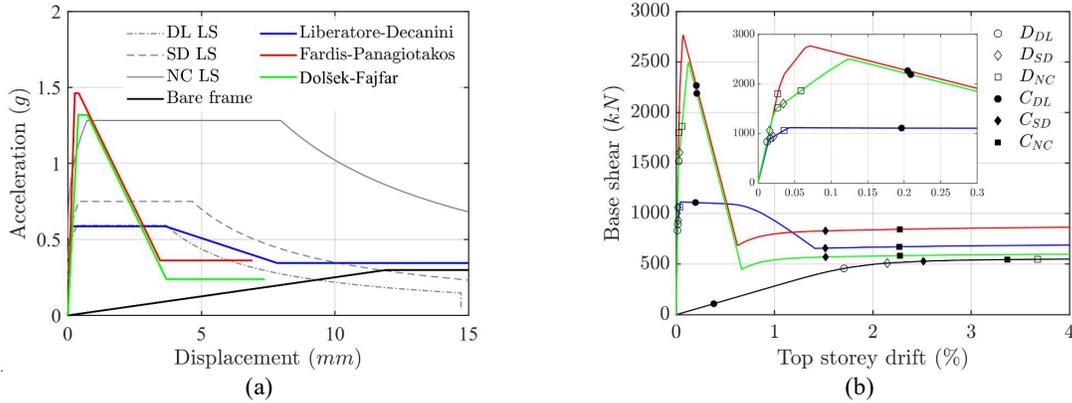
Figure 8. Pushover curves of the bare and infilled prototype building: (a) Implementation of the N2 methods; (b) Capacity curves with seismic demands (D) and capacities (C).

419 It can be seen in Figure 8 that the bare frame exhibited an ultimate strength slightly larger than 500 kN, and was
 420 considered unsafe for both the DL and SD limit state. In the case of infilled frames, it is demonstrated in Figure 8
 421 that the pushover curves obtained by the three approaches of masonry struts differed significantly from each other. In

430 the presence of masonry infills also reduced the displacement capacity of the case study building by 48, 40 and 33%,
 431 respectively, for DL, SD and NC limit state, compared to the capacity of the bare frame. The reduction in the displacement
 432 capacities was due to the soft storey mechanism at the first storey, whose capacity dominated the overall capacity of the
 433 infilled steel building.
 434

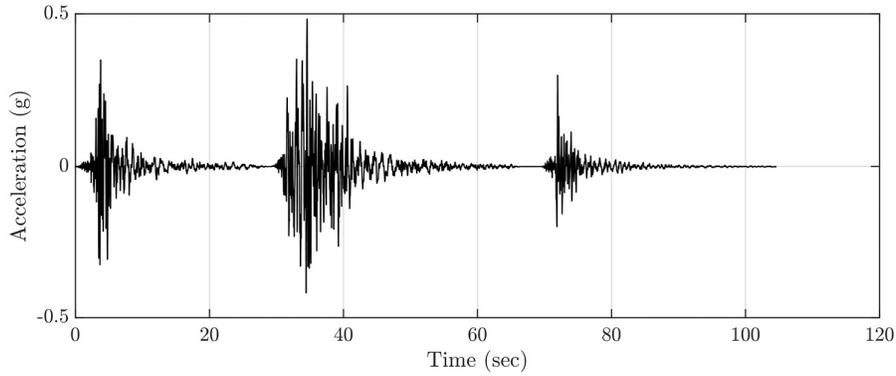
Figure 9. Time history of the seismic sequence.

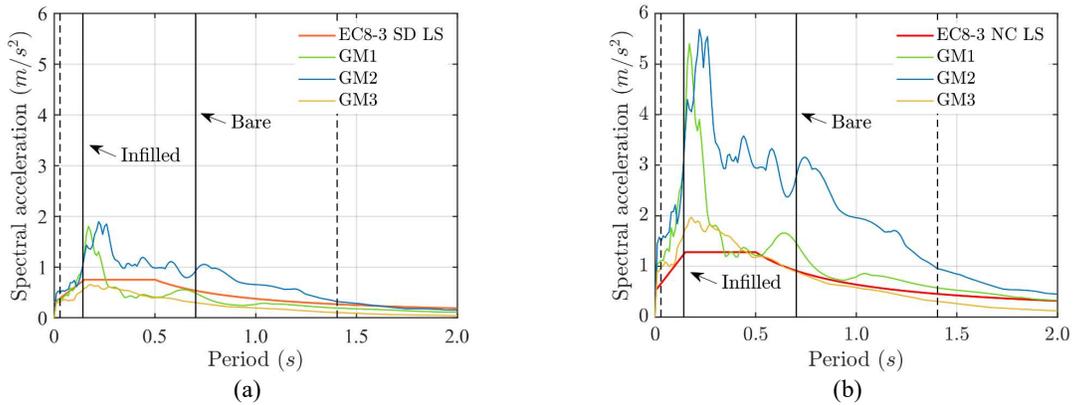
Figure 10. Comparison of the response spectra of selected ground motions with the elastic response spectrum suggested in EC8-3: (a) Unscaled ground motions at significant damage limit state; (b) Scaled ground motions at near collapse limit state.

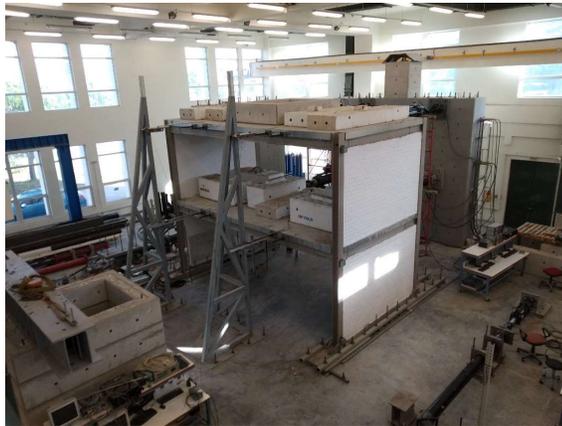
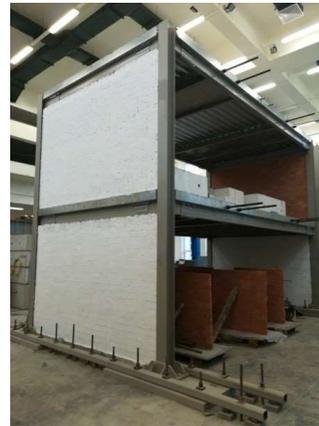
Figure 11. Layout of the setup used for the 3D structure.

The setup of the 3D test is shown in Figure 11. The tested structures were designed and built based on the common European constructional practice. Therefore, the steel frames were welded and prepared in the workshop and fully assembled on-site (*i.e.*, in the lab for this case). Two parallel tubular beams were placed on top of each steel base plates and anchored to the strong floor of the lab in order to increase the rigidity of the base restraints of the mockup. The composite slab was built following the erection of the bare steel frame. Indeed, the corrugated steel sheetings were installed on the beams and once fixed with the shear connectors. The concrete constituting the slab was cast and poured on-site.

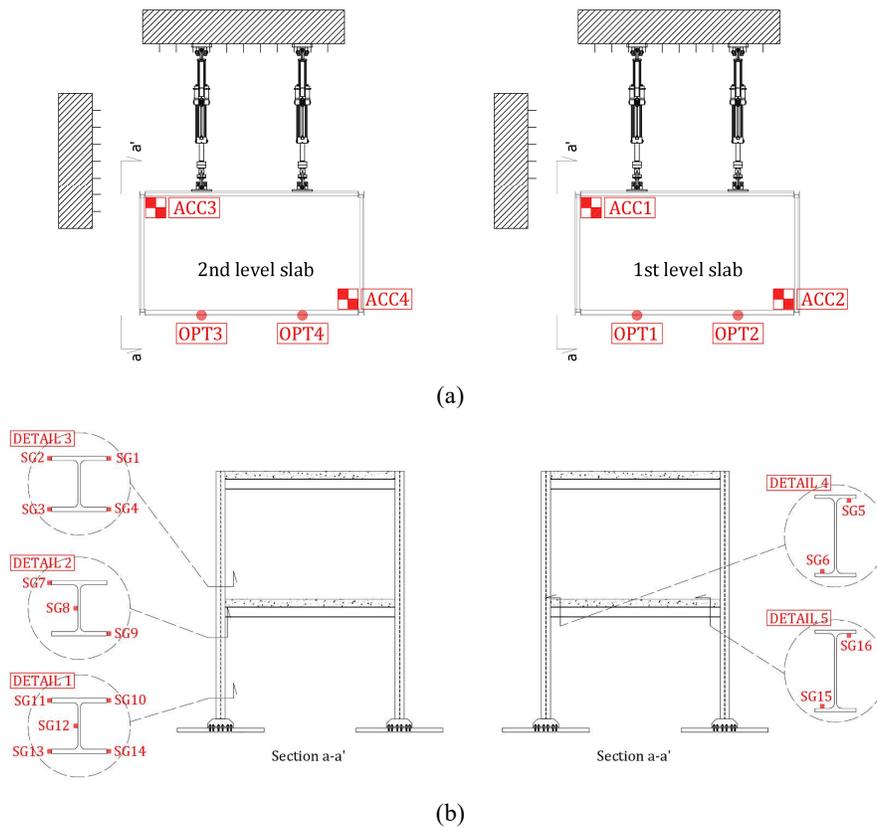
Figure 12. Locations of actuators and sensors on the 3D scaled steel frame.

519
 520 The instrumentation for the PsD tests was designed to monitor the response of several structural components, however,
 521 only those relevant to this study are described here and are summarised in Table 18. Apart from the accelerometers used
 522 in the free vibration tests (Figure 12(a)), a total of four displacement-measuring optical devices were utilised in the test
 523 to monitor storey displacements, with two at each storey, whose locations are demonstrated in Figure 12(a) as well.
 524 Furthermore, 16 strain gauges were also utilised to measure the strains induced in columns and beams, whose locations
 525 are shown in Figure 12(b). It can be seen that the measurement of strain primarily focused on the steel components at the
 526 first storey, which was decided on the basis of the number of strain gauges available during the test.
 527

Figure 23 presents the strain measured at certain cross-sections of steel components of the test mockup (See Figure 12(b) for the locations of monitored cross-sections and the strain gauges), which are normalised to the strain at yielding obtained from the coupon test. It can be seen that no yielding was detected until the last cycle of the PsD test, where yielding was noticed in the first floor column only, as shown in Figure 23(a) and (b). For the p column where yielding was detected, yielding only occurred in its flanges while its web remained elastic. Besides, large plastic deformation was found at the cross-section close to the column base, with a peak strain of more than twice the yield strain, as shown in Figure 23(a). On the other hand, the top region of the first floor column was anticipated to experience limited plastic deformation, as shown in Figure 23(b), since the peak strain at the monitored cross-section only slightly exceeds the yield strain. Lastly, the monitored cross-sections of the first floor beam remained elastic throughout the entire PsD test, which suggested that all beams of the test mockup were not damaged.

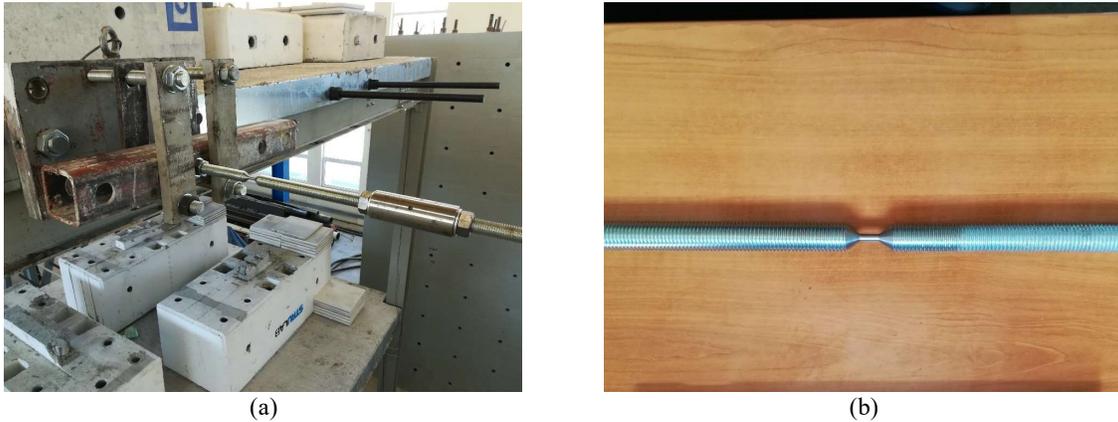
Figure 13. The apparatus for the snap-back free-vibration test (a); details of the rod with reduced section (b).

3D FE models of both the bare and infilled configurations of the test frame were also developed in OpenSees [36]. The modelling procedure followed the same approach described in Section 3.2 as per the prototype frame. As summarised in Table 16, snap-back free-vibration tests were firstly performed on the bare (*i.e.*, ‘Test 1’) and the infilled frame (*i.e.*, ‘Test 2’) for comparison of the initial stiffness and natural periods. At the beginning of each snap-back test, the structure was pulled at the top storey through a rod with reduced section, as demonstrated in Figure 13, which broke at a certain predefined level of load, allowing the sudden release of force and free vibration of the tested frame. The forces applied to the bare frame and the infilled frame were 26 and 62 kN, respectively.

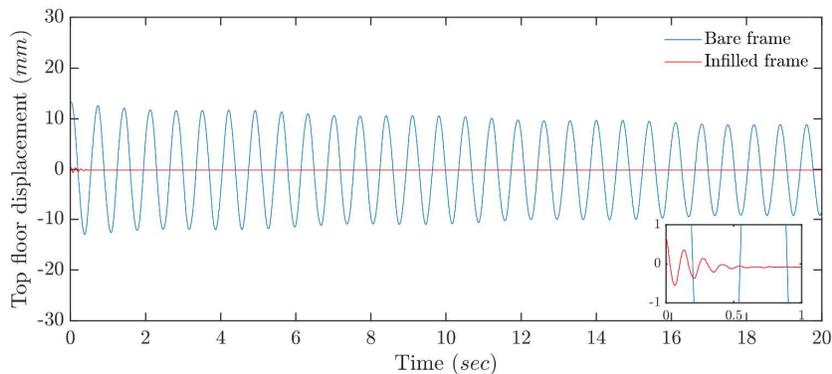
Figure 14. Time-history of top floor displacement of the test frame obtained from snap-back tests.

Figure 14 shows the time-history of the mean top floor displacement of the test frame. It can be seen that despite a larger initial force was applied to the infilled frame, the consequential displacement induced at the top floor of the infilled frame was much smaller compared to the case of bare frame, due to the higher lateral stiffness of the infilled frame. Also, the infilled frame’s vibration decayed much faster than the bare frame, indicating higher damping caused by the presence of infills. Figure 15 shows the profiles of initial lateral displacements of the test frame obtained numerically and experimentally for the purpose of calibrating the numerical model based on initial stiffness. It is clear that the initial displacement profile of the bare frame achieved a good match with the experimental results, as shown in Figure 15(a), where the differences were smaller than 5% according to Table 19. On the other hand, the comparison of the infilled frame’s initial displacement is shown in Figure 15(b), where it can be seen that the numerical model had a much larger initial stiffness than the lab specimen, as the initial displacements obtained from all three models were significantly underestimated by approximately 60% at both storeys. Given the good match of the numerical and experimental results for the bare frame, the infilled frame’s higher initial stiffness has to be attributed to the overestimated initial stiffness of the adopted masonry infills models.

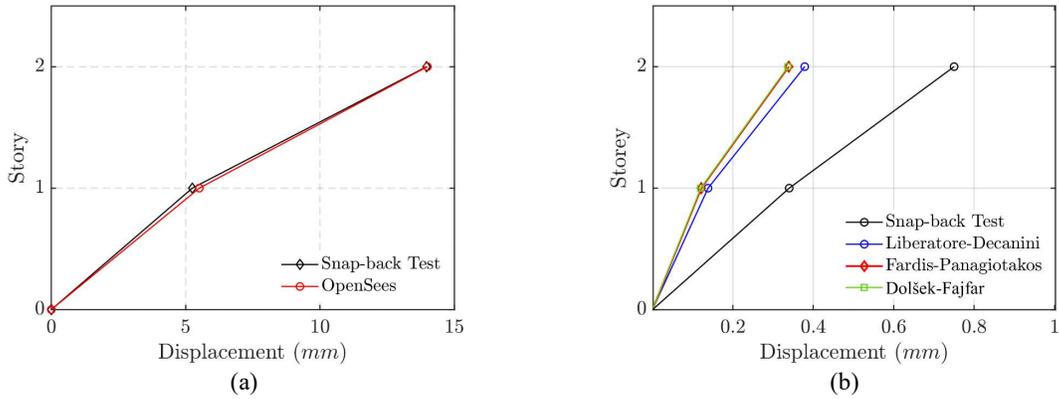
Figure 15. Initial displacements induced by actuators: (a) bare frame and (b) infilled frame.

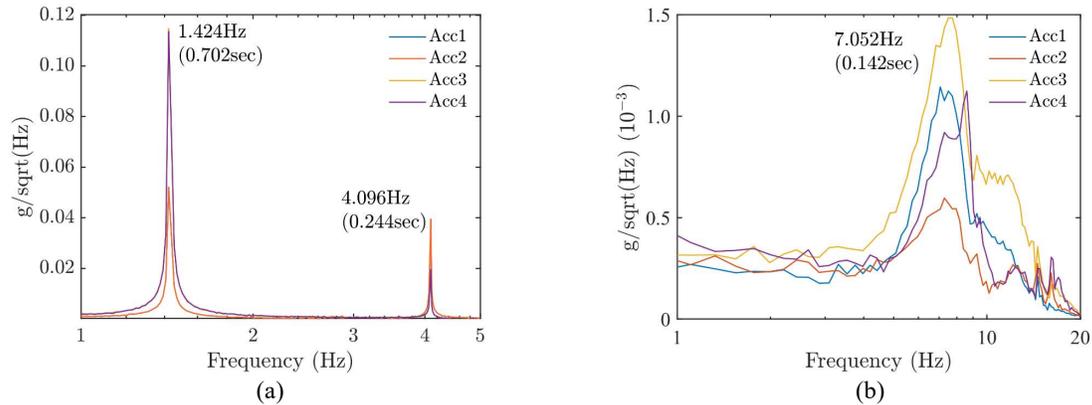
Figure 16. Power spectral density: (a) the bare frame; (b) the infilled frame (low-pass filter applied at 20Hz).

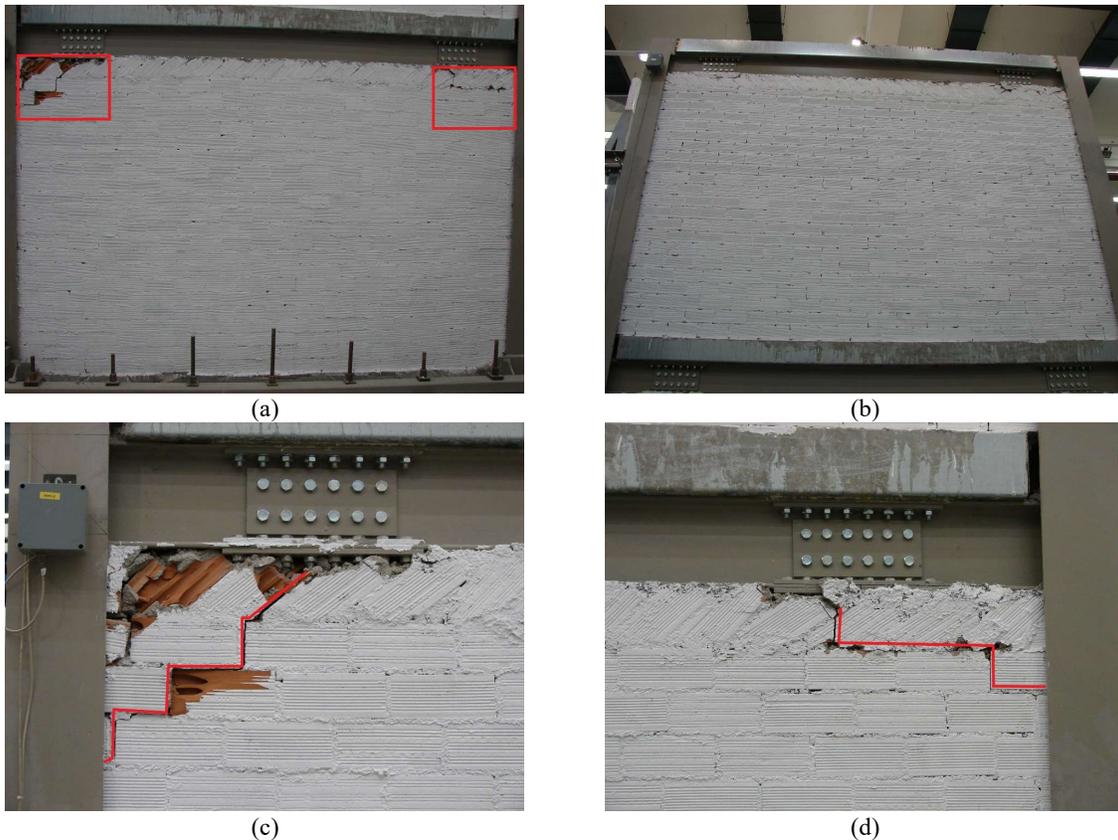
Figure 17. Damage observed on the infilled steel frame during 'Test 3' and 'Test 4': (a) first floor infill wall; (b) top floor infill wall; (c) detail of cracks at the top left corner; (d) detail of cracks at the top right corner.

588 During 'Test 3', the infilled frame was subjected to the first component of the earthquake sequence with SF equal to 1.
589 The damage was firstly observed at the top corners of infill walls next to the beam splice connections, where the interlock
590 between the bolts and the top layer of bricks created a strut at the corner, resulting in local crush around the bolts and
591 cracks at corners, as shown in Figure 17 and demonstrated in Figure 18. The cracks were originated from the bolts in the
592 beam splice connections and propagated along the bricks' surface to the edge of the infill wall panel. This damage at top
593 corners must be distinguished from the corner crush damage pattern, one of the most common damage modes on infill
594 walls summarised in literature [58], where the strut formation is corresponding to the entire infill wall panel, hence cracks
595 normally occur at both corners, *e.g.*, top-right and bottom-left, in the diagonal direction.

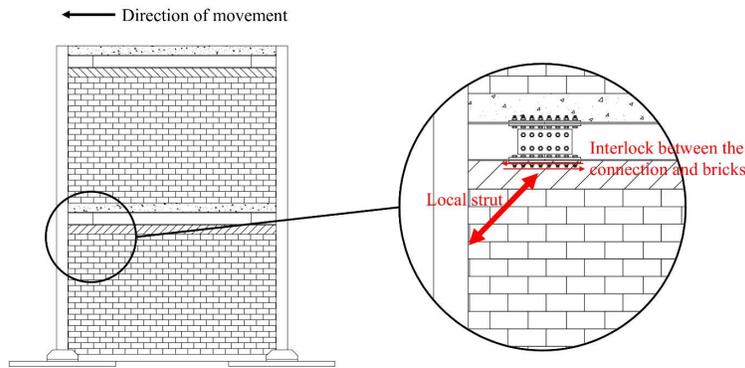
Figure 18. Demonstration of the formation of local struts near the beam splice connection.

- The local crush and cracks at top corners of infill walls were due to the interlock between bolts in the beam splice connections and the top layer of brick, which caused the formation of local struts at top corners of infill walls and might have effectively prevented the corner crush damage mode due to the formation of global diagonal struts across the infill wall panels. This is considered a distinctive feature of the infilled steel frame from RC frame;

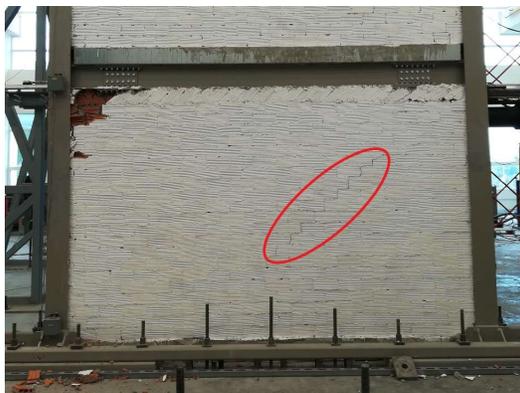
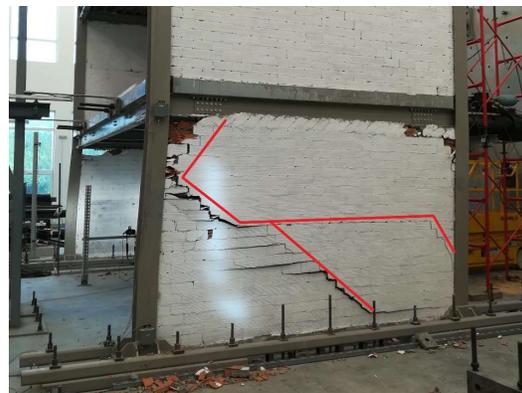
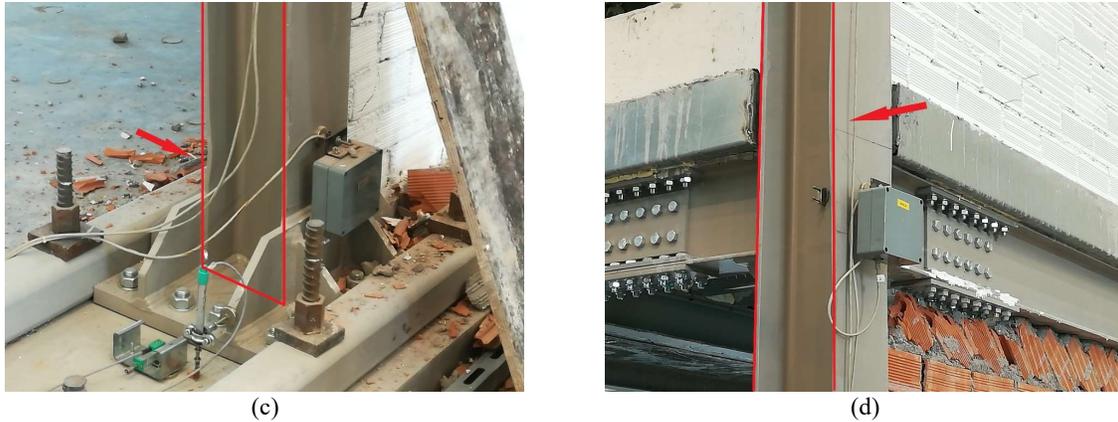
Figure 19. Damage pattern on the infilled steel frame during Test 5: (a) diagonal cracks; (b) combination of corner cracks, diagonal cracks and sliding shear damage pattern (c) yielding at column base (see the flange buckling pointed out by the red arrow); (d) yielding at beam-column joint (see the bending deformation of the column flange in the test direction highlighted by the red arrow).

During ‘Test 5’, where the structure was subjected to the earthquake sequence with SF equal to 3, significant drifts were observed at both the first and top floor, and the test was terminated during the second ground motion component when the IDR was approaching 5%. For the masonry infills, the crush at top corners became larger with some bricks falling onto the ground. Also, three additional damage pattern were observed on the infill walls, which were similar to what typically occurs to the infill walls in RC structures namely: (i) the diagonal cracks due to tension, (ii) the sliding shear at mid-height of wall, and (iii) the diagonal compression mode leading to out-of-plane failure (which is due to the slenderness of the wall). Initially, the diagonal crack occurred only at the central part of the infill wall, as shown in Figure 19(a), but a horizontal crack subsequently developed at approximately mid-height of the wall, together with out-of-plane deformation of the wall, as shown in Figure 19(b). Besides the damage on the infill walls, significant yielding was also observed at columns, particularly near column base and beam-column joints, as highlighted in Figure 19(c) and (d). Lastly, it should be noted that at the top floor, only the cracks at top corners and diagonal cracks were observed on the infill walls, so the damage was considered limited compared to the severe damage at the first floor.

665 and 0.84% respectively at the first and top storey, which were more than three times the peak IDR during its counterpart
 666 in 'Test 4'. Eventually, the PsD test was terminated during the second ground motion of 'Test 5', when the IDR of the
 667 lab specimen was approaching 5%. In this case, it can be seen from Figure 20(c) that the lateral displacement at the first
 668 floor became evidently more significant than the displacement at the top floor, particularly during the second ground
 669 motion when the collapse of the first floor infill wall happened. Therefore it can be anticipated that a severe soft storey
 670 mechanism would occur at the first storey of the test frame if the test continued, particularly when the infill on the ground
 671 was about to fail and collapse, as shown in Figure 19(b).
 672

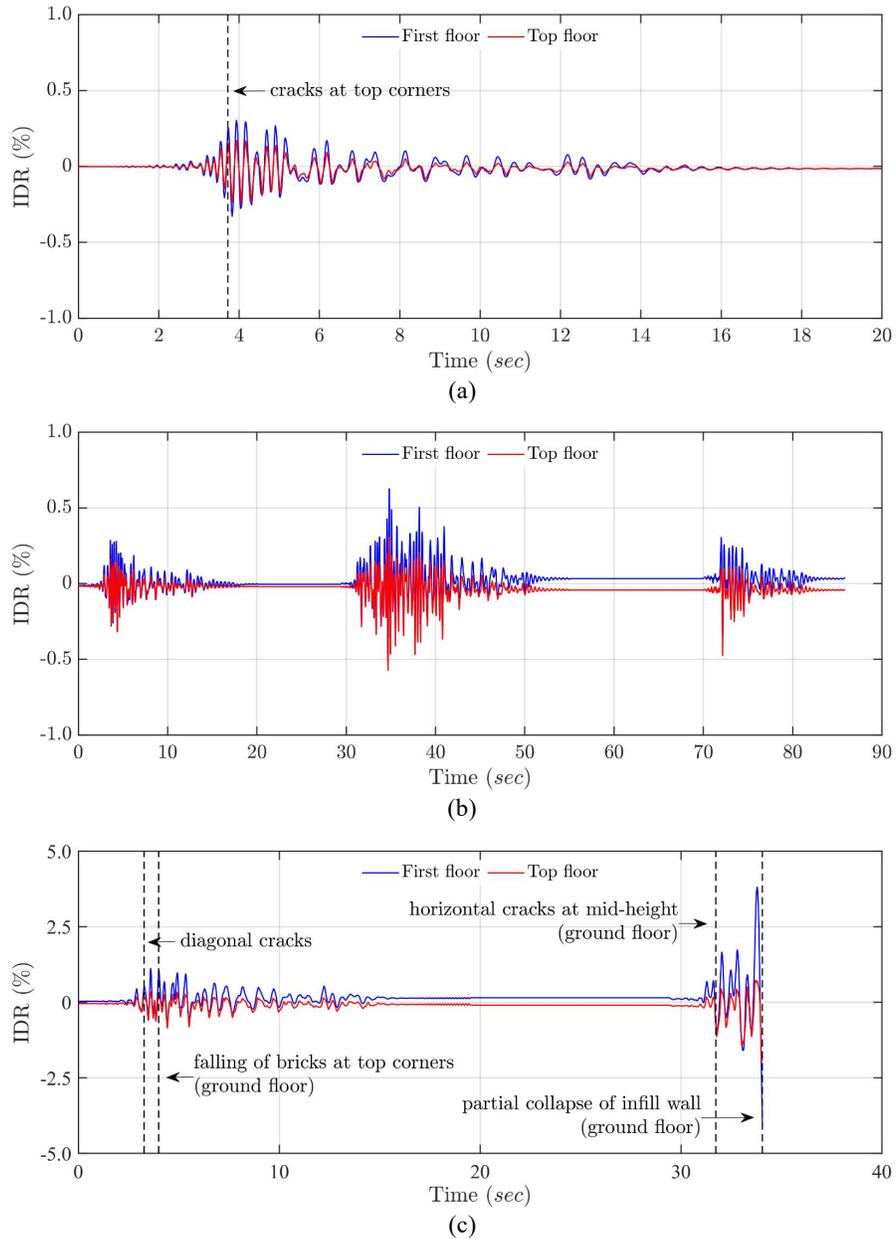
Figure 20. Displacements recorded at both storey of the tested frame: (a) 'Test 3'; (b) 'Test 4'; (c) 'Test 5'.

Figure 20 shows the time-history of IDR at both storeys of the tested frame during each PsD test session. The test frame was only slightly damaged after 'Test 3' and 'Test 4', as indicated by the negligible permanent drifts at both storeys (see Figure 20(a) and (b)). The peak IDR was 0.33% and 0.25% for the first and top storey during 'Test 3', and was 0.30% and 0.32% during the first component of 'Test 4', where only a small increment was observed. During the second component of 'Test 4', the peak IDR was raised to 0.63% and 0.57%, respectively, for the first and top storey, which were approximately twice the peak IDR with respect to the previous ground motion's component. Subsequently, during the last component of 'Test 4', the peak IDR was 0.34% and 0.48% for the first and top storey, respectively. A soft-storey mechanism at the first floor did not occur as expected at this stage, where the displacement at both storeys was very similar to each other during both 'Test 3' and 'Test 4'. This was due to the fact that the damage on the masonry infill was very limited and similar at both storeys, where only cracks at the top corners of each wall were noticed. During 'Test 5', the structure was subjected to up-scaled earthquake records with SF=3, and significant drifts were observed at both the first and top storeys (see Figure 20(c)). The peak IDRs during the first ground motion's component of 'Test 5' were 1.24%

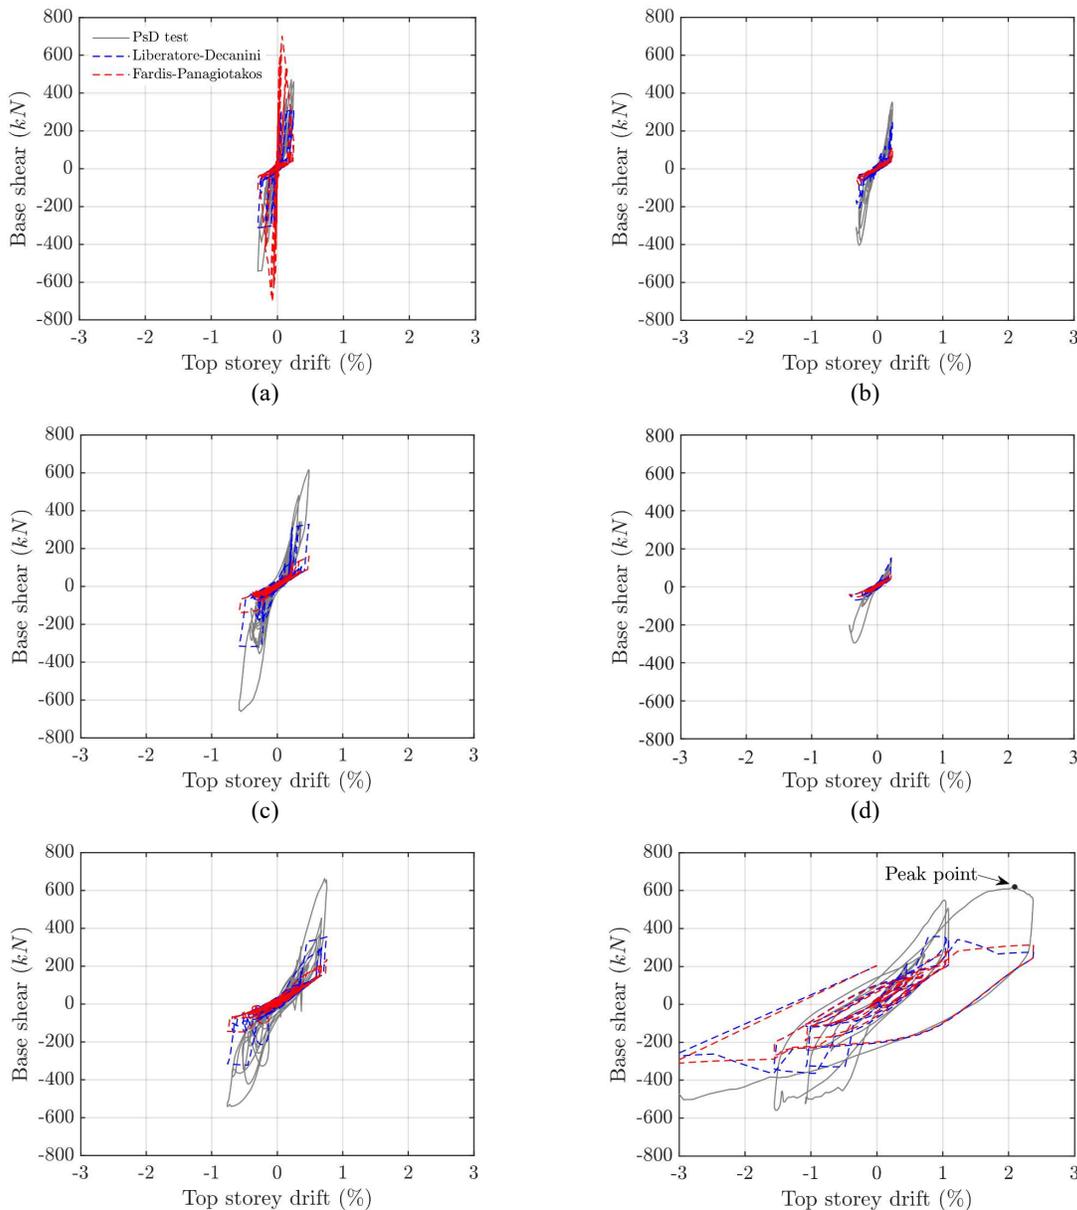
(e) (f)
 Figure 21. Cyclic response of the mockup: (a) Test 3; (b) Test 4-GM1; (c) Test 4-GM2; (d) Test 4-GM3; (e) Test 5-GM1; (f) Test 5-GM2.

673
 674 Figure 21 shows the comparison between the experimental and numerical cyclic response of the infilled frame, and Table
 675 22 contains comparison of peak base shear obtained numerically and experimentally. The experimental results indicated
 676 that during 'Test 3', 'Test 4' and the first ground motion's component of 'Test 5', the mockup experienced little plastic
 677 behaviour despite the slight pinching effects due to the opening and closing of the cracks at the top corners of infill walls.
 678 Then during the last ground motion's component, the mockup experienced large plastic deformation and exhibited
 679 significant pinching effects, as new cracks occurred and existing cracks became wider. According to the structural
 680 response in Figure 21(c), (e) and (f), it can be inferred that the mockup had an ultimate strength higher than 650 kN,
 681 which deteriorated to around 600 kN at the end of the PsD test. Besides, as shown in Figure 21(f), the mockup started to

682 exhibit a negative stiffness and also a drop of strength at about 2.1% top storey drift. Degradation of stiffness was also
 683 observed, as also demonstrated in Figure 22, which shows the initial stiffness at the beginning of each test. The lateral
 684 stiffness was initially around 90 kN/mm but dropped to about 60 kN/mm after ‘Test 3’ due to cracks on the infill. The
 685 large reduction of stiffness was noticed at the start of the third ground motion of ‘Test 4’, during which the stiffness
 686 decreased from 60 to 30 kN/mm as cracks on the infill became more severe. Eventually, the lateral stiffness dropped to
 687 around 15 kN/mm during ‘Test 5’, during which the damage on the infill walls became more extensive due to the increased
 688 ground motions intensity.
 689
 690
 691

By comparing the numerical results with the experimental measurements, it can be seen in Figure 21(f) that the Liberatore-Decanini model had an ultimate strength of around 350 kN, which was 46% lower than the real strength of the test frame. Nevertheless, it only showed negative stiffness during the second ground motion of ‘Test 5’, which agrees with the experimental observations. On the other hand, the Fardis-Panagiotakos model showed an ultimate strength of about 700 kN, which was slightly higher than the test frame’s real capacity, as can be seen in Figure 21(a). However, its masonry infill on the ground failed during the first test by reaching the residual strength, which explained the considerably lower strength of this model in the following tests (*i.e.*, less than 200 kN during ‘Test 4’ and around 300 kN during ‘Test 5’). The Fardis-Panagiotakos model reached its ultimate strength at about 0.07% top storey drift, which was very small compared to the 2.1% drift of the test frame and the 0.78% drift of the Liberatore-Decanini model. This result was consistent with the measured initial stiffness and fundamental period (see Figure 15 and Table 20). Apart from that, the total failure of masonry struts in the Fardis-Panagiotakos model during ‘Test 3’ suggested that it had a very steep post-peak negative stiffness, which led to the quick loss of strength of the infills at very small displacements. It can then be concluded that the Liberatore-Decanini model significantly underestimated the strength of test frame, so that the relevant formulae to determine the strength associated with different damage patterns need further investigation since the interaction between the local struts and the column flanges is not accounted for. Meanwhile, although the Fardis-Panagiotakos model provided a ‘good’ estimate of ultimate strength, it does not achieve the same level of accuracy for other experimental tests, as formerly pointed out by Mohammad Noh *et al.* [21]. Moreover, due to the much higher initial stiffness, as shown in Figure 22, both models underestimated the displacement considerably at both ultimate strength and the onset of residual strength, since those displacements depend on the initial stiffness. Lastly, as demonstrated in Figure 22, the stiffness of the mockup was found to be considerably overestimated by the selected modelling strategies before the PsD test. However, as the damage on the infill wall became more severe, the stiffness of the numerical models became closer to the actual stiffness of the mockup.

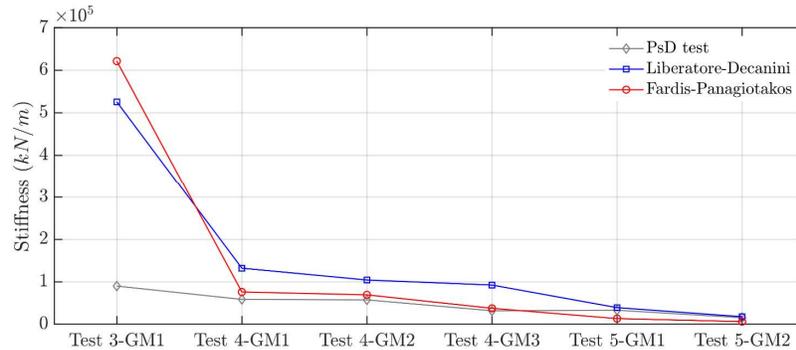
Figure 22. Comparison of the initial stiffness of the mockup at the beginning of each test.

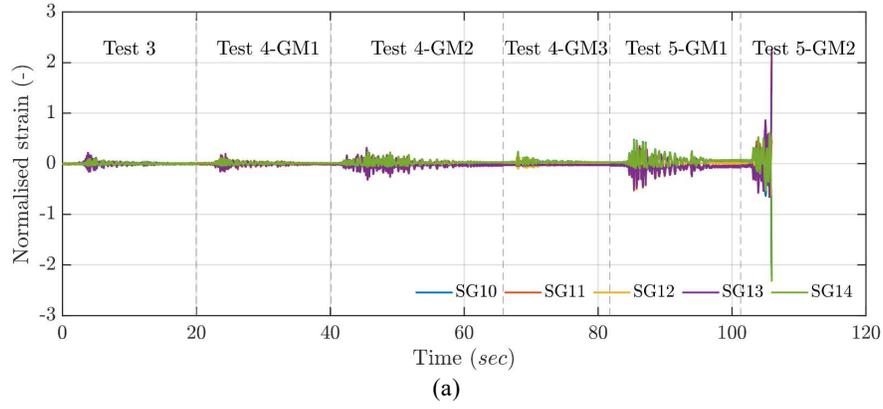
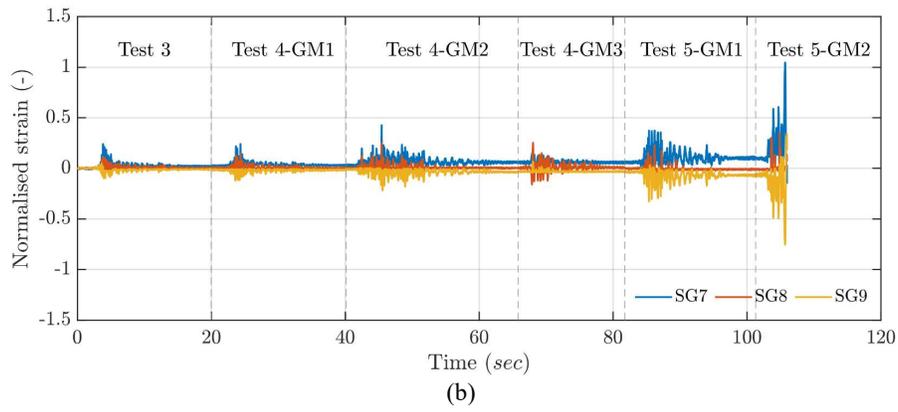
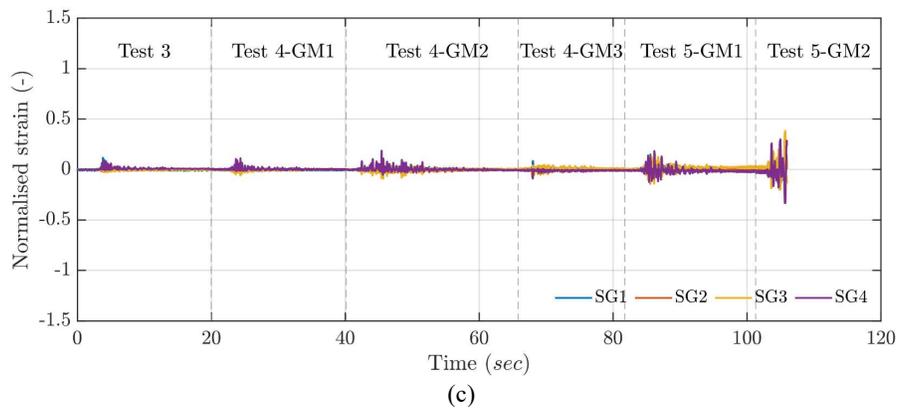
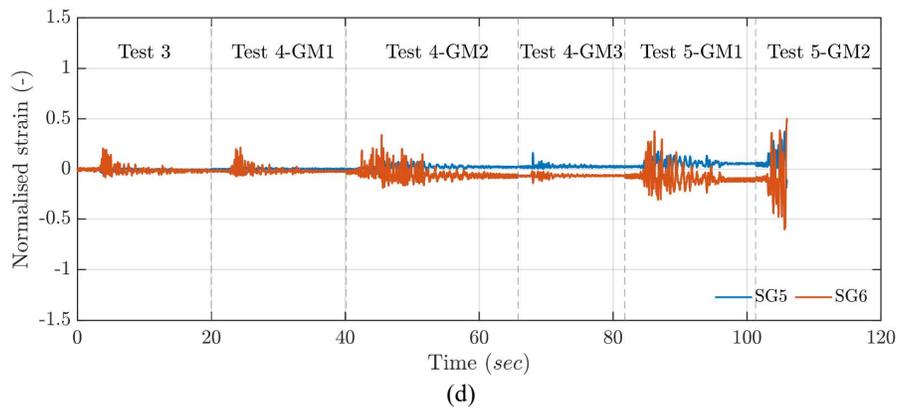
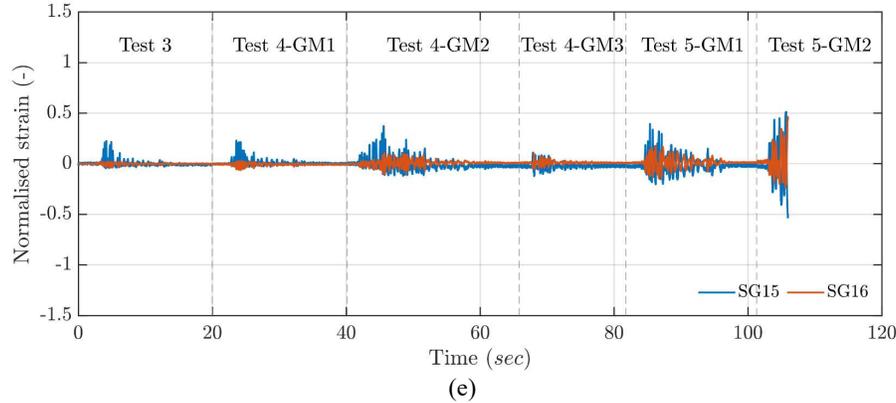
Figure 23. Normalised strain (unit strain at yielding) measured at signeted cross-sections of column and beam (See Figure 12(b)): (a) Detail 1; (b) Detail 2; (c) Detail 3; (d) Detail 4; (e) Detail 5.
