# Industrial application of a low-cost structural health monitoring system in large-scale airframe tests

*J Strain Analysis*

DOI: 10.1177/03093247231222951

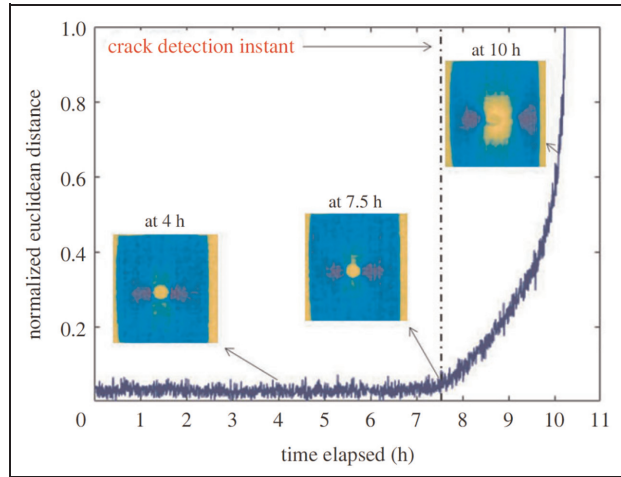
**Figure 1.** An example of damage monitoring through orthogonal decomposition of CATE data collected during cyclic loading under laboratory conditions. From Amjad et al.<sup>24</sup>

This prototype system has been used previously in laboratory tests on simple specimens subjected to cyclic and flight-cycle loading. Figure 1 shows an example of this, where an increase in damage has been determined from the full-field thermal emission data using orthogonal decomposition, and the feature vector difference (Euclidean distance) between vectors representing an initial and the current state is shown to increase as a fatigue crack initiates and propagates. Here, we extend that work to show the application of this system in

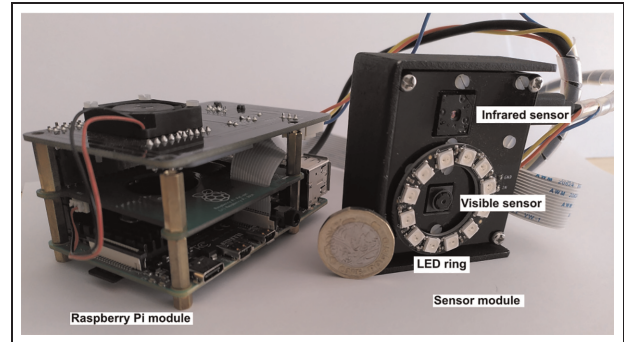
**Figure 2.** Sensor unit comprising a Raspberry Pi module (left) and sensor module (right) with £1 coin shown for scale.

Each sensor unit is manufactured from COTS (commercial-off-the-shelf) components, and consists of a Raspberry Pi module, containing the control computer and related control boards, and a sensor module, comprising an infrared sensor (Lepton 3; Lepton 1.5 in earlier systems, FLIR) and a visible sensor (Sony IMX219 8-Megapixel Sensor) with accompanying LED ring light (Figure 2). The Pi and sensor modules can be mounted together as a fixed unit, or, for spatially restricted installations, the sensor module can be fitted at the region of interest with the Pi module at a more convenient location, constrained by the cabling between the modules. Here, a maximum of two units were used concurrently, however a higher number of units can be used simultaneously, controlled by the capacity of the Ethernet switch.

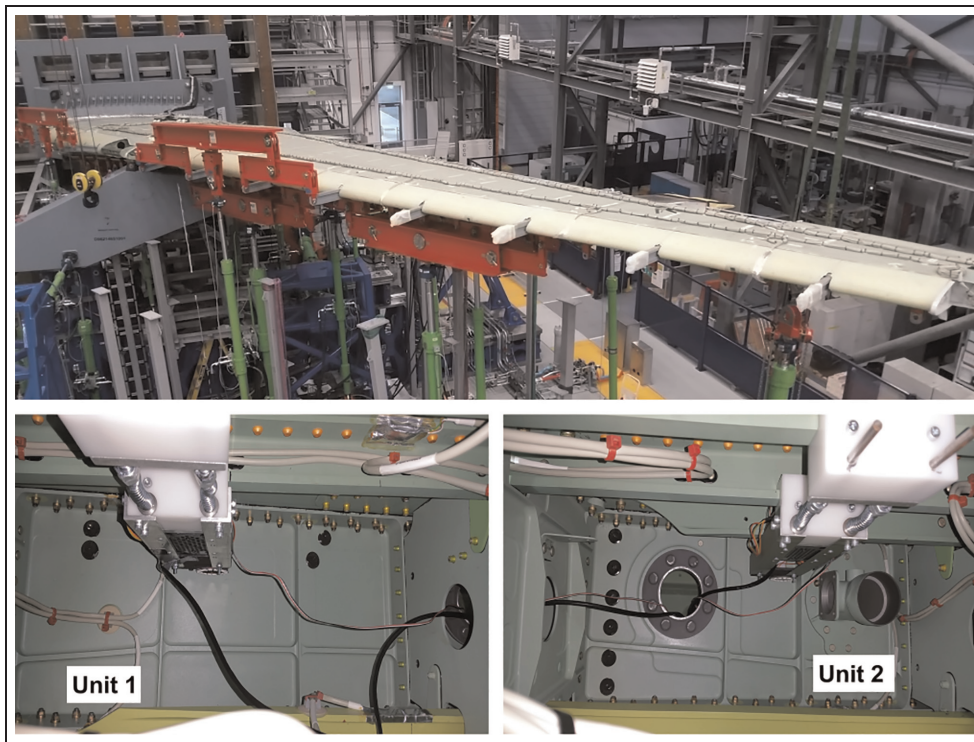
**Figure 3.** Installation of system in wing fatigue test. Top: View of the fatigue test rig, bottom: two sensor units installed in adjacent rib bays.

1.5 sensors was on a full-scale wing fatigue test at the Airbus AIRTeC (Aerospace Integrated Research and Test Centre) facility in Filton, Bristol UK. Two rib-bays were identified for internal installation of the sensor units before closure of the Fuel Tank Access Covers (FTACs). Modules were clamped to stringers on the topside of the wing with sensors facing down to regions of interest on the junction between the front spar and the lower cover (Figure 3). Each sensor unit received input from a dedicated RSG close to its position but out of its field of view.

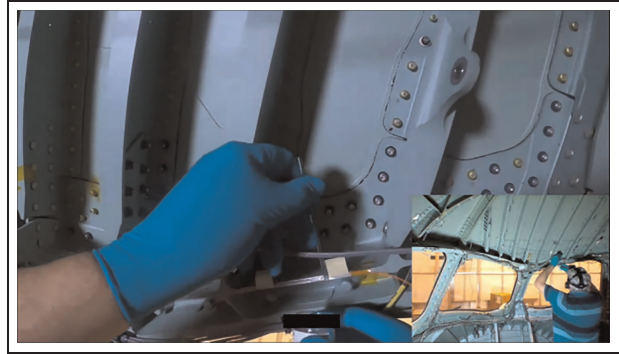
**Figure 4.** Installation of sensors in a fuselage test. Main image is a view from operator headset, inset figure shows a wide view of the installation area.

The second industrial case study was a fuselage section undergoing pressurisation and depressurisation cycles at Airbus, Toulouse, France. Due to travel restrictions during the Covid-19 pandemic, a remote installation procedure was developed in order to guide Airbus personnel through deployment of the system. A crack in the internal frame was identified, and the sensor unit was located to image this region of interest with a speckle pattern applied before data collection began. Figure 4 shows the installation of the system in the internal structure of the fuselage.

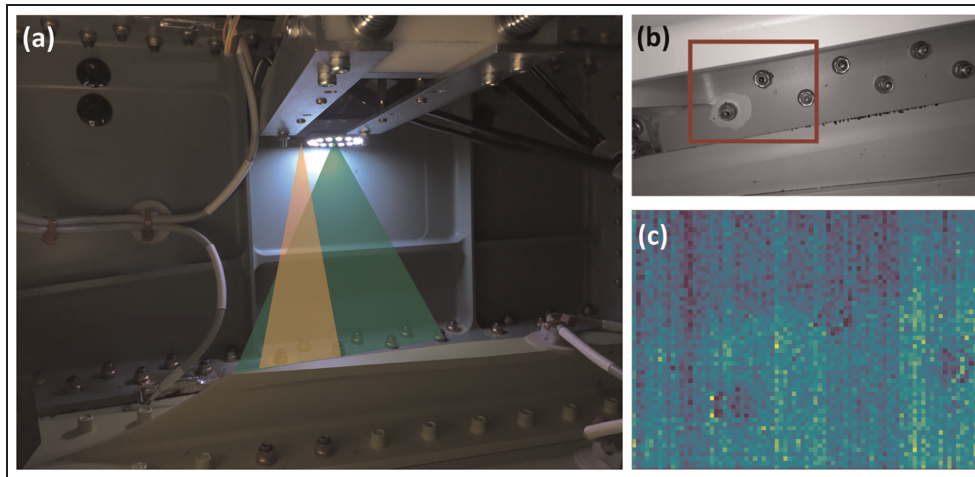
**Figure 5.** (a) sensor module installed in rib bay, overlain triangles illustrate approximate Fields of View (FOV) for infrared (left) and visible (right) sensors; example outputs from (b) visible sensor and (c) CATE data map. The red rectangle in (b) indicates the approximate FOV of the CATE map.

infrared images were collected during the fatigue loading. The infrared images were combined with the local strain data reported by the gauge to generate CATE data. An installed sensor unit and example outputs are shown in Figure 5. Data was successfully collected from inside the two wing boxes during representative fatigue loading over several weeks.

Although time and access restrictions did not allow for speckle application, the consistent output of visible images suggests that DIC processing would be possible using data from this, or a similar, installation. The CATE map in Figure 5(c) shows the position of rivets, likely due to the relative motion of the camera compared to the field of view, but there are no other indications of stress concentrations. No damage was expected to develop in the rib-bays monitored during the time-frame of data collection on the wing. Therefore, the absence of observed stress concentrations or changes in CATE maps was an expected result.

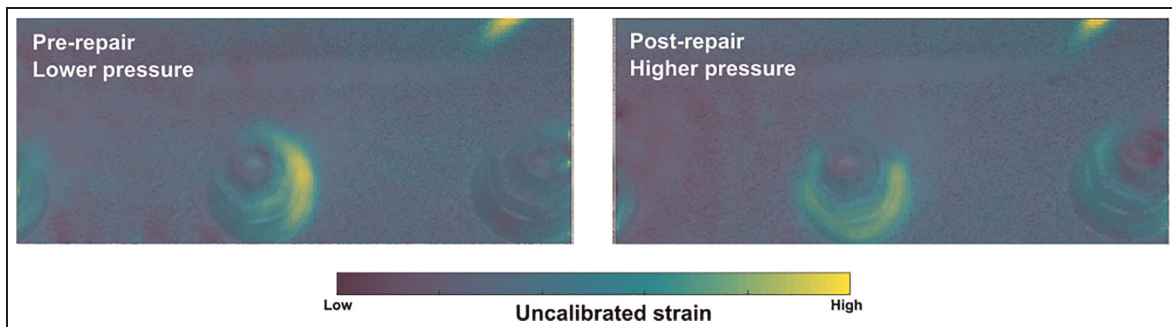
**Figure 6.** Uncalibrated maximum principal strains pre- (left) and post-repair (right). The fuselage was pressurised to a higher level after repair (by a factor of  $\sim 2$ ), but the local strains related to the crack are similar in both.

Data were collected from the fuselage test over a period of months, with some intervals where loading was paused, for inspection or repair. One repair was carried out on the crack in the internal frame that was inside the FOV of the system. Figure 6 shows the uncalibrated strain maps indicating the crack position pre- and post-repair. As the orthogonal decomposition technique relies on comparisons between datasets, it is not necessary for strains to be calibrated, and therefore only relative values are shown in these uncalibrated strain maps. Due to differences in pressurisation before and after repair, it was not possible to collect images at the same local strain as reported by the RSG. However, the effect of the repair can be observed, as similar local values of uncalibrated DIC strain are reported, even at higher pressurisation.

Uncalibrated DIC strain maps were decomposed, and the feature vector difference reported between a reference image and later images. Unfortunately, after the repair shown in Figure 6, the sensor module was

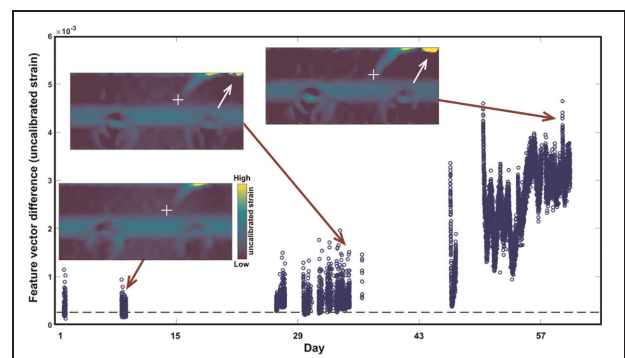
**Figure 7.** Feature vector difference against time for the FOV during the pressurisation test. Data points related to images collected during depressurisation have been excluded during post-processing (see text). Inset figures show uncalibrated maximum principal strain maps from DIC processing. Overlain white cross is shown at the same position in each inset figure and can be used as a reference for the reader to visualise the evolution of crack position with time. Arrows indicate development of a secondary strain concentration. Horizontal dashed line represents the noise floor, here defined by averaging the standard deviation of a series of uncalibrated strain datasets collected at zero load.<sup>26</sup> Gaps indicate times when the loading was paused.

The repositioning of the sensor unit also resulted in an irregular connection between the sensor unit and the processing computer, which interrupted the data collection algorithm. To solve this problem on a time scale that allowed data collection during the test, the algorithm was modified so that a series of visible images were collected and processed at, or near, peak strain. To exclude images collected during depressurisation and when the peak strain was no longer being experienced, the timing between images was interrogated in post-processing and only results from one image of each of these series were reported. For simplicity, the first image of each series was chosen. The feature vector difference after repositioning until the end of data collection is shown in Figure 7, along with example uncalibrated DIC strain maps at given times.

Crack growth is seen in the inset figures, as the crack tip moves further into the FOV, and a secondary strain hotspot develops. The appearance of this new strain

concentration may be related to the growth of a new branch of the crack, close enough to the FOV to influence the strain field. These changes correlate to an increase in the feature vector difference. In contrast to the well-defined curve shown in Figure 1 from laboratory testing for simple loading, this line shows a significant amount of variation.

This variation in the feature vector difference may be due to slight differences in the maximum pressure experienced during each loading cycle, or visible images not being collected at the exact peak pressure for each cycle. Despite the noise, an increasing trend can be observed, particularly in data collected after day 29. Further processing of this signal could reduce the noise, but care would have to be taken to avoid removing details representing real changes if a smoothing approach were used. Alternative approaches could involve improvements in the triggering of image collection or normalisation by the applied load where known.

A band of, what appears to be, higher strain concentration above the rivets has appeared when comparing these inset figures to the pre- and post-repair data. This may be related to the problems of repositioning, and resultant images being slightly out-of-focus in this area.
